V8 XJ Series/XK

600-03

TECHNICAL BULLETIN

Part-Load Engine Breather – Partial Blockage of Restrictor – Scheduled Cleaning – Service Action S474 MODEL 1997-2001 MY XK Range 1998-2001 MY V8 XJ Series VIN

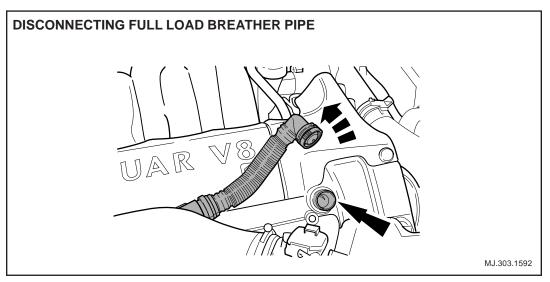
ILLUSTRATION 1

- 1. Open the hood. Cover the fenders with protective fender covers.
- 2. On normally aspirated engines, remove the engine cover from the left cylinder bank.
- 3. Start the engine.
- 4. Disconnect the full load breather line on the right camshaft cover, (Illustration 1).

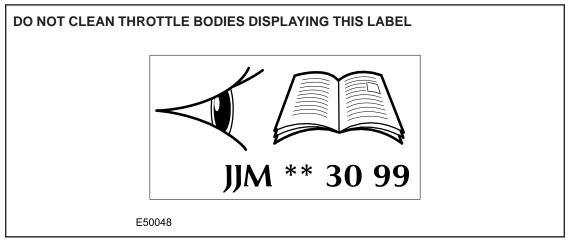
ILLUSTRATION 2

A Caution: If the throttle body displays the label shown in Illustration 2, do not clean the throttle body bore and butterfly valve as damage to the vehicle can result.
