## Jaguar V8 Engines 1997-2000 Preventive Tensioner Replacement

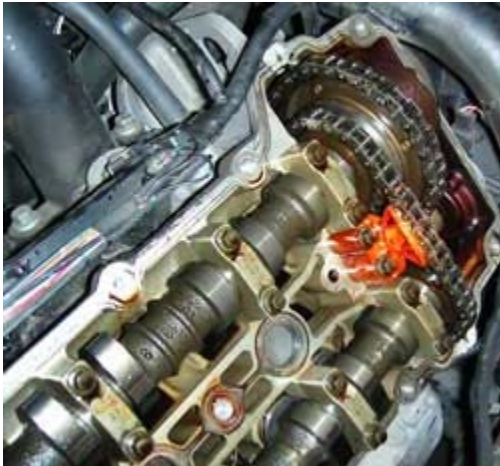
**The secondary tensioner (red) for each cylinder bank is visible when the valve cover is removed.**

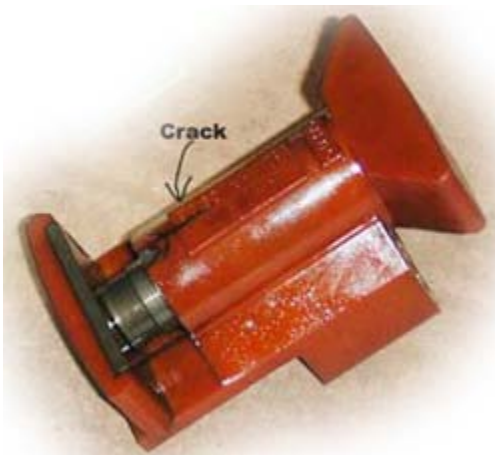
**This tensioner is cracked in the typical way first-generation tensioners fail. Cracked tensioners can break apart, causing severe engine damage.**

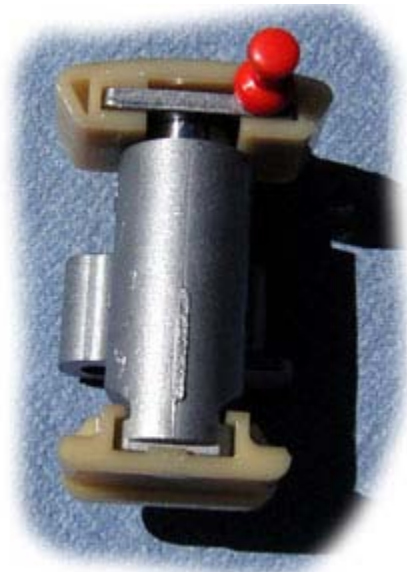
**As of April 2005 we use Jaguar's third-generation metal replacement tensioners exclusively.**

In 2005, Jaguar introduced a third-generation metal-based tensioner kit. (See the photos at left.) We now use the metal-based third-generation tensioners exclusively when replacing cracked first- and second-generation Jaguar V8 tensioners.

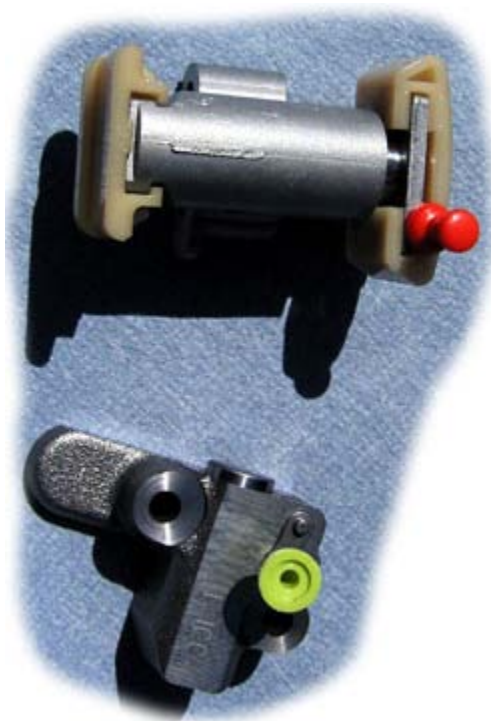
**Jaguar's third-generation secondary and primary tensioners are mostly metal, not plastic. Although we have not had problems with the second-generation plastic units, as of April 2005 we are using third-generation tensioners exclusively.**

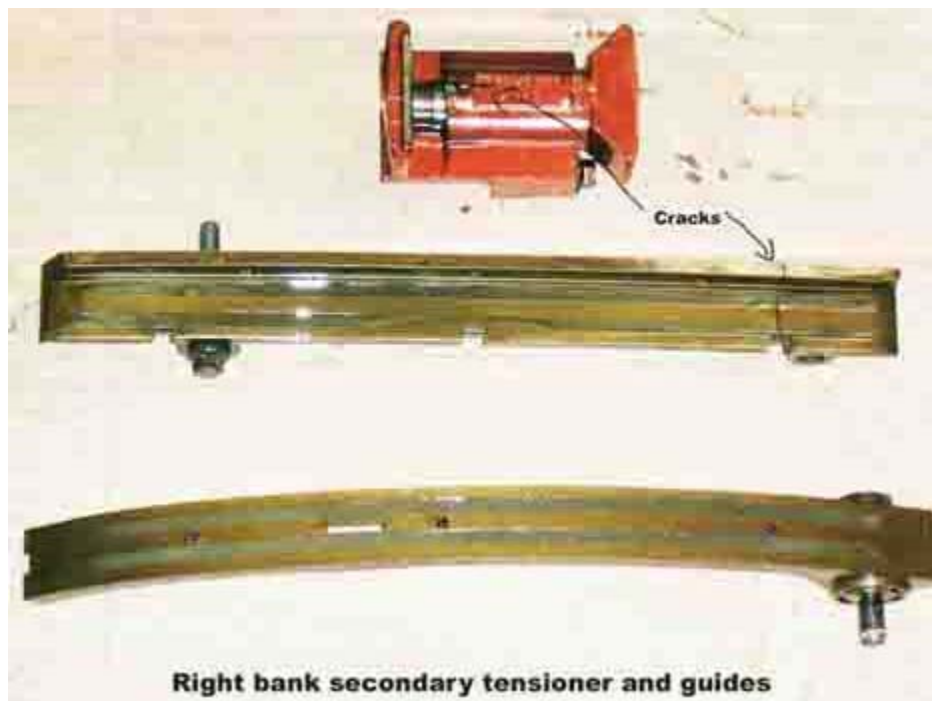
**Right bank secondary tensioner and guides**

**Though the tensioners of this 1998 XJ8 engine with 56,000 miles appeared intact on visual inspection with the valve covers removed, upon disassembly both were discovered to be badly cracked, and so was one of the main tensioner guides. A cracked tensioner can break apart and cause cam chain failure, damaging the engine severely.**

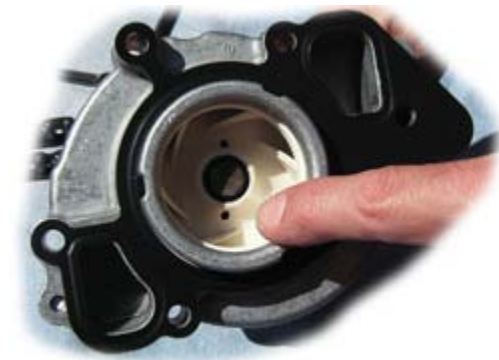
**Jaguar's original water pump design was faulty, resulting in broken ceramic impeller blades and engine overheating. The improved unit (above) is far more reliable and highly recommended if your car still has the original.**

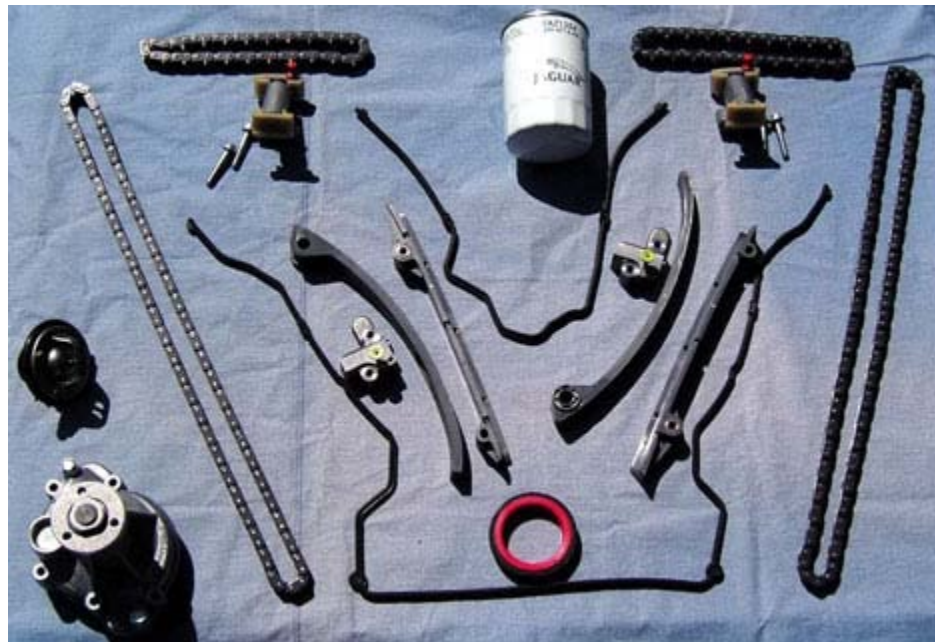
**Depending on your needs, we can replace only the secondary tensioners, or as shown above, the primaries, secondaries, chains and guides. At the bottom left are replacement water pump and thermostat, another weak point on early Jaguar V8s.**

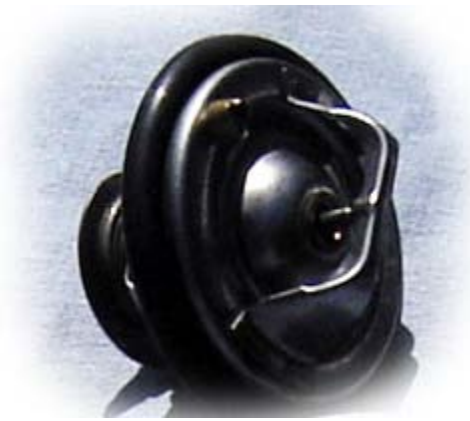
**Thermostats should be replaced at least every two years on late-90s Jaguar V8 cars. Worn units can cause secondary problems that are not immediately traceable to the thermostat unless the technician has experience spotting the tell-tale indicators.**

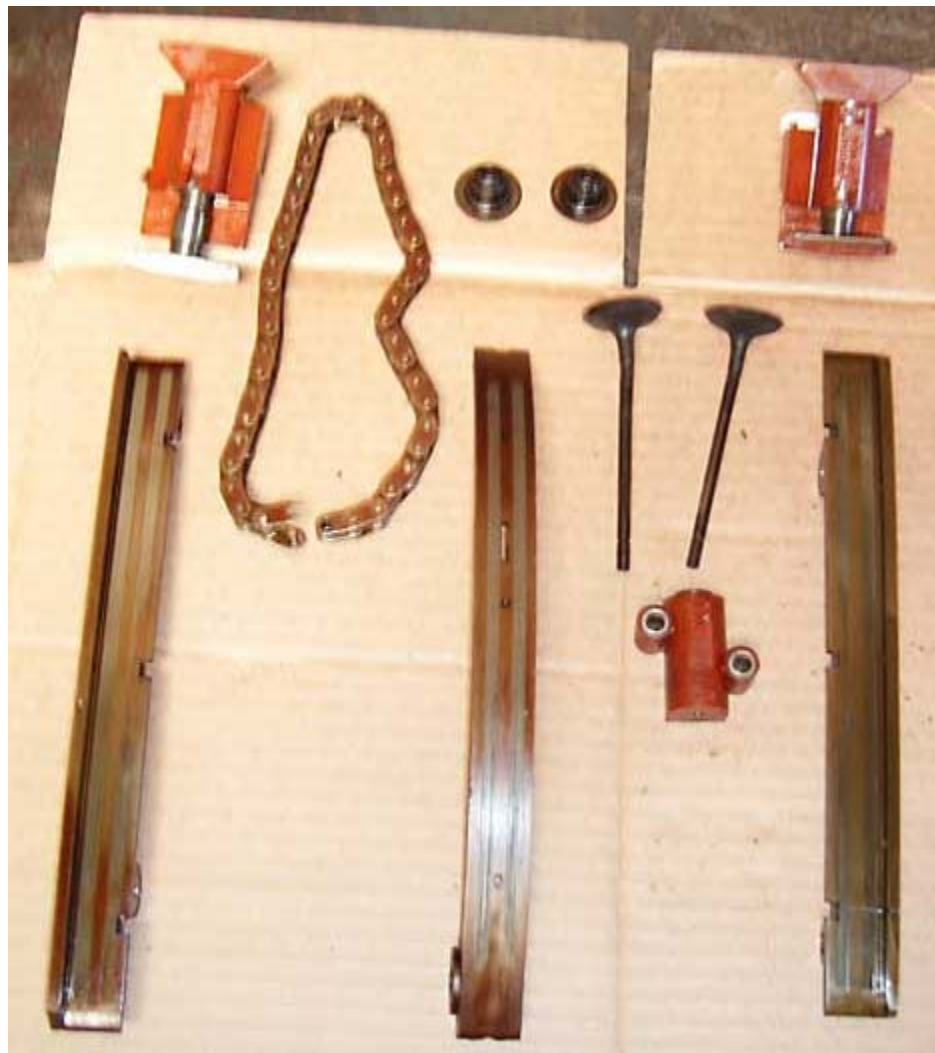
**When the worst happens:** This 1999 XJ8's tensioners both cracked. When the one at the top left broke, its timing chain (shown) snapped and the valves collided with the pistons. Two of the bent valves are shown in this photo. Though such damage requires significant shop time to repair, engine replacement is usually NOT indicated, and the parts required are reasonable in quantity and cost.

If the worst happens and the valves contact the pistons due to tensioner failure, all is not necessarily lost. Whereas some places recommend engine replacement (at a cost of \$10,000 or more), we can repair an engine that has suffered tensioner failure and subsequent valve damage on one bank for less
