Jaguar V8 Engines 1997-2000 Preventive Tensioner Replacement

In their Technical Service Bulletin No. X303-68 of February 2005, titled "Rattle From Engine on Start-up and Idle," Jaguar states:

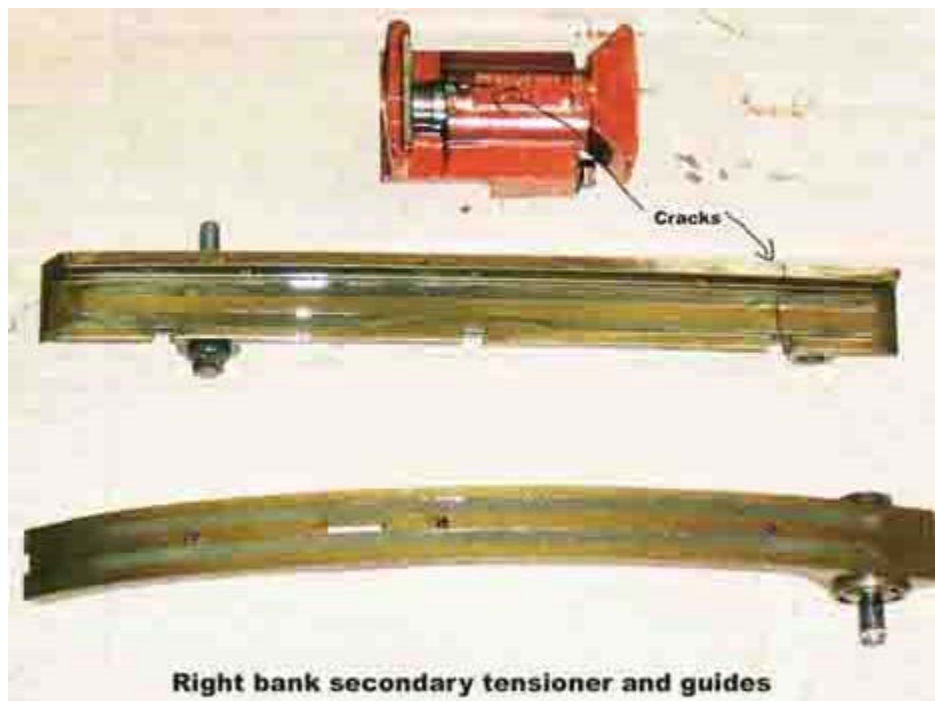
Though the tensioners of this 1998 XJ8 engine with 56,000 miles appeared intact on visual inspection with the valve covers removed, upon disassembly both were discovered to be badly cracked, and so was one of the main tensioner guides. A cracked tensioner can break apart and cause cam chain failure, damaging the engine severely.

We recommend that if your XJ8/XK8 has passed 35,000 miles, you take preventive action and have the tensioners inspected. If they are cracked, have them replaced before they fail.

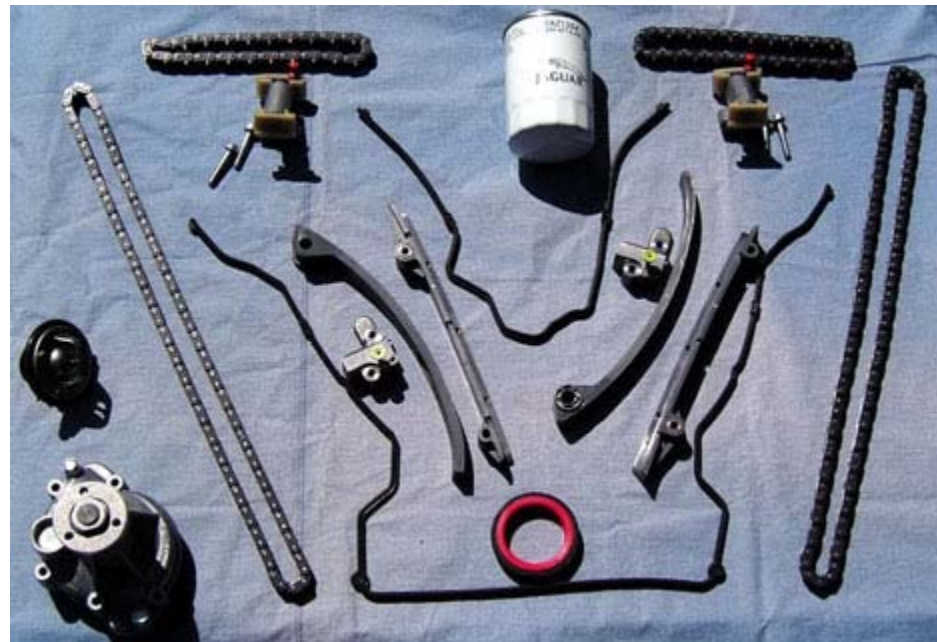
Depending on your needs, we can replace only the secondary tensioners, or as shown above, the primaries, secondaries, chains and guides. At the bottom left are replacement water pump and thermostat, another weak point on early Jaguar V8s.
