TECHNICAL BULLETIN

Rough Idle/Engine Misfire – New Spark Plug Wires and Routing

18-43

MODEL XJS Range (V12) and XJ12 DATE 11/94

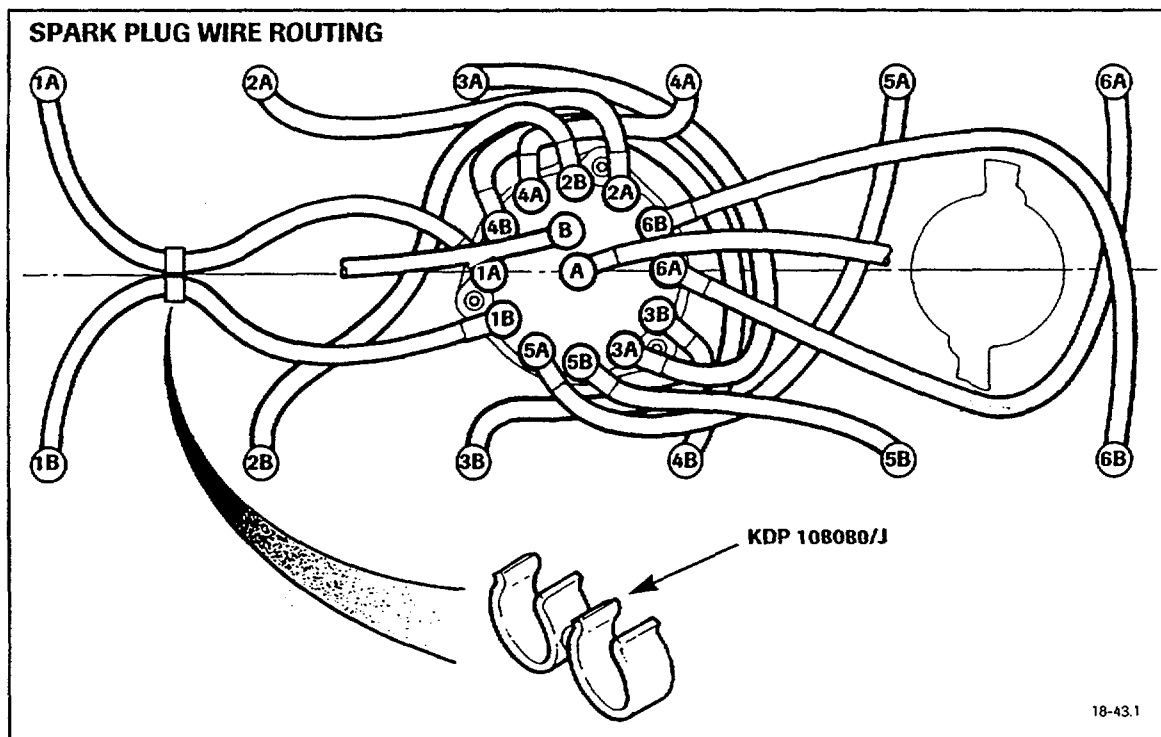
Rough idle and engine misfire conditions that develop after approximately 20,000 miles may be caused by high voltage leaks between the spark plug wires and cylinder head bolts.

Route the new wires as shown in Illustration 1.

IMPORTANT: The clip (P/N KDP 108080/J) must be installed on the spark plug wires for cylinders 1A and 1B as shown in the illustration.
