TECHNICAL BULLETIN

Engine Crankcase – Oil Leaks – Sealing Procedure

12-53

MODEL All V12

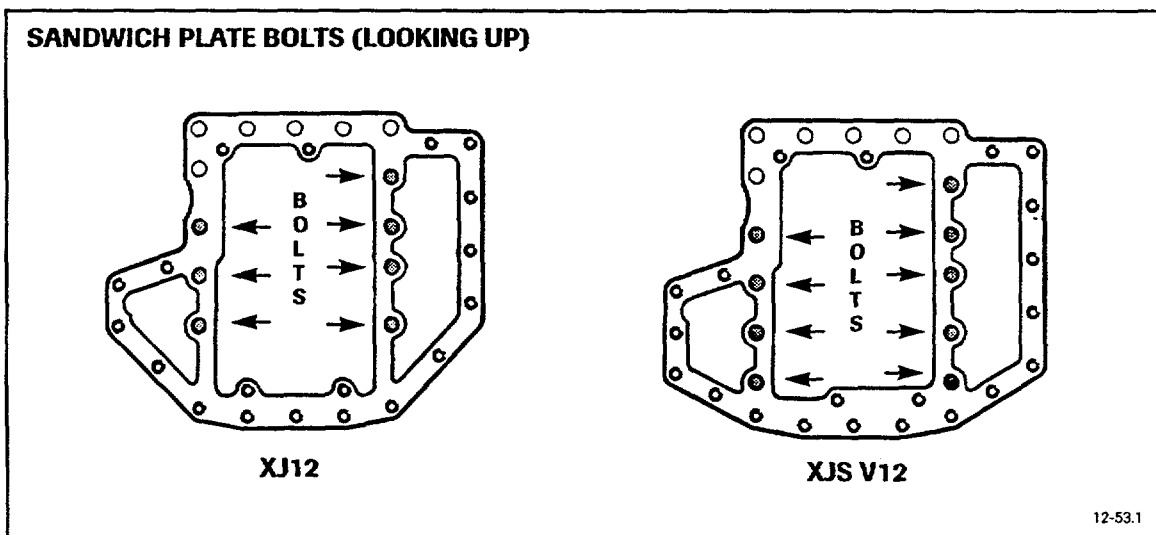
ILLUSTRATION 1

For oil leaks at the oil pan gasket or at the baffle tray and sandwich plate bolts, perform the following:

1. Remove the oil pan.
2. Remove the sandwich plate and baffle tray bolts shown in Illustration 1.
 - XJ12 - 7 bolts
 - XJS V12 - 9 bolts

3. Thoroughly clean the bolts and bolt hole threads.
4. Apply Loctite Primer to the bolt hole threads.

5. Apply Loctite 545 to the sandwich plate and baffle tray bolts. Install and torque the bolts to 16 - 20 lb ft (21 - 27 Nm).
6. Install the oil pan with a new gasket and torque to 6 - 20 lb ft (21 - 27 Nm).
