TECHNICAL BULLETIN

Automatic Transmission – Defaults To “Limp Home” in Wet Weather – Repair Procedure MODEL Sedan Range (4.0L) up to 93 MYDATE 12/94

04-18

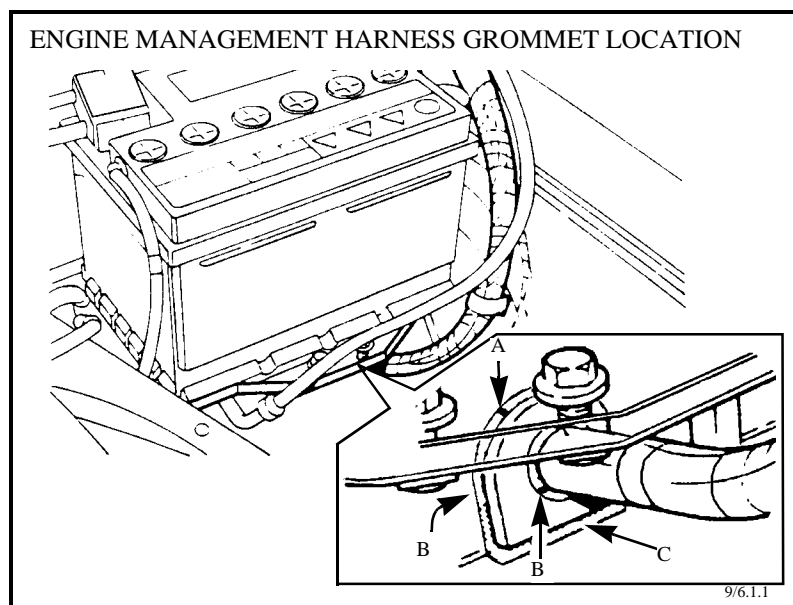
ILLUSTRATION 1

Water can enter the vehicle through the engine management harness grommet in the vacuum tank under the battery tray. The water can drip onto the Transmission Control Module (TCM) causing it to illuminate the transmission MIL and default to the “Limp Home” mode.

1. Record the preset radio stations (including X-mem) and remove the battery from the vehicle.
2. Remove the battery tray, disconnect the EMS harness from the vacuum tank and remove the vacuum tank
3. Inject a liberal amount of Bostik Alpha Seal 132 or an equivalent sealant into the areas shown in Illustration 1.

A. - Around the vacuum tank inner recess for the grommet.

B. - Around the EMS harness at the front and back of the grommet

C. - Between the EMS harness grommet and the body panel face
