TECHNICAL BULLETIN

Poor Running in Wet or Hot Weather Conditions – Replace Air Cleaner Housing

19-31

MODEL Sedan (3.6/4.0L) Range through 94 MYDATE 2/95
Up to VIN 708757

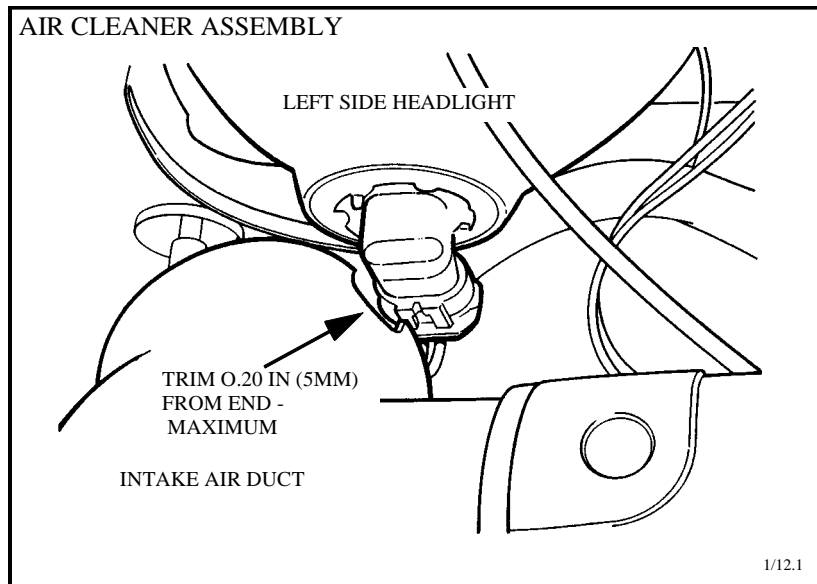
ILLUSTRATION 1

The symptoms may also be caused by water entering the air cleaner housing through the air intake duct under the left front wheel arch during wet weather driving. Also, during low speed operation in very hot weather, fuel vapors may vent from the evaporative emission canister and be drawn into the engine air intake. The excess fuel vapor will cause poor idling or stalling at low vehicle speeds.

5. Route the wiring harness behind the left headlight to ensure clearance for the new air intake duct.
6. Trim the flared end of the air intake duct with a round file to provide clearance for the left headlight assembly as shown in Illustration 1.

IMPORTANT: Do not trim more than 0.20 in (5mm) from the end of the air intake tube.
Profile the trimmed area to provide clearance for the headlight connector assembly.
Radius all sharp edges of the trimmed area to avoid intake air “whistles” or noise.
