XJ 6 Series III 4.2 - Cold Start EFI Overfueling

TECHNICAL SERVICE BULLETIN REFERENCE B-001 VOL V

MODEL XJ6 SERIES III 4.2

SUBJECT: AIR FLOW METER

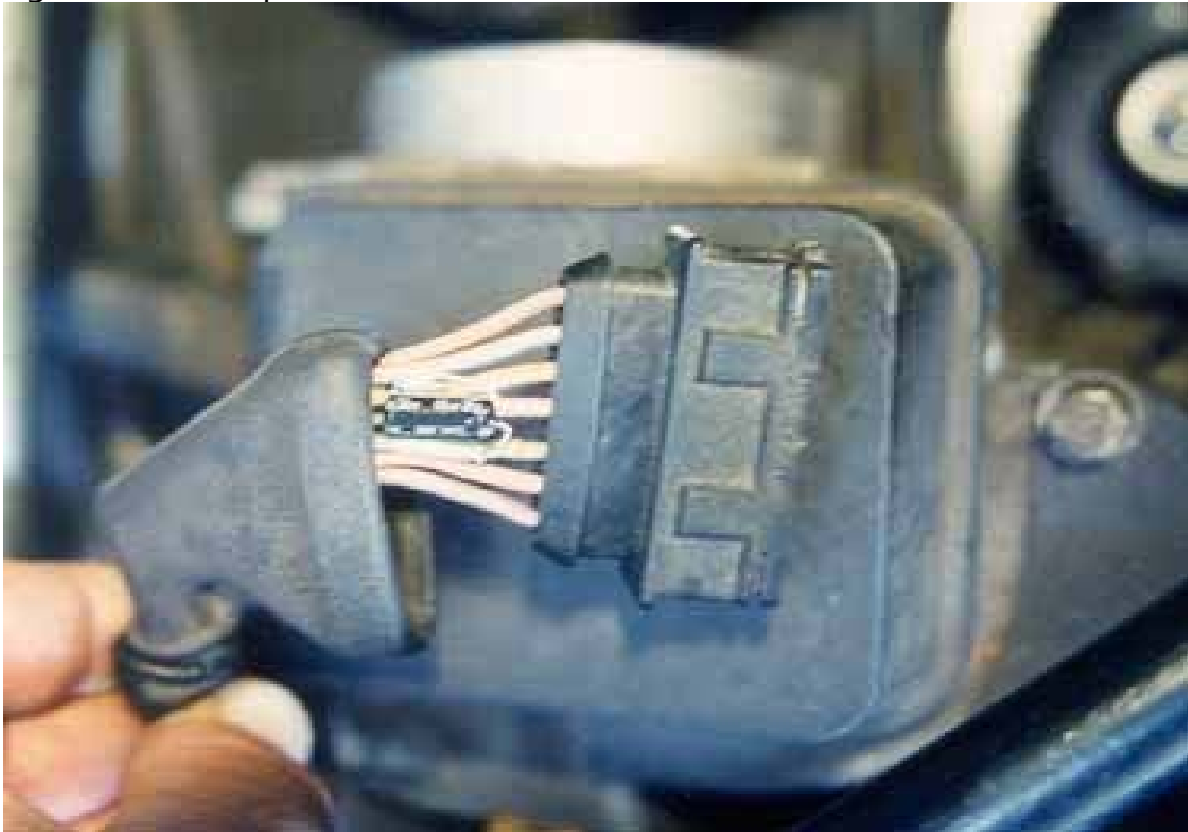
Image of installed capacitor.

- use 30 to 100 microfarad capacitor [100 preferable]
- band or negative lead towards the front of car
- capacitor wires are soldered to the wires on either side of the middle wire
- spray the soldered connections with clear plastic spray paint to protect from moisture
