# TECHNICAL BULLETIN

JTB00301v2

### Fuel Gauge Operation

##### **XK Range (X150)**

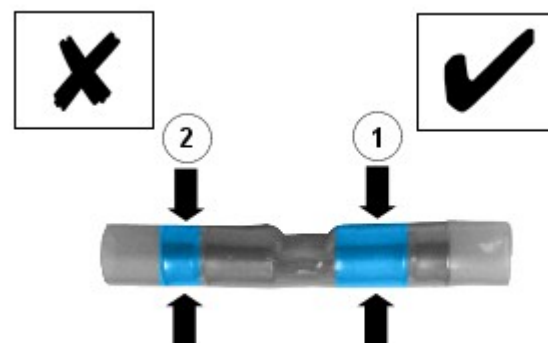
E155408

1. Correct location for crimping.
2. Incorrect location for crimping.

When installing the splices, make sure that the splice is crimped in the correct location.
