TECHNICAL BULLETIN

JTB00283v2

XK Folding Top and Glass Separation

XK Range (X150)

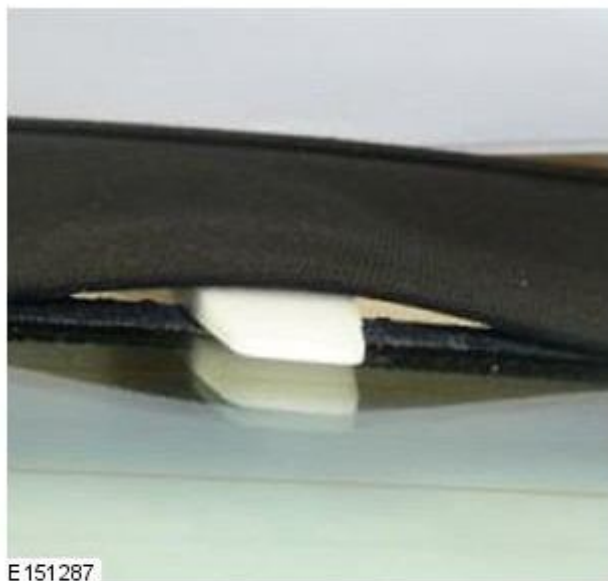
NOTE: Plastic peg shown inserted for clarity of separation.

Graphic E151287 shows separation of the backlight bonding.

1. **NOTE: 350mm is the maximum length of any one delaminating area that can be repaired. Up to maximum of 3 repairs around the glass are permitted.**
