Models	X150 - XK (Coupe) X150 - XK (Convertible) X250 - XF
--------	---

Title	Loose battery terminals
-------	-------------------------

Last Modified	16-JUL-2008 16:19
---------------	-------------------

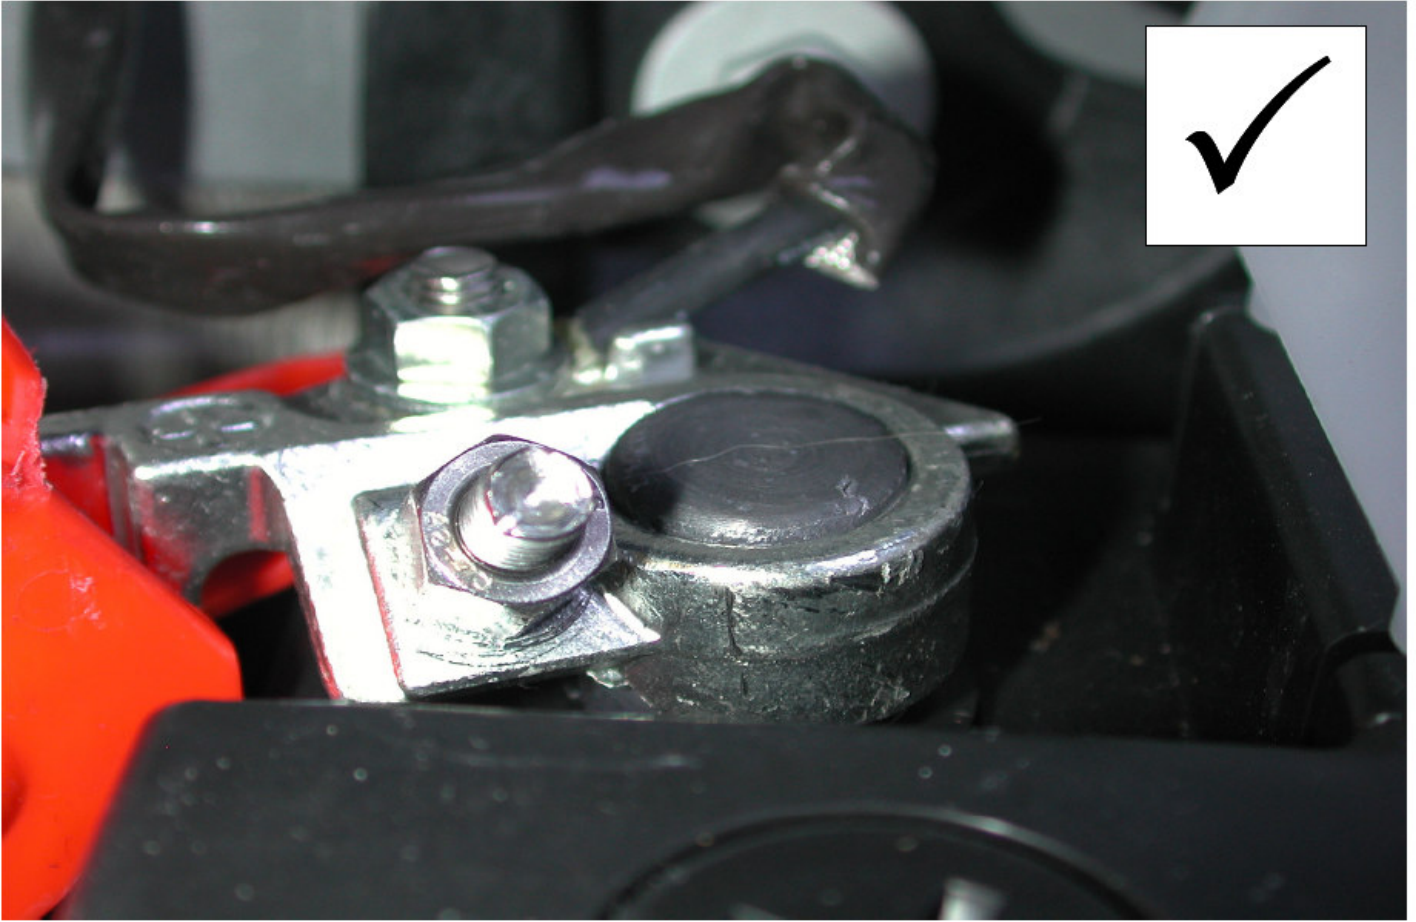
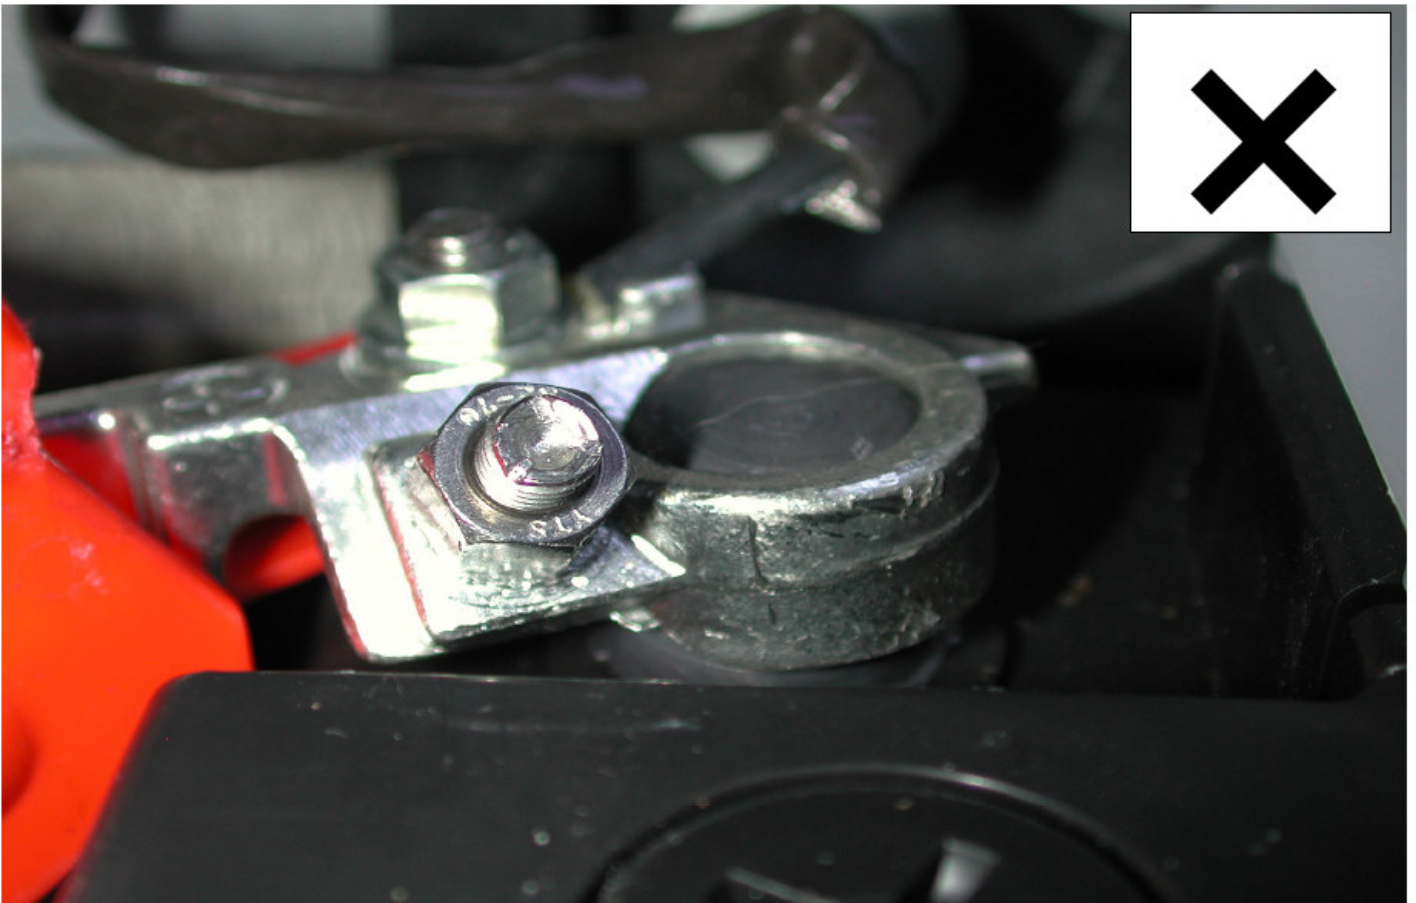
A number of reports have been received where the battery terminal has come adrift causing significant electrical concerns.

The battery terminal has been incorrectly fitted during the PDI process or whilst the vehicle is in the workshop for repair.

Battery terminal – correct fitting.

Ensure that the battery terminal is located correctly as shown in the attached document. The battery post should protrude through the clamp and then be torque tightened to 6 Nm for XF or 5 Nm for XK variants.
