MODEL
XK
(X150)

NUMBER
JTB00038

TECHNICAL BULLETIN

Console Ashtray Operation

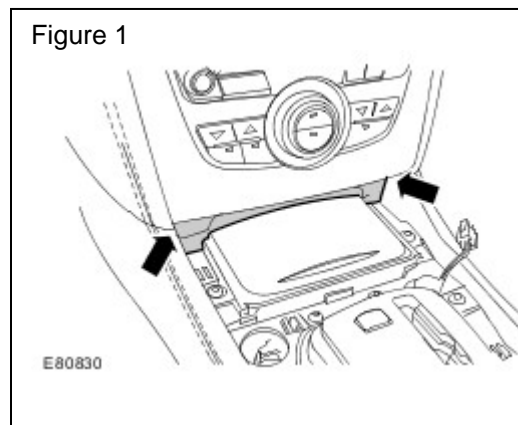
Figure 1

CAUTION: To avoid damage to the components, the hooked screwdriver, or suitable tool, must be carefully inserted as high up the ashtray cover panel as possible when releasing the clips to remove the ashtray cover panel. (Arrowed in Figure 1)

3. Using a thin hooked screwdriver, or suitable tool, release the two clips securing the ashtray cover panel. (Arrowed in Figure 1)
4. Remove the ashtray cover panel.
5. Check operation of ashtray lid.
6. If the ashtray lid operation 'noise' has disappeared or the 'slow' operation has been resolved, modify the ashtray cover panel as follows:
 - Select a suitable fine file.
 - Lightly file along the lower edge of ashtray cover panel, removing only enough material to allow smooth operation of the ashtray lid. (Figure 2)
7. Install the ashtray cover panel.
8. Verify that the lid operates properly and no noise is present.
9. If no other symptoms are present, refer to GTR Workshop Manual, Section: 501-12 (76.47.26) and install the floor console veneer panel.

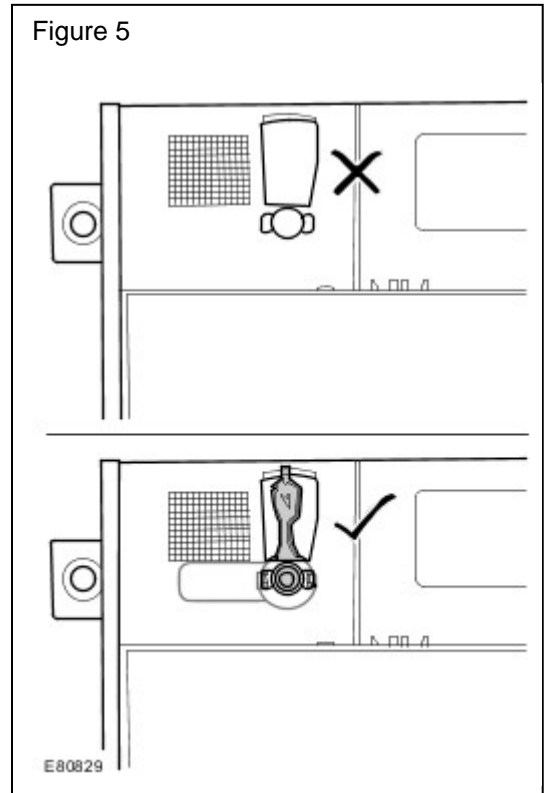
△ **NOTE: Safe VIN for welded latch - B14220**

7. If the ashtray lid will not latch, perform the following:
 - Refer to GTR Workshop Manual section 501-12 operation 76.25.01, and remove the floor console to gain access to the ashtray securing screws.
 - Remove the ashtray securing screws and the ashtray from the floor console.
 - Verify that the ashtray lid latch is installed.
 - If the latch is not installed (X-marked in Figure 5), install a new latch assembly (C2N3916).
 - If the latch has become detached, install the latch correctly. (✓-marked in Figure 5)
 - Verify proper operation of the ashtray lid.
8. Refer to GTR Workshop Manual, section: 501-12 operation 76.25.01 and install the floor console.
9. If noise is heard or the operation is slow, perform the operations detailed in **REPAIR NOISY OR SLOW ASHTRAY LID OPERATION** section of this bulletin.
