TECHNICAL BULLETIN

JTB00242

Front Bumper Beam Pedestrian Impact Sensor Rework

The New XK (X150)

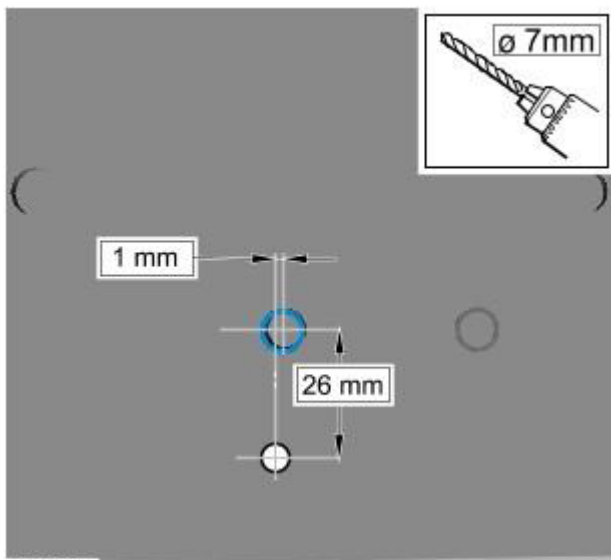
E137908

4. Using a 7mm drill bit, drill a hole in the position shown.

1. Mark a position that is 1 mm to the left (plus or minus 1mm) and 26mm (plus or minus 1mm) below the original left hand threaded hole.

2. Drill the hole.

3. Apply a suitable corrosion protection to the exposed metal.

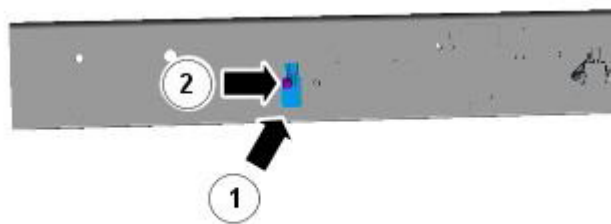
E137907

**CAUTION: Make sure that the sensor dowel is correctly located in the hole.**

Install the new sensor.

1. Install the dowel on the new sensor to the new hole.

2. Install the bolt and tighten to 10 Nm.
