MODEL
XK

NUMBER
JTB00086
(Issue 1)

TECHNICAL BULLETIN

'Radar Sensor Blocked' Message Displayed - Repair Procedure

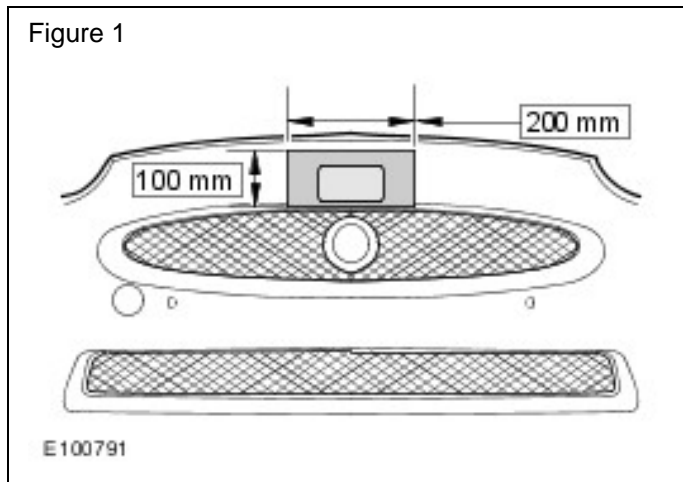
1. Inspect for obstruction (badges, license plates, etc) in front of the radar sensor. (Figure 1)
 - Clear any obstruction found.
