TECHNICAL BULLETIN

JTB00283v2

XK Folding Top and Glass Separation

XK Range (X150)

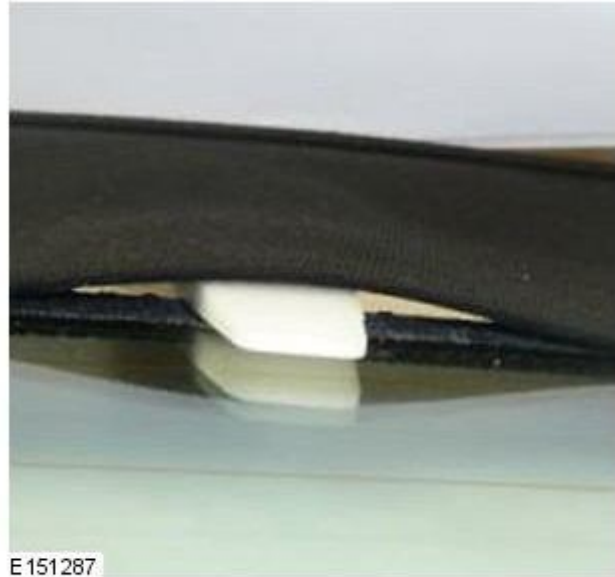
The rear glass is separating from the folding top.

Cause: Failing of the adhesive. **Suggested Customer Concern Code - J03.**

NOTE: Plastic peg shown inserted for clarity of separation.

Graphic E151287 shows separation of the backlight bonding.

1. **NOTE:** 350mm is the maximum length of any one delaminating area that can be repaired. Up to maximum of 3 repairs around the glass are permitted.
