TECHNICAL BULLETIN

JTB00283v2

XK Folding Top and Glass Separation

XK Range (X150)	Model Year:	2006-2012
	VIN:	B00379-B47446

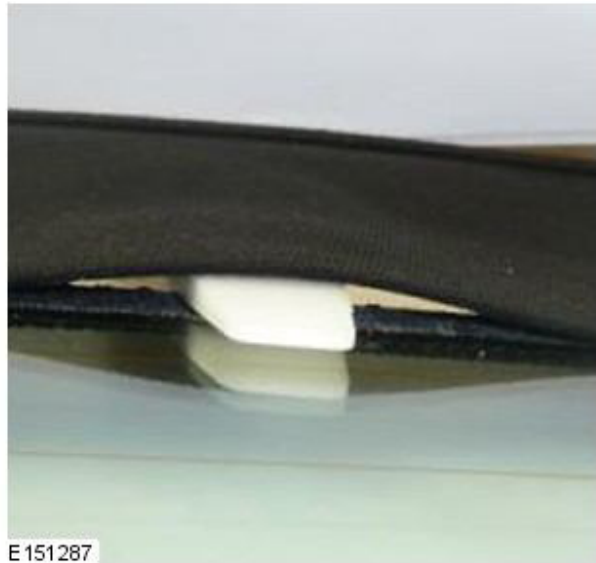
The rear glass is separating from the folding top.

Cause: Failing of the adhesive. **Suggested Customer Concern Code - J03.**

NOTE: Plastic peg shown inserted for clarity of separation.

Graphic E151287 shows separation of the backlight bonding.

NOTE: 350mm is the maximum length of any one delaminating area that can be repaired. Up to maximum of 3 repairs around the glass are permitted.
