**Creaking Noise from Windshield and Fascia
Area – Plenum Contacting Body Braces –
Repair Procedure**MODEL 1997 MY
XK8 Range
VIN
001001-010766**Issue:**

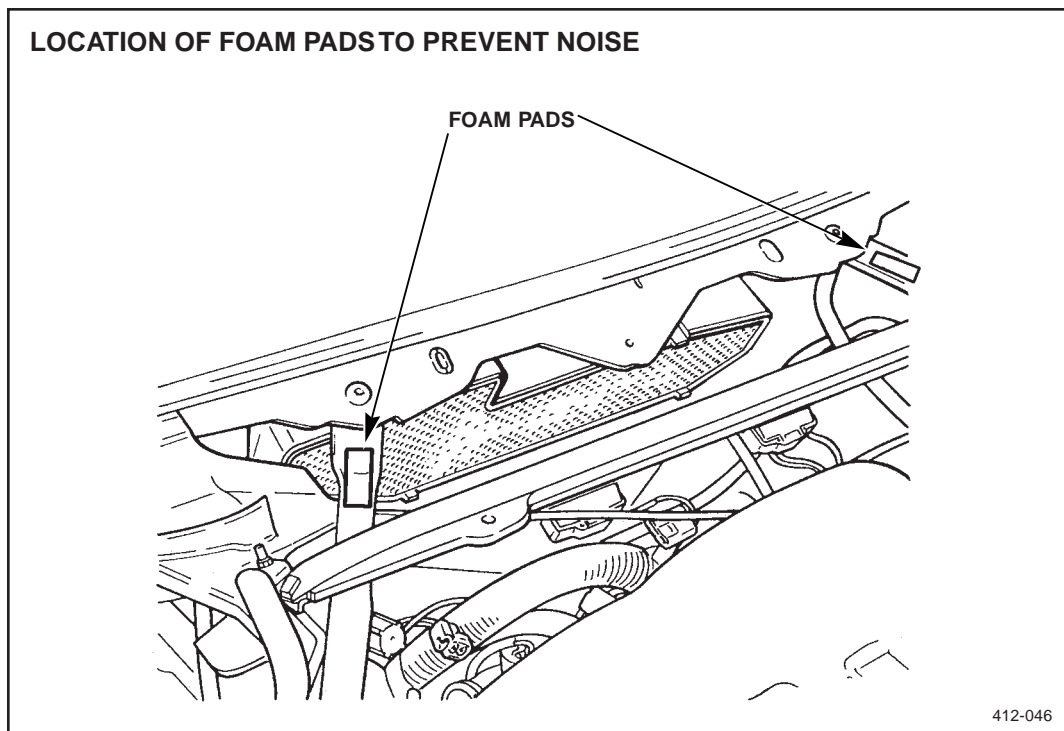
ILLUSTRATION 1

Some 1997 MY XK8 vehicles within the above VIN range may exhibit a creaking noise that appears to come from the fascia or windshield area. The noise may be caused by contact between the plenum cover and the body braces.

In case of a customer complaint of a creaking noise as described above on a 1997 MY XK8 vehicle within the above VIN range, remove the plenum cover. Check the body braces for evidence of contact, such as worn paint. If contact is found, install two closed cell foam pads (HNA-1210BA) on the locations shown in Illustration 1. Reinstall the plenum cover.
