© D. Jensen 2006	REPLACEMENT OF XK8 CONVERTIBLE REAR WINDOW REGULATOR	V. 1.0 September 2006
Distribution: www.jag-lovers.com

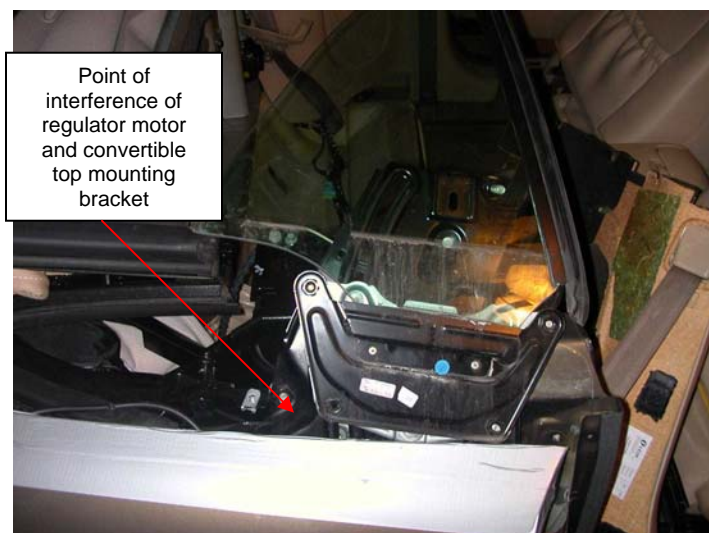
Fig. 19 Window/regulator partially removed

14. Remove the upper and middle nuts holding the regulator in place and undo the lower nut (it will remain in place because the attached washer is held to the body by silicone sealer) (Sec. 86.25.11, Steps 12 and 13) (see Fig. 12 above). Route the feed link and multiplug connector through the water shedder. Once loose, push the regulator outward to free the adjustment bolts from their holes. As I inferred from the Jag instructions re removal of the top, I could not remove the window/regulator due to interference between the regulator motor and the convertible top bracket (see Fig. 19).

16. The next step is the real time saver. Remove the three bolts holding the convertible top bracket in place. Then push the bracket inward enough to provide clearance for the window/regulator assembly. As you might imagine, I breathed a large sigh of relief when the assembly came up and out.
17. Upon examination, the cause of the failure was evident (see Fig. 21). The plastic slide that secures both ends of the drive cable had split, allowing one end of the cable to come free (accounting for the loud "pop" since the cable is very tightly wound) and preventing further movement. Note that the slide is of two-piece construction plus pivot (not evident in the photo) and has fairly complex internal features that could be replicated, but not easily.

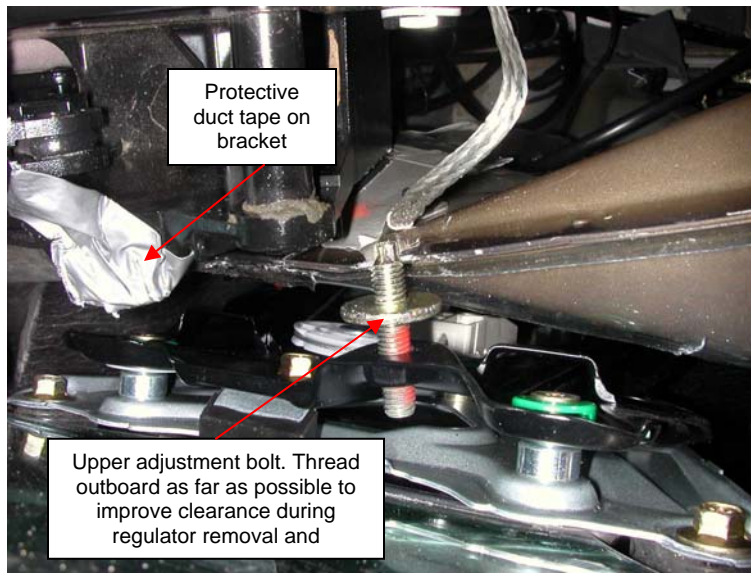
Fig. 20 Close up of upper adjuster bolt

15. Thread the upper adjuster bolt fully outboard (see Fig. 19). This eases removal in the regulator in the limited space available. The small piece of protective duct tape in Fig. 20 sits on the protruding portion of the convertible top bracket that causes the interference if the bracket is not first loosened and pushed inward.

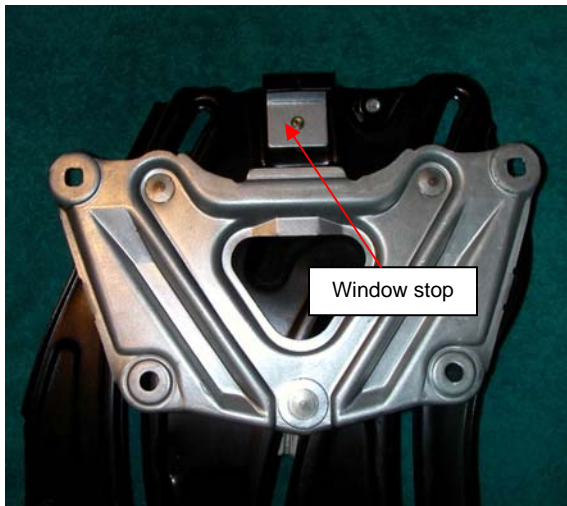
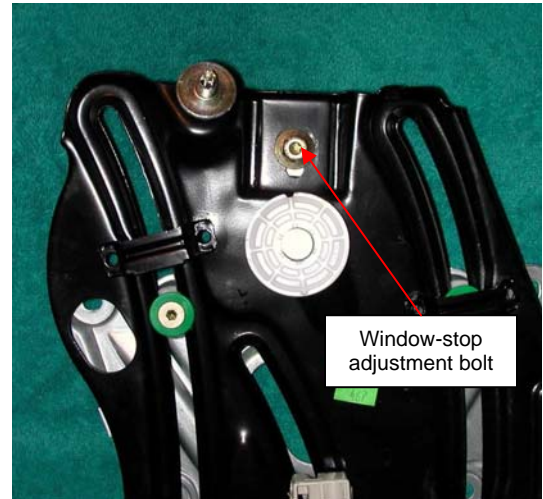
Figs. 22a and 22b View of window stop and adjustment bolt

20. One item not mentioned in the manual and that I overlooked at first was adjustment of the window stop on the new regulator (see Figs. 22a and 22b). As received, the stop on the new regulator did not allow the window to rise to a fully closed position in the convertible top rubber seal, leading to wind noise and water leaks. A check of my failed regulator showed the stop had been at its uppermost position, whereas the new unit was at its midpoint. As expected, making this adjustment addressed both the wind noise and water ingress issues.
