**Wind Noise at A Posts –
Inject Foam in A Post –
Procedure**MODEL 1997 MY-ON
XK8 Range

VIN 001001-ON

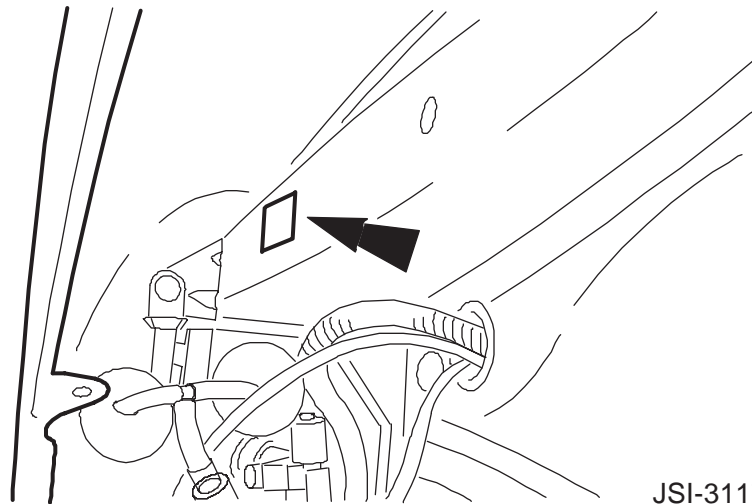
ILLUSTRATION 2

SQUARE OPENING FOR FILLING RIGHT SIDE A POST

4. Identify the square hole in the A post assembly at each side (Illustrations 2 and 3).
5. Using suitable equipment and an approved foam generating material, inject the foam into the A post assembly at both sides.

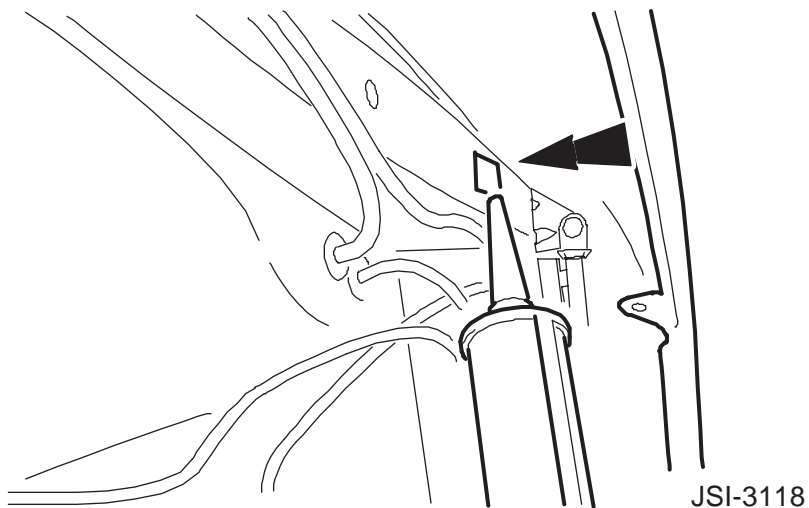
ILLUSTRATION 3

SQUARE OPENING FOR FILLING LEFT SIDE A POST
