XK8

501-14

# TECHNICAL BULLETIN

## Convertible Top – Headlining Retention – Modification

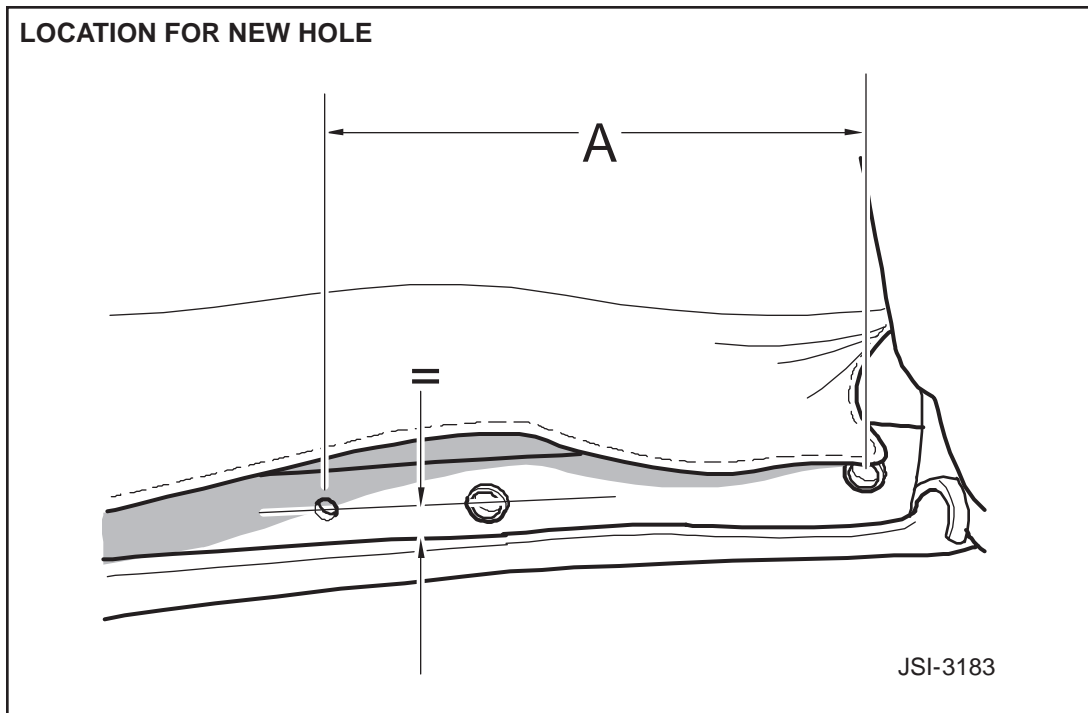
ILLUSTRATION 1

On some 1997 MY XK8 vehicles, the headlining can become trapped in the convertible top frame when raising the convertible top.

2. Position a piece of masking tape, (sufficient to provide a mark for a hole center), on the frame at 190 mm., (dimension A, Illustration 1), from the center of the first snap.

3. Mark the proposed hole center, on the masking tape, at 190 mm., (dimension A, Illustration 1), and the same distance from the edge of the frame as the nearest snap.
