# SERVICE ACTION

Service Action Number:  
S514

## Throttle Closed Position Operation

Publication No.:	303-S514
Model:	XK Series N/A vehicles
Model Year:	1997 to 1998
VIN Range:	001036 to 031302
Model:	XK Series SC vehicles
Model Year:	1998.75 to 1999
VIN Range:	024695 to 042775
Model:	V8 XJ Series N/A vehicles
Model Year:	1998
VIN Range:	812256 to 853935
Model:	V8 XJ Series SC vehicles
Model Year:	1998 to 1999
VIN Range:	812256 to 878717
Date of Issue:	13 May 2004

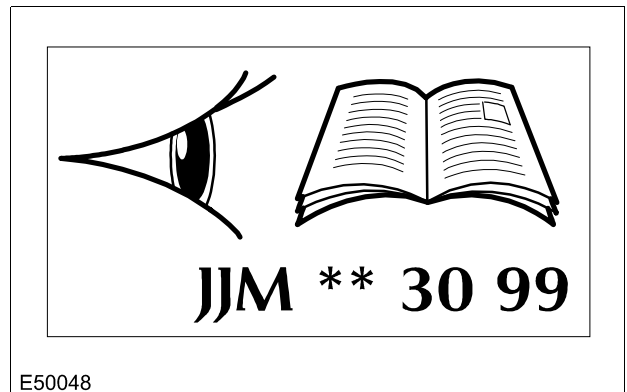
Fig. 11

**Note:** The new throttle body has a molykote coating and can not be cleaned. The new throttle bodies can be identified by a sticker. See Fig. 11.
