My driver's window had been playing up for a while, clunking when wound to the top. The drivers door regulator will take a pounding over its lifetime as it is actuated every time the driver door is opened.

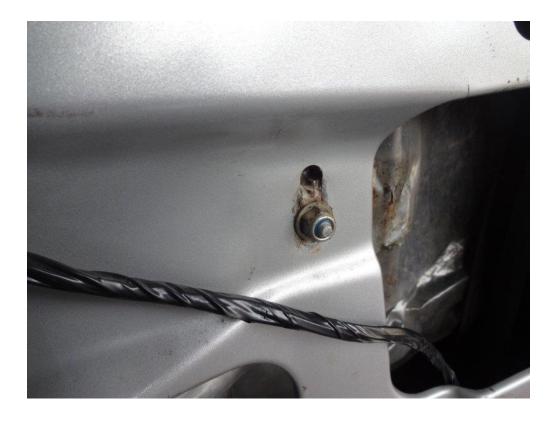
JTIS says that it is important to mark the position of this nut before removal to ensure refitting is done correctly, looks like mine has been all over the place.

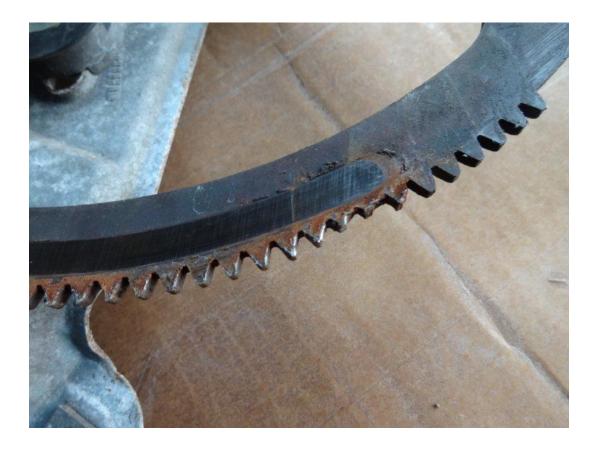
So here is the problem.

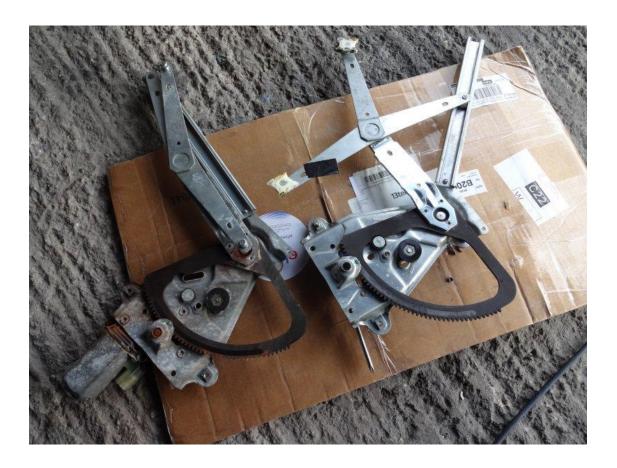
The new and the old.

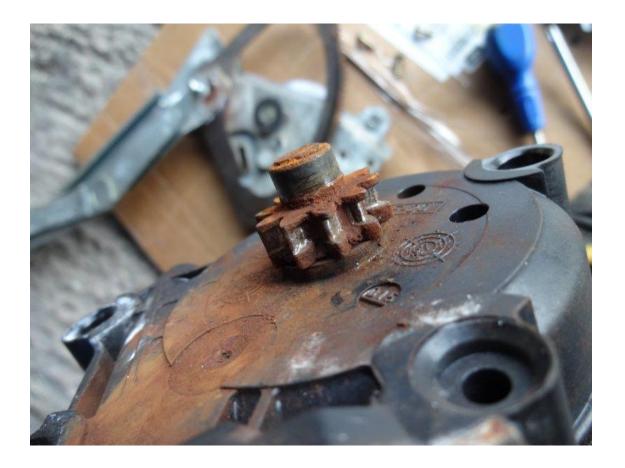
But bad news, my motor gear is trashed.

So now ordered a new one off ebay (from a Range Rover), hope its teeth are in good condition. It should be less worn as the Range Rover door is not frameless like the XK8.

Part number is - Bosch 0130821317

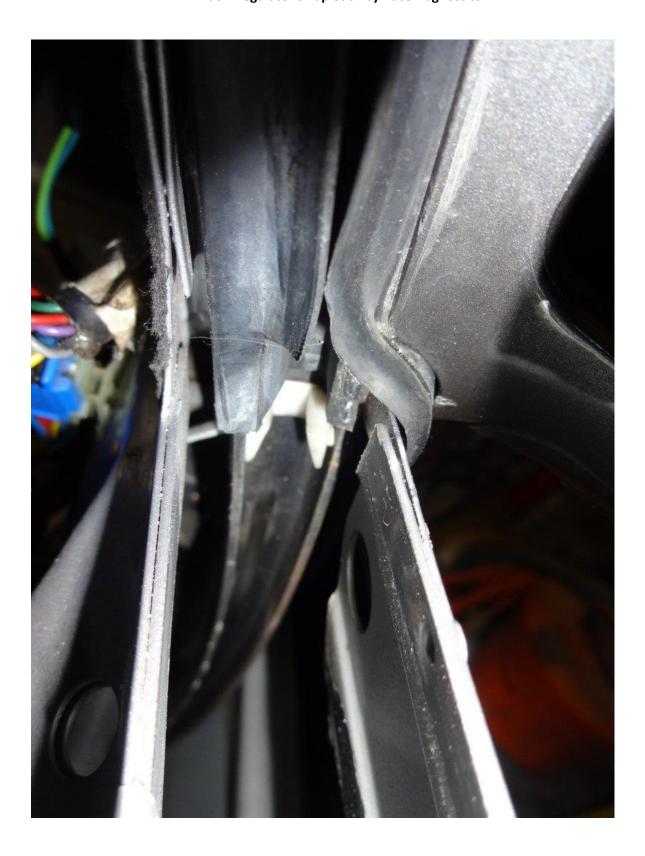
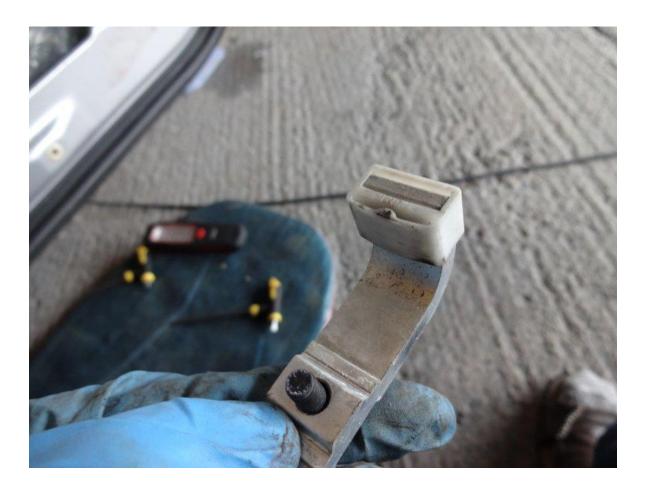
Close inspection of the runner guides shows they are ok but I will need to search for pics on the web to confirm this.
