Damaged Cupholder –
Replace Mechanism Only –
Repair Procedure

MODEL
1997 MY-ON XK8 Range
1998 MY-ON V8 XJ Series
VIN
001001-ON
812256-ON

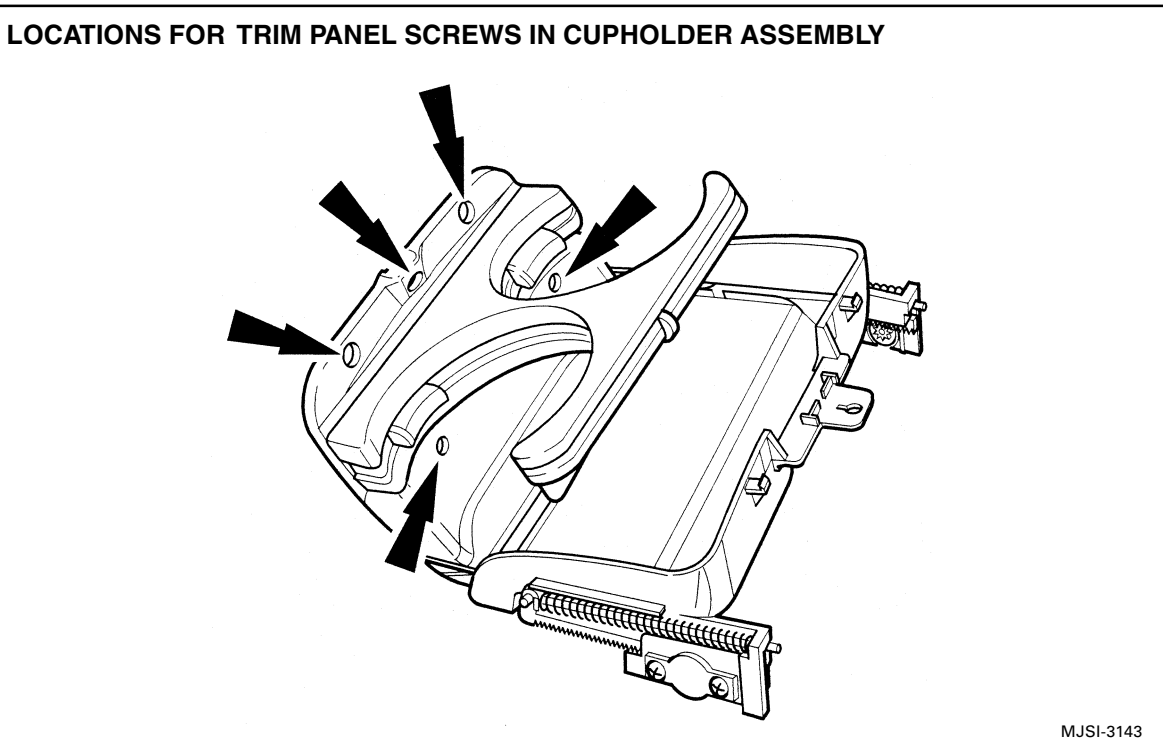
ILLUSTRATION 1

In case of a customer complaint of a broken cup-holder assembly, (shown in Illustration 1), remove the holder and install a new assembly in the cubby box lid as described on the next page.

CONSOLE LID RETAINING SCREWS

4. Remove the cup holder latch retaining screw, (Illustration 3).
5. Remove the latch and the cup-holder mechanism with its trim panel from the lid.
6. Remove the five No. T8 Torx head screws, (arrowed in Illustration 1), that retain the trim panel. Remove the panel from the mechanism.

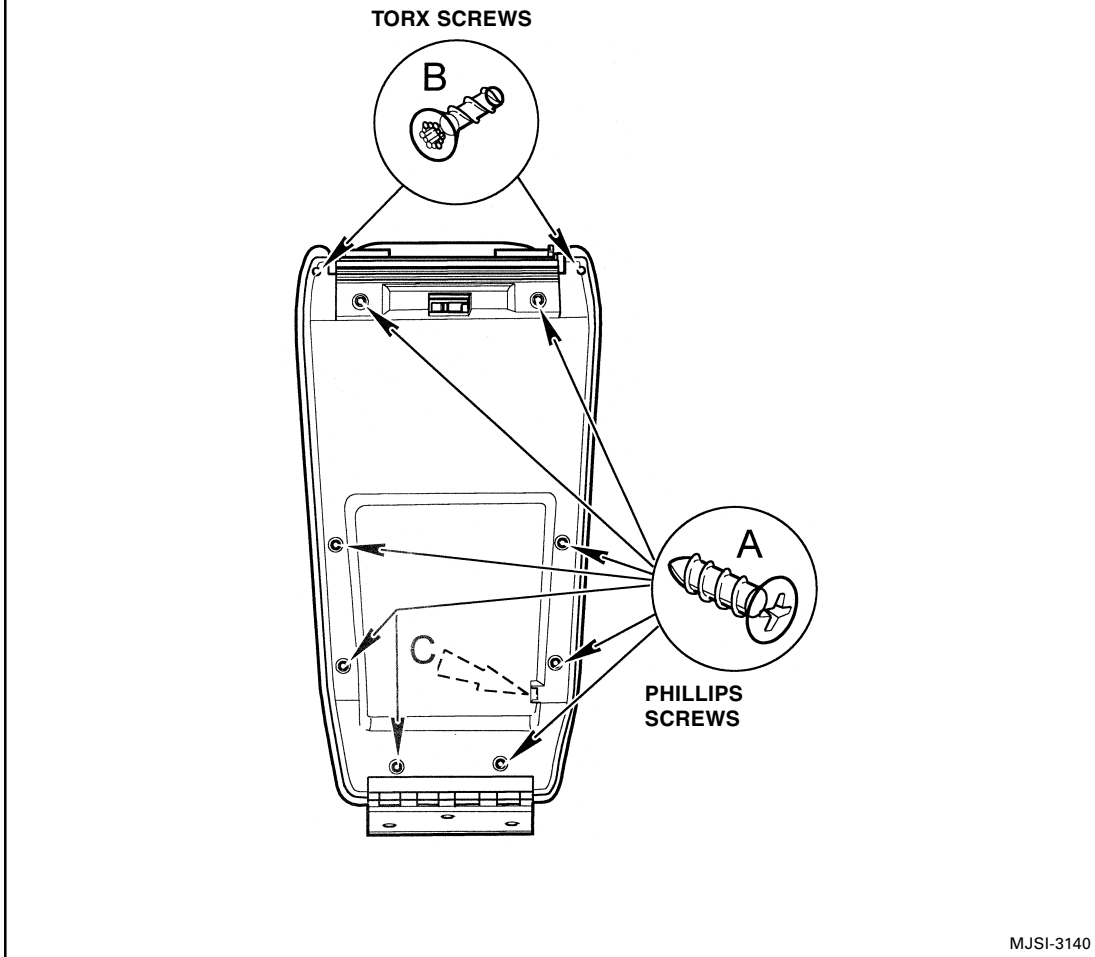
ILLUSTRATION 2

REPLACING CUPHOLDER MECHANISM

1. Open the Console Lid and remove the screw, (C, illustration 2), that secures the check arm to the lid.
2. Remove the three screws that retain the lid and hinge to the console. Remove the lid from the console. Place the lid assembly on a clean bench area.
3. Remove the eight phillips-head screws, (A, Illustration 2), and the two T8 Torx head screws, (B, Illustration 2), that hold the inner finisher to the console lid. Remove the finisher and the hinge from the lid.

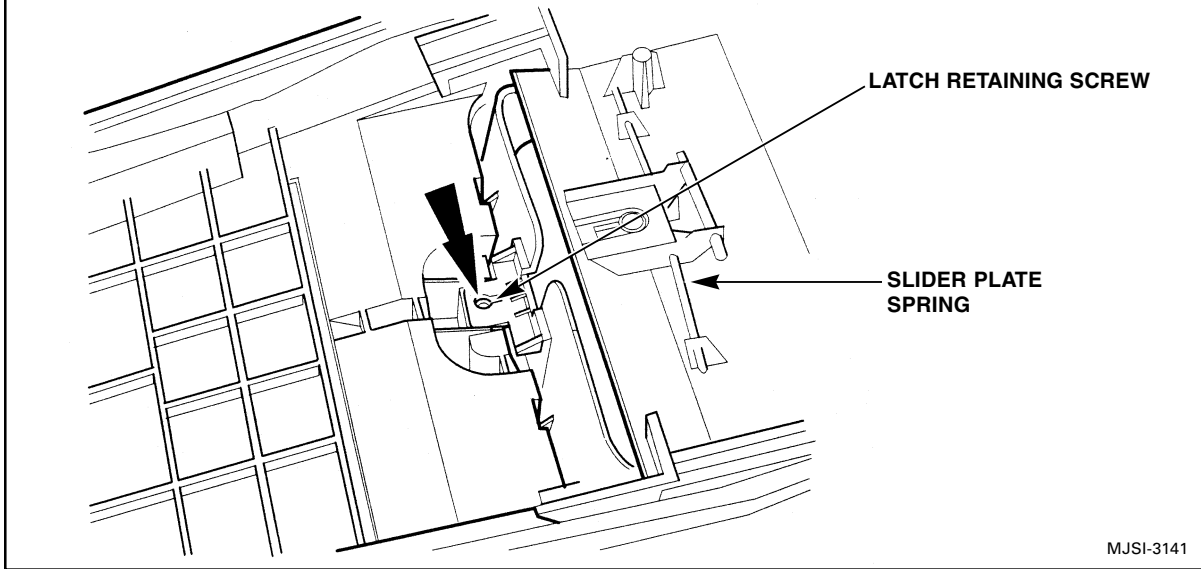
ILLUSTRATION 3

RETAINING SCREWS AND SPRING

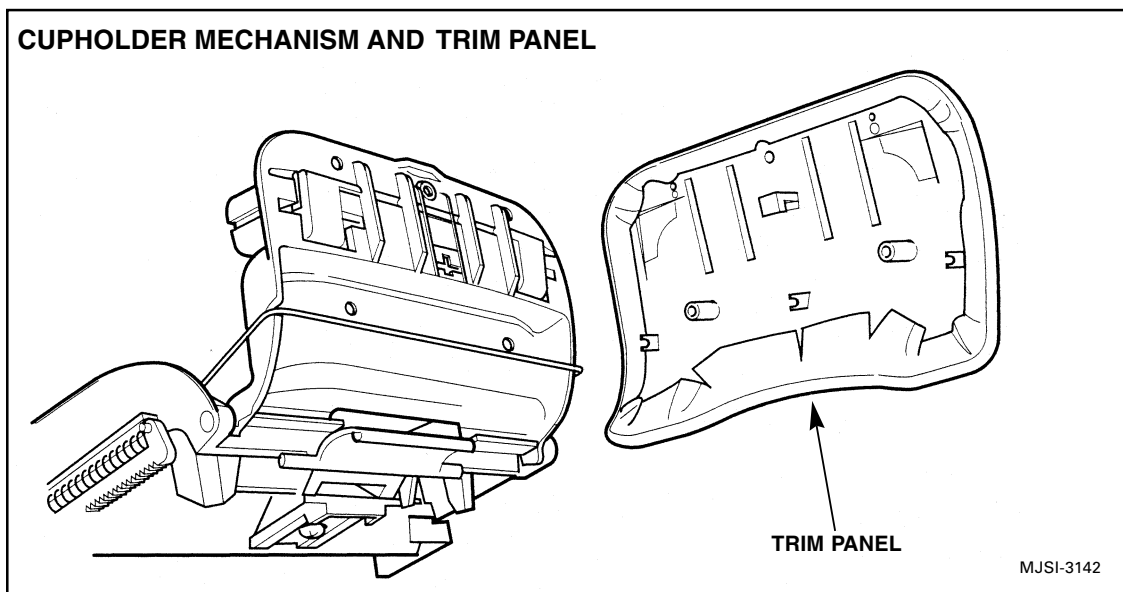
ILLUSTRATION 4

CUPHOLDER MECHANISM AND TRIM PANEL

Installation of a new Console Lid Assembly is a reversal of the removal procedure.

- Always refer to the recommended torque settings when assembling the mechanism.
- Ensure that the damper wire, which acts as a check-arm, and the hooked projection, which locates the trim pad to the mechanism, are correctly engaged when the trim panel is installed on the mechanism.
- Check that the slider-plate spring, (Illustration 3), is present and in the correct position and that the latch paddle functions correctly i.e. it must fully latch to the console.
- Ensure that the lock screw, (C, Illustration 2), is present and correctly aligned in the substrate before assembling the lid.
