XK8

501-17

TECHNICAL BULLETIN

Water Ingress - Body Seams - Diagnosis

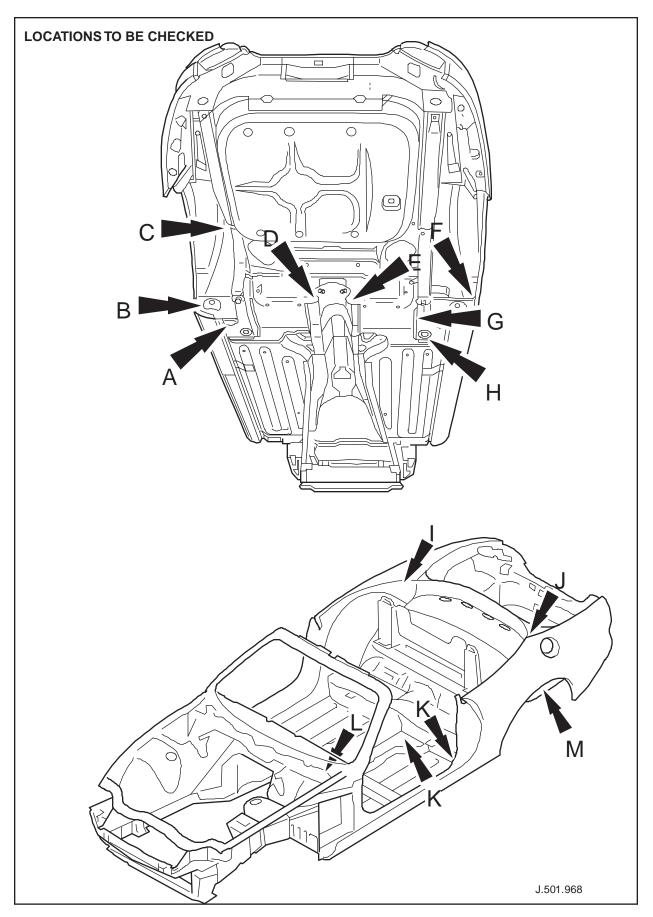
Illustration 1, on page 2, lists the areas of potential leaks in alphabetical order and these areas are then referred to, in the following pages, in that order.

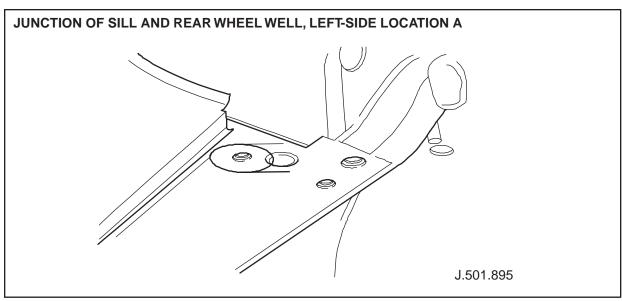
ILLUSTRATION 2

A. JUNCTION OF SILL AND REAR WHEEL WELL, LEFT-SIDE

Clean away any old sealant around the rear suspension mounting bolts.

Seal around the bolt head and the bracket and test.

If, after testing, further sealing is required, remove the bolts, clean around the bracket, install new bolts and then fully seal the area.

The above operation applies to both left and right sides

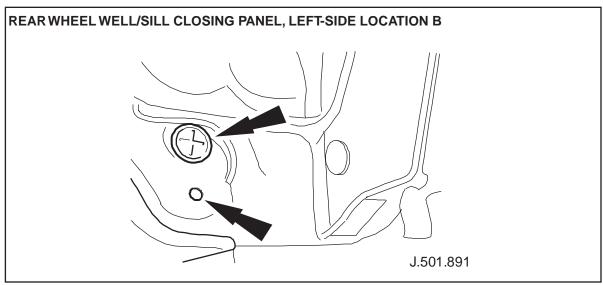
ILLUSTRATION 3

B. REAR WHEEL WELL/SILL CLOSING PANEL, LEFT-SIDE

Remove the large grommet, (upper arrow Illustration 3), and clean all the existing sealer from the grommet and the opening.

Replace the grommet, (replace, if necessary), and seal the grommet to the opening.

Identify the hole, (lower arrow Illustration 3) which is in the sill void area and through this hole fill the void with sealer.

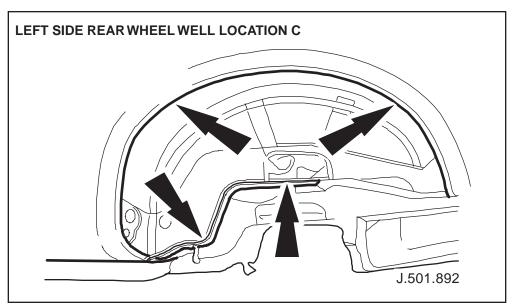
ILLUSTRATION 4

C. LEFT-SIDE REAR WHEEL WELL

Remove all old sealant from within and around the seam areas indicated in Illustration 4, and then check for possible leakage in these areas by applying air pressure behind the seams.

Apply a two pack adhesive/sealer to the seams, (see the next section for information on sealing the luggage compartment side of the wheel well seam).

The above operation applies to both left and right sides.

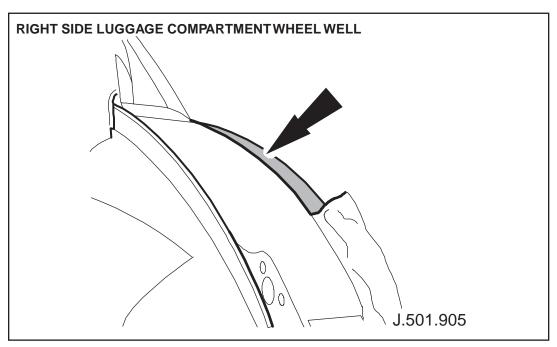
ILLUSTRATION 5

RIGHT-SIDE LUGGAGE COMPARTMENT WHEEL WELL

From within the luggage compartment, remove any sealer that lies in the seam between the wheel well and the outer skin, (shown shaded in Illustration 5).

Fill the whole length of the seam with adhesive/sealer.

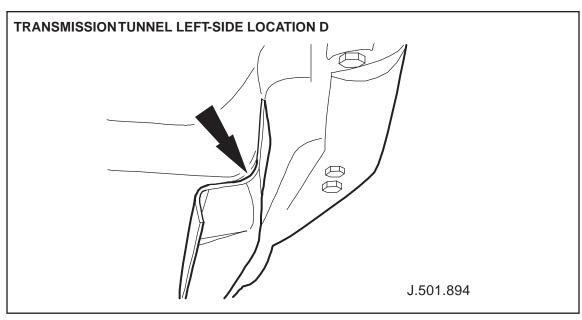
ILLUSTRATION 6

D. TRANSMISSION TUNNEL LEFT-SIDE

Using a suitable tool, probe the seam between the floor panel and the transmission tunnel, (arrowed in Illustration 6), to remove all the existing sealing material.

When the seam has been cleaned of all sealing debris, fully seal the area with adhesive/sealer. Check the seal with air pressure.

The above operation applies to both left and right sides.

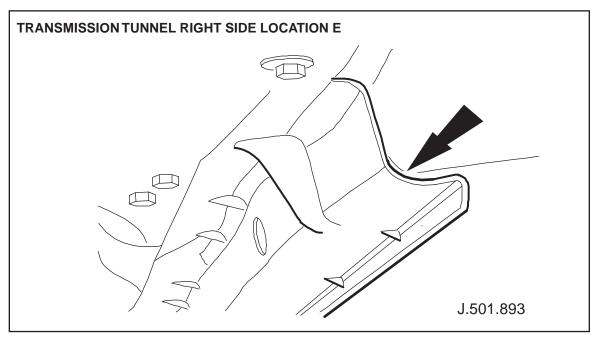
ILLUSTRATION 7

E. TRANSMISSION TUNNEL RIGHT SIDE

Clean and seal this area as with area D. (Illustration 6). The above operation applies to both left and right sides.

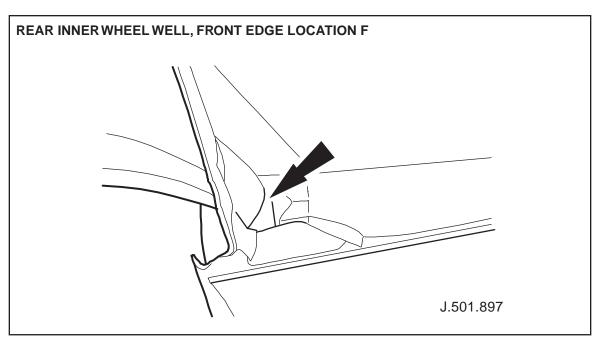
ILLUSTRATION 8

F. REAR INNER WHEEL WELL, FRONT EDGE

Clean and seal this area, (Illustration 6).

The above operation applies to both left and right sides.

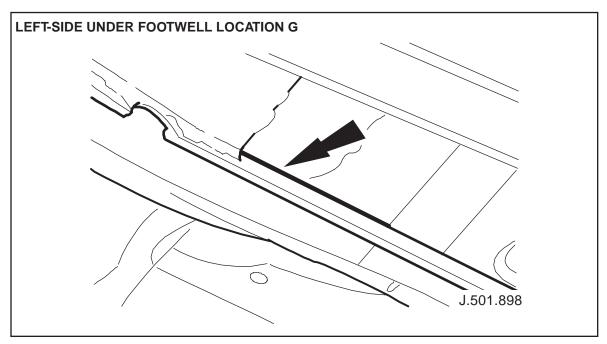
ILLUSTRATION 9

G. LEFT-SIDE UNDER FOOTWELL

The sill to floor seam, indicated by the arrow, should be inspected for any gap in the seal.

If a break or gap is discovered, the sealing material in that area should be removed and the area resealed.

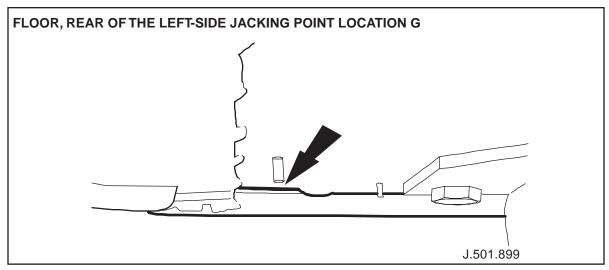
ILLUSTRATION 10

G. FLOOR, REAR OF THE LEFT-SIDE JACKING POINT

The seam, indicated by the arrow, should be inspected for any gap in the seal.

If a break or gap is discovered, the sealing material in that area should be removed and the area resealed.

The above operation applies to both left and right sides.

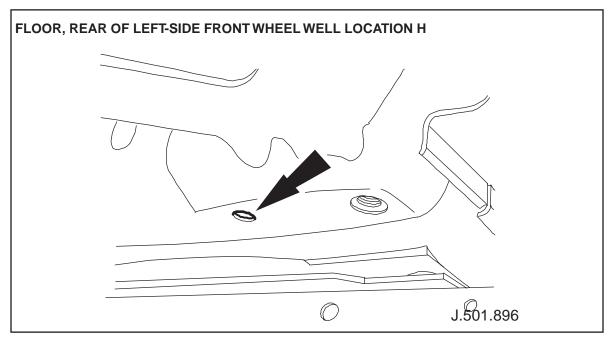
ILLUSTRATION 11

H. FLOOR, REAR OF LEFT-SIDE FRONT WHEEL WELL

Inspect the hole indicated by the arrow. Clear out any debris and fill with sealant.

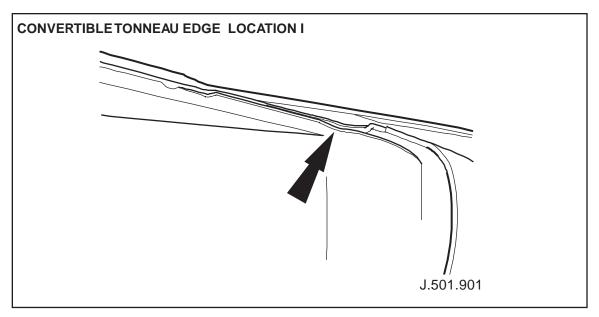
ILLUSTRATION 12

I. CONVERTIBLE TONNEAU EDGE

Clear out any debris and fill with sealant.

The above operation applies to both left and right sides.

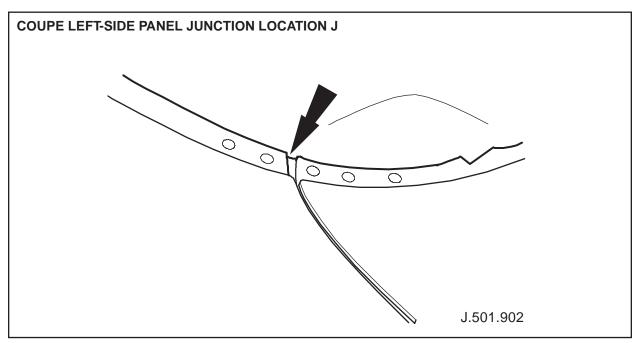
ILLUSTRATION 13

J. COUPE LEFT-SIDE PANEL JUNCTION, REAR GLASS MOUNTING FLANGE

If water is leaking into the luggage compartment this area should be inspected.

If this area is proved to be the source of the leak, the rear glass must be removed, the gap, (arrowed in Illustration 13), filled with glass sealer adhesive and the glass reinstalled.

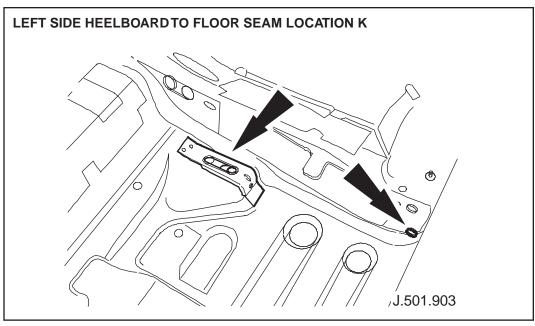
ILLUSTRATION 14

K. LEFT SIDE HEELBOARD TO FLOOR SEAM LOCATION

Inspect the seam indicated by the arrows and, if there is evidence of a water leak, remove the existing sealant and fill the seam with sealant.

The above operation applies to both left and right sides of the floor and the transmission tunnel.

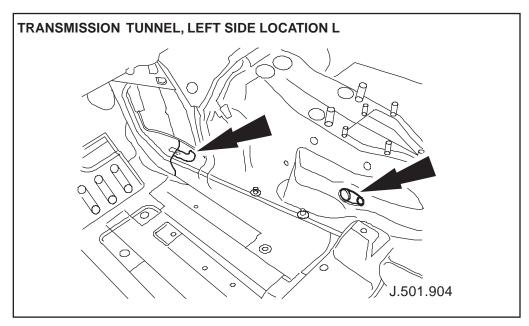
ILLUSTRATION 15

L. TRANSMISSION TUNNEL, LEFT SIDE LOCATION

Inspect the selector lever cable grommet, indicated by the arrow and if there is evidence of a leak, remove the grommet, clean off all sealant from the grommet and the body, replace the grommet in position in the body aperture and then seal the area.

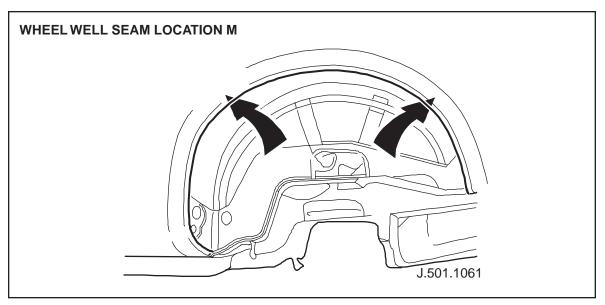
ILLUSTRATION 16

M. WHEEL WELL SEAM

Inspect the area around the wheel well, between the inner and outer panels, indicated by the arrows. Clear out any debris and fill with sealant.

The above operation applies to both left and right sides.
