Door Trim Panel Loose or Adrift –
Upper Rear Retainer Clip Bracket –
Repair

MODEL 2000 MY-ON
XK Range

VIN A00016-ON

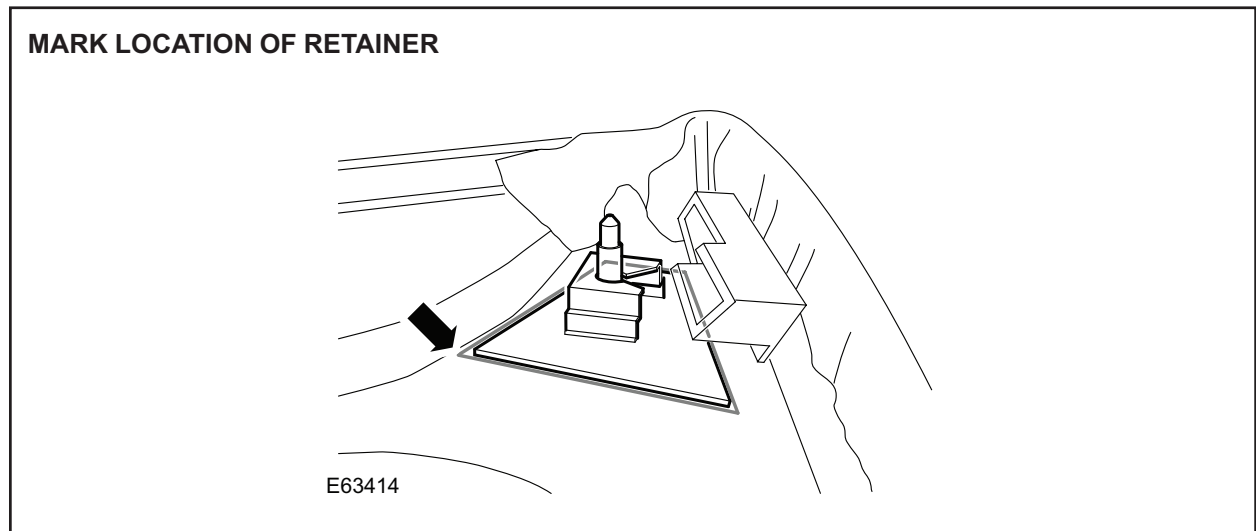
ILLUSTRATION 1

Some vehicles may exhibit a door trim panel that is loose due to a broken upper rear retainer clip bracket. The bracket can be renewed, to avoid replacing the complete trim panel.

1. Remove the door trim panel (see Global Technical Reference GTR Workshop Manual, section: 501-05).
2. Using a suitable pen, draw a line around the damaged retainer clip bracket (Illustration 1).
