Technical Service Bulletin

No.JTB00070
29 November 2007

Subject/Concern: Transmission Noise During Gearshifts - Gasoline

Models:		
S-TYPE	Gasoline Only	Gasoline Only VIN-range: M45255-N52047
XJ Range	Gasoline Only	Gasoline Only VIN-range: G00442-G49700
XK Range	Gasoline Only	Gasoline Only VIN-range: A30645-A48684

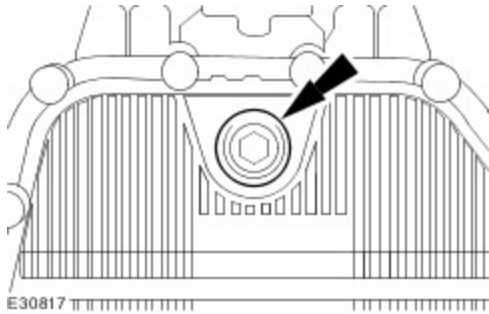
NOTE: XJ Range shown; S-TYPE and XK similar.

Undo and partially remove the transmission fluid drain plug.
