NUMBER  
JAGA309-001  
(Issue 2)

TECHNICAL BULLETIN

**SECTION: 309 - EXHAUST SYSTEM**

**Removal of Seized Oxygen (O<sup>2</sup>) Sensors**

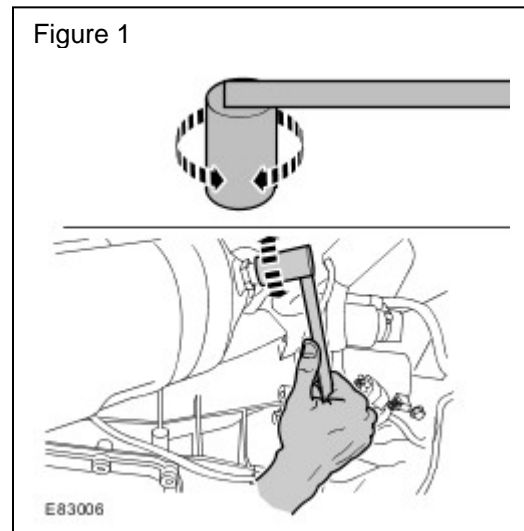
Figure 1

**△ NOTE:** Turning the O<sup>2</sup> sensor clockwise and then counter-clockwise will help loosen and distribute the lubricant throughout the threads. The back and forth rotations will aid removal of the sensor and minimize potential damage to the catalyst threads. (Figure 1)

5. Turn the O<sup>2</sup> sensor clockwise and counter-clockwise to distribute the lubricant around the threads. (Figure 1)
6. After adequately distributing the lubricant, attempt to remove the O<sup>2</sup> sensor.
7. If the breakaway torque exceeds **70 Nm (52 lbf-ft)**, STOP torque application and allow further time for the lubricant to penetrate the threads.
8. Clean the catalyst pipe threads using a 3/4 inch diameter wire brush (similar to a male battery terminal cleaning brush) to remove any debris.
9. Inspect the catalyst down-pipe threads for any damage and ensure a new sensor can be installed.
