Your Vehicle: 1999 Jaguar XK-8 Convertible (X100) V8-4.0L (AJ27)

Engine Hard Start - Diagnosis

310-02

Engine Hard Starting - Diagnosis MODEL 1997 MY-ON XK8 Range

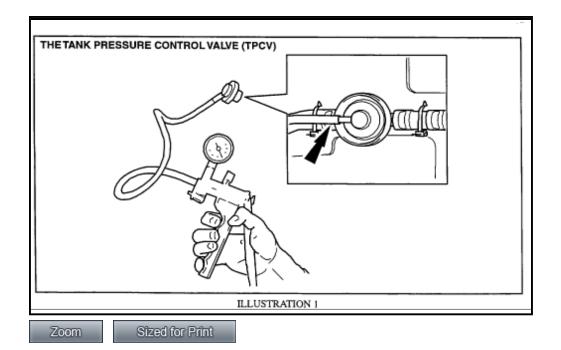
TPCV SHOWI	NG TANK & CAN PORTS		
		CAN JSI-3052	
ILLUSTRATION 2			
Zoom	Sized for Print

^Tank Pressure Control Valve, (TPCV), known as a "Rochester Valve"

Connect a hand vacuum tester to the TPCV vacuum port, as shown in Illustration 1 and follow the flow chart.
