**Damaged Cupholder –
Replace Mechanism Only –
Repair Procedure**MODEL 1995-97 MY
Sedan Range
VIN 720001-812255**ISSUE:**

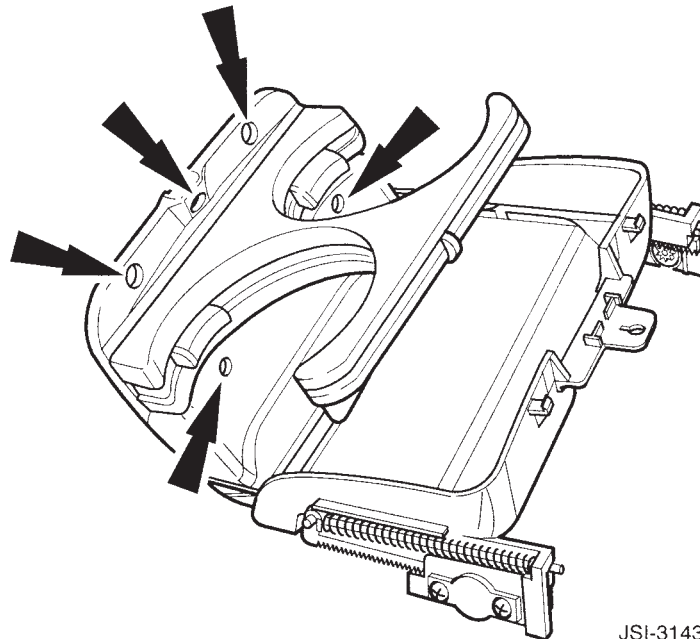
ILLUSTRATION 1

In case of a customer complaint of a broken cup-holder assembly, (shown in Illustration 1), remove the holder and install a new assembly in the cubby box lid as described on the next page.

4. Remove the cup holder latch retaining screw, (Illustration 3).
5. Remove the latch and the cup-holder mechanism with its trim panel from the lid.
6. Remove the five No.T8 Torx head screws, (arrowed in Illustration 1), that retain the trim panel. Remove the panel from the mechanism.
