**Damaged Cupholder Mechanism –
Replace Mechanism Only –
Repair Procedure**

MODEL
1997 MY-ON XK8 Range
1998 MY-ON V8 Sedan
VIN
001001-ON
812256-ON

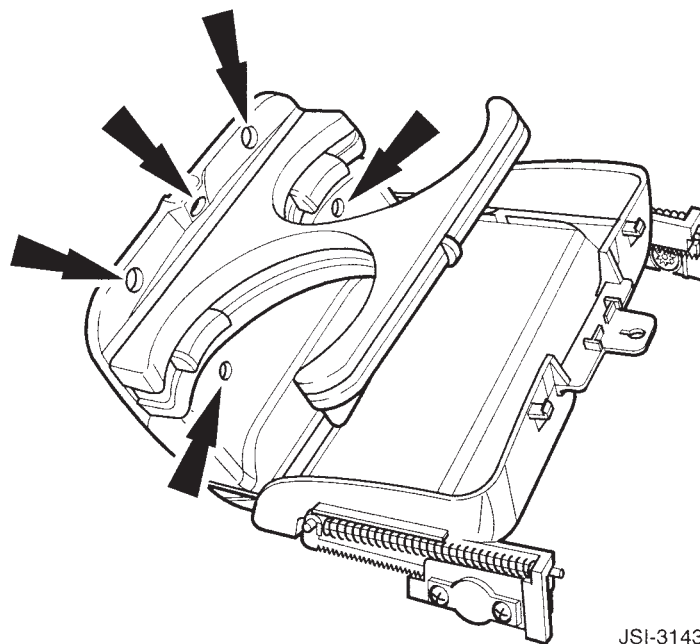
ILLUSTRATION 1

In case of a customer complaint of a broken cup-holder assembly, (shown in Illustration 1), remove the holder and install a new assembly in the cubby box lid as described on the next page.

LOCATIONS FOR TRIM PANEL SCREWS IN CUPHOLDER ASSEMBLY

4. Remove the cup holder latch retaining screw, (Illustration 3).
5. Remove the latch and the cup-holder mechanism with its trim panel from the lid.
6. Remove the five No. T8 Torx head screws, (arrowed in Illustration 1), that retain the trim panel. Remove the panel from the mechanism.

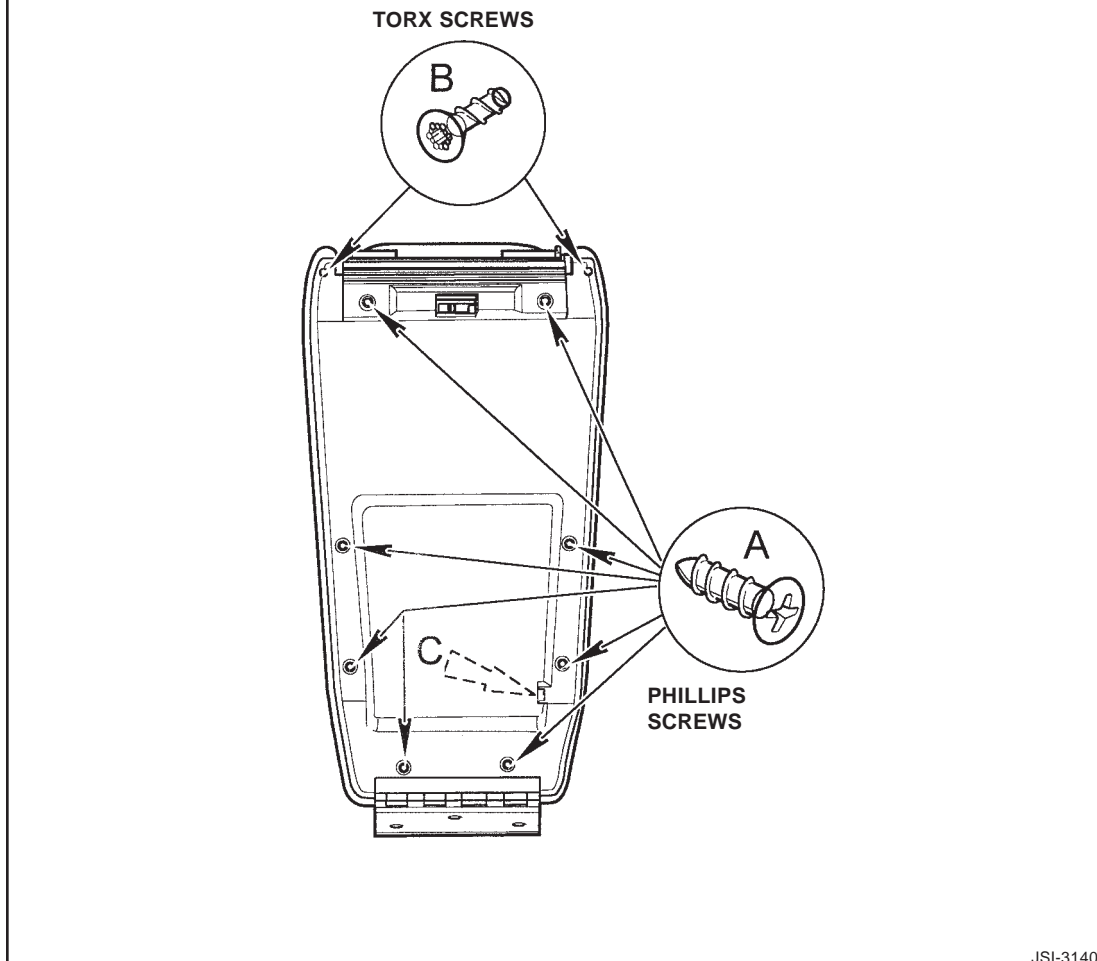
ILLUSTRATION 2

CONSOLE LID RETAINING SCREWS

1. Open the Console Lid and remove the screw, (C, illustration 2), that secures the check arm to the lid.
2. Remove the three screws that retain the lid and hinge to the console. Remove the lid from the console. Place the lid assembly on a clean bench area.
3. Remove the eight phillips-head screws, (A, Illustration 2), and the two T8 Torx head screws, (B, Illustration 2), that hold the inner finisher to the console lid. Remove the finisher and the hinge from the lid.

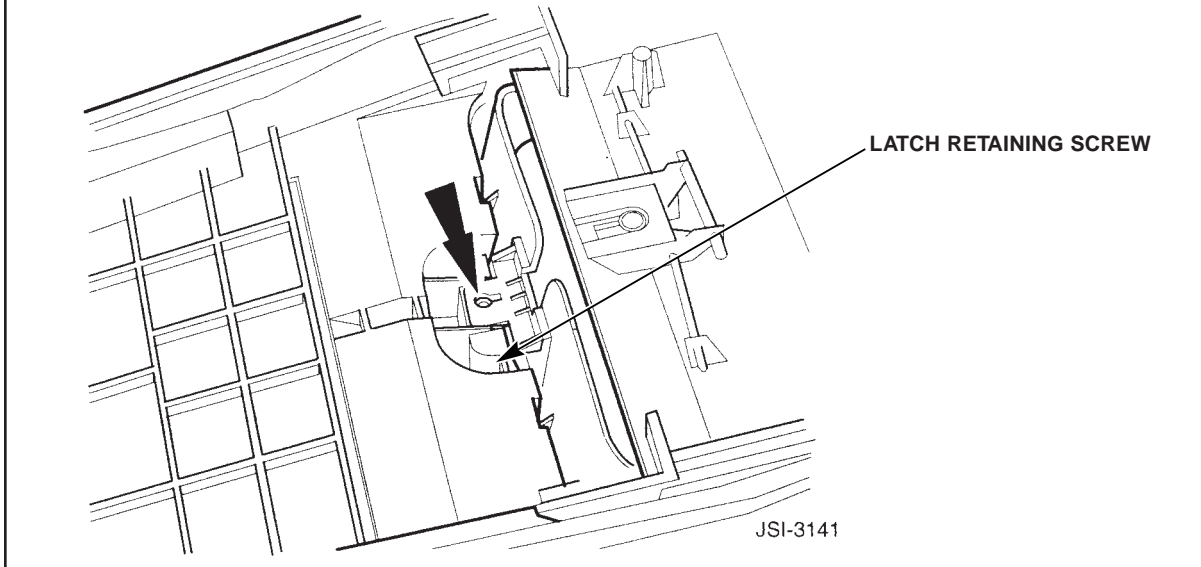
ILLUSTRATION 3

RETAINING SCREWS AND SPRING

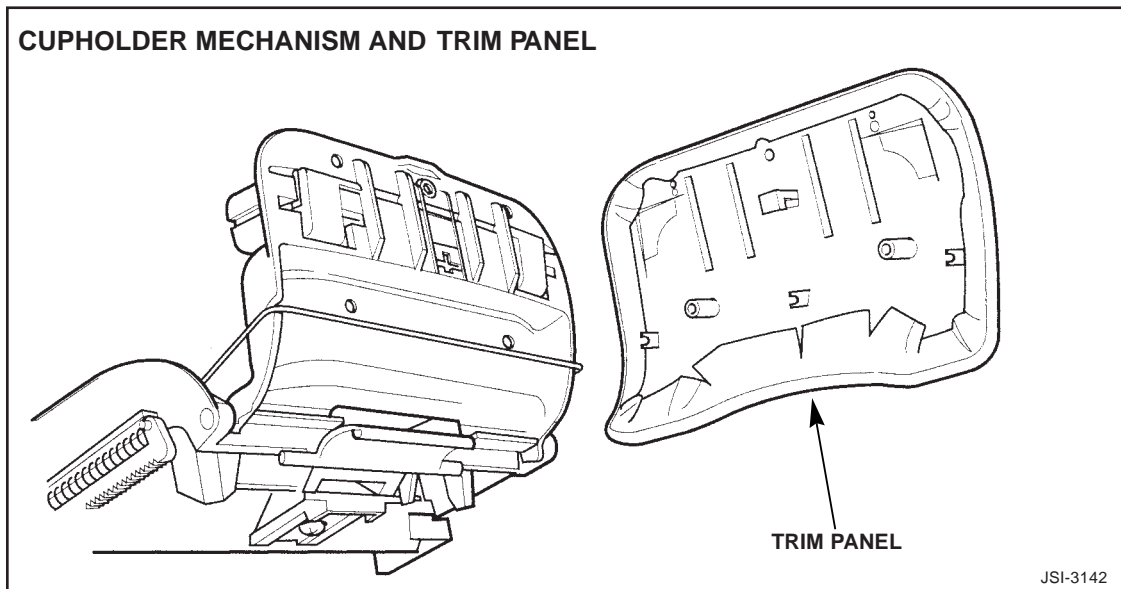
ILLUSTRATION 4

CUPHOLDER MECHANISM AND TRIM PANEL

Note: The trim panel is released by pulling the bottom edge out a little and then pushing upwards, to disengage the hooked projection on the rear of the trim pad from the mechanism.

7. Discard the damaged mechanism.
