TECHNICAL BULLETIN

412-00

Poor Air Conditioning (A/C) Performance.

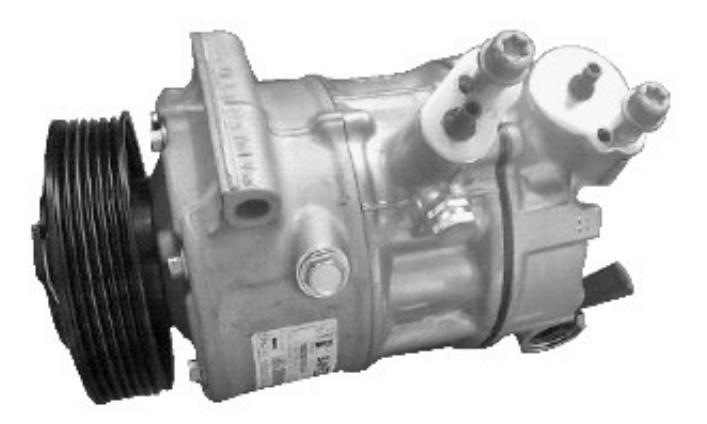
E165840

Make sure to avoid foreign materials entering the DPS control valve hole on the cylinder head when the DPS valve is removed.

Using compressed air or similar, remove all foreign materials from around the DPS valve/A/C compressor cylinder head.

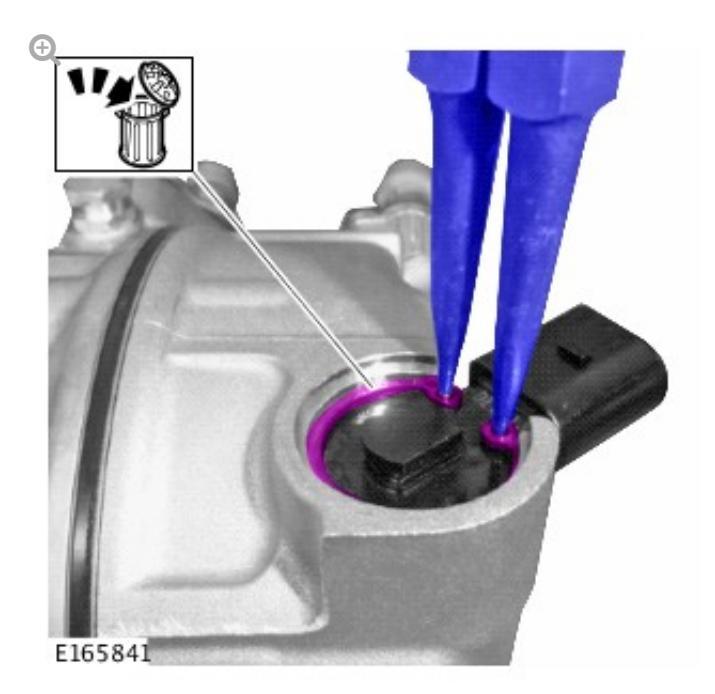
Make sure not to damage the circlip housing in the A/C compressor cylinder head.

Place the A/C compressor on a clean flat work surface.

Using a suitable tool, remove and discard the circlip that retains the DPS valve in the A/C compressor cylinder head.

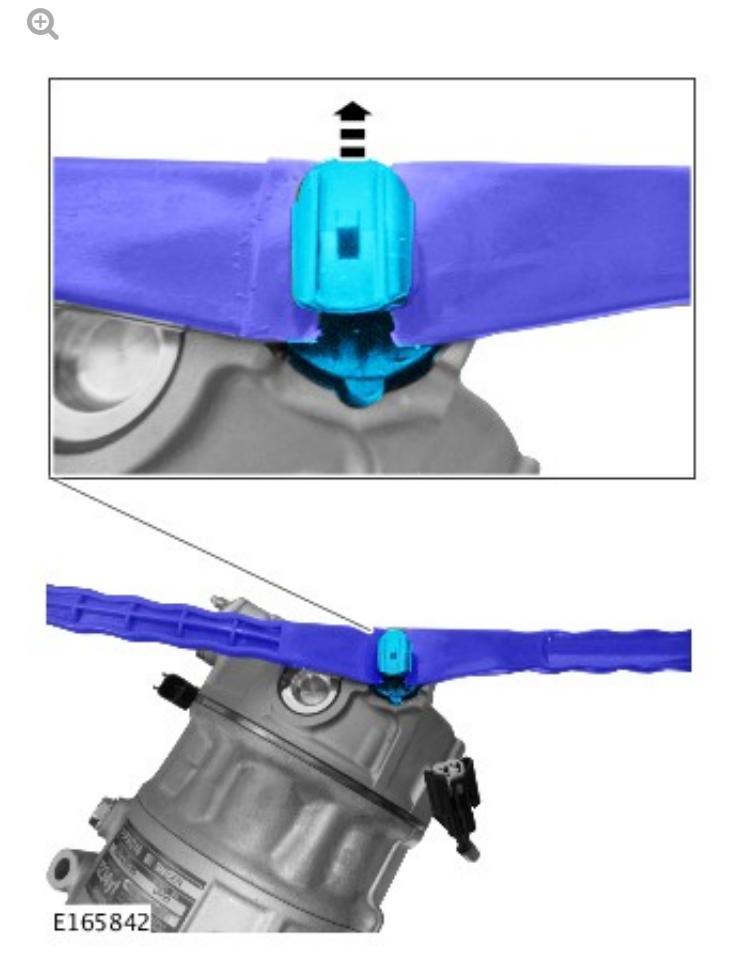
Make sure not to damage the housing in the A/C compressor cylinder head.

Using suitable tools, release the DPS valve.

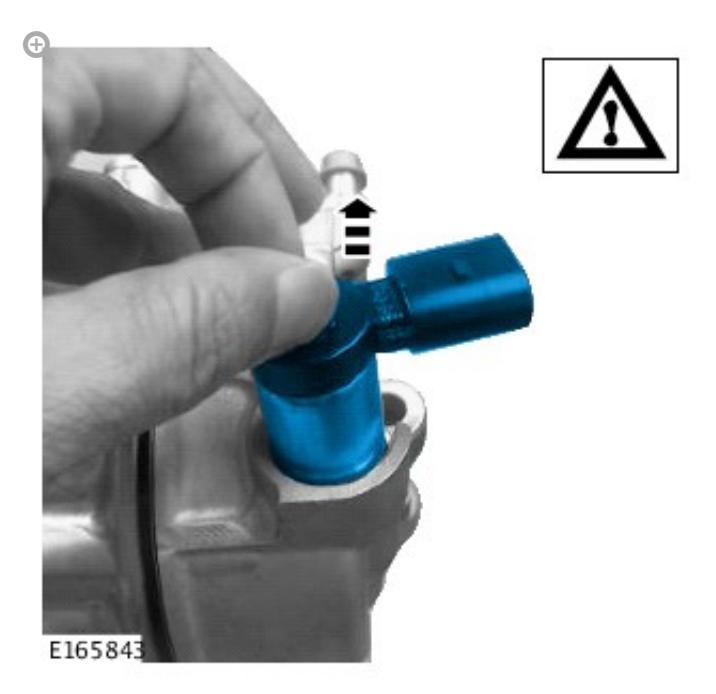
Take care to remove the DPS valve in a vertical direction to avoid damage to the inside wall of the A/C compressor cylinder head.

Remove by hand the DPS valve from the A/C compressor cylinder head, and discard.

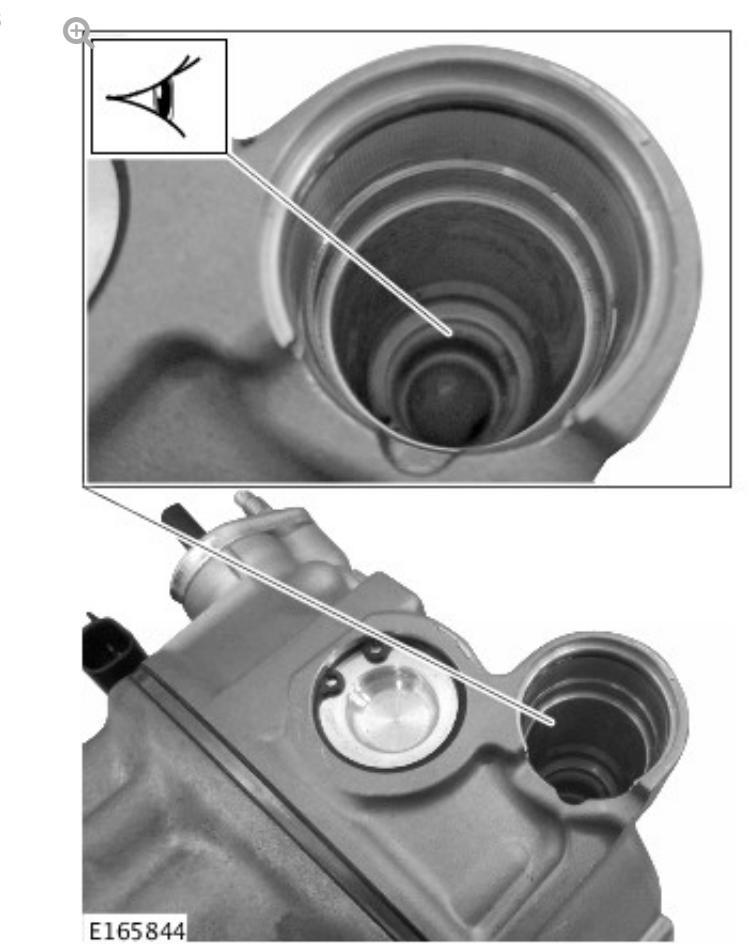
Inspect the inside wall of the A/C compressor cylinder head for scratches, scoring, or foreign material.
