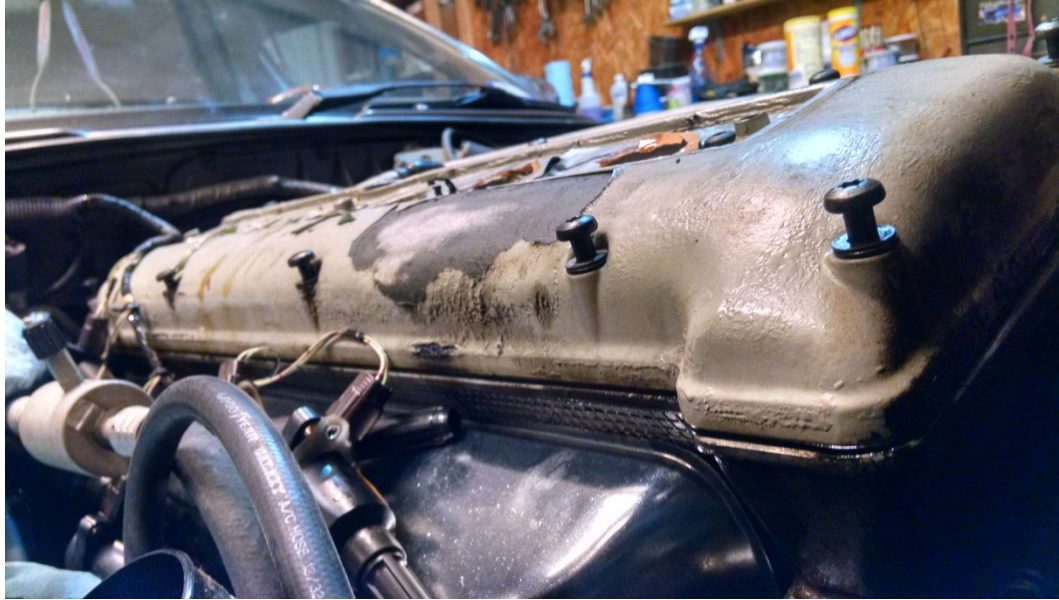
Having recently pulled 4 cam-covers, I think I found only 2 cam-cover bolts (out of 52 total) that would pull out of the holes easily after total thread disengagement. Just make sure they are totally unscrewed and leave them in the holes (remember, there are 13 in total, don't forget the 3 down the center):

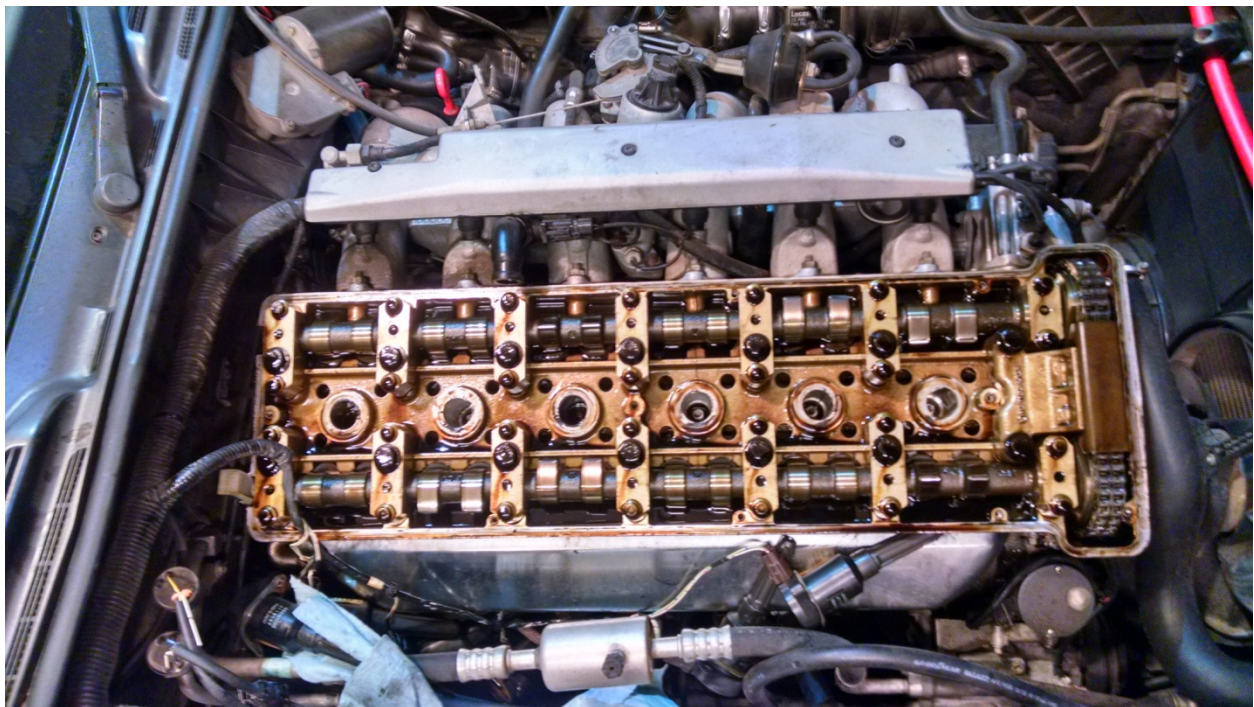
Removing the oil fill cap (710 cover!) will leave you a nice hand-hold for lifting it off. You may need to pry gently around the corners to break it loose if the last installation was accomplished with a smear of RTV on both sides of the gasket and the SPB seals. Go easy, it is a fragile piece.

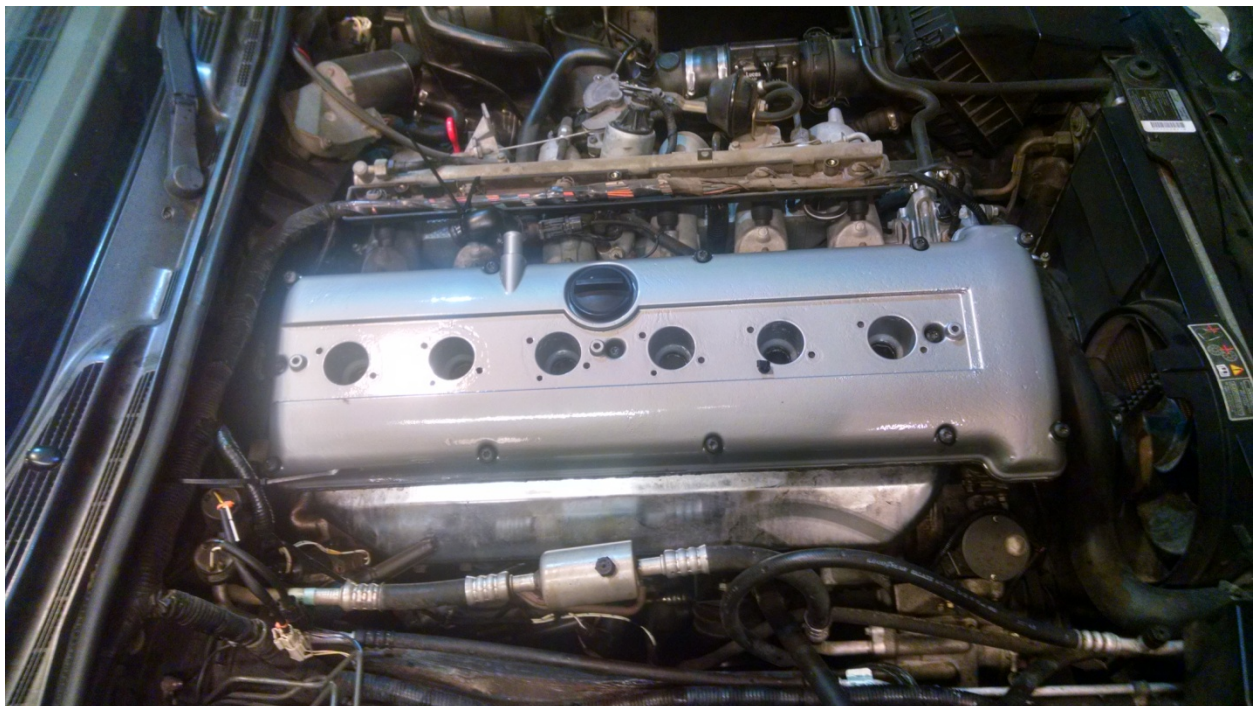
As is evident, my paper coil gaskets were destroyed. I found a couple that I had made back at the 85k mile plug swap when I took it apart. I don't remember EXACTLY what I constructed them from back then but it was some kind of plastic. They were still intact, but I made a full set this time from plastic water jug material. You'll need: Knife (I used an exacto), a couple of gallon water or milk jugs, most of a sheet of adhesive label paper, a pencil, and a hole punch. I found the cap (+ tracing clearance) on a gallon water jug was the perfect diameter to fit snugly around the coil boot: Cut out a flat piece of the jug large enough to cover the coil base and stick a piece of label paper to it:

Then, starting in the middle, and alternating sides and working toward opposite ends, I snugged each bolt down finger-tight. The original torque spec of 3-5 nm was revised via TSB to 6.5 nm, which still isn't very much. Again, starting in the middle, and working diagonally outward to both ends, I applied about a half-turn to each and continued the rotation sequence until I got the 6.5nm click on the torque wrench. Refer to TSB 03. 1-08 "Camshaft Cover Oil Leaks – AJ16 Engine – Revised Bolt Torque Specification" for the proper Jaguar way of doing it. (including diagram of bolt-order tightening sequence)

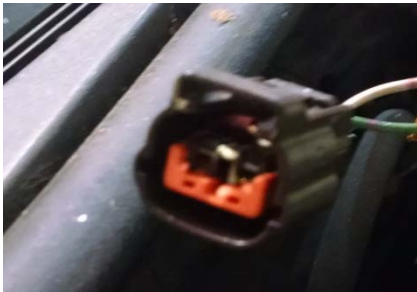
By now the keen eye has spotted that the coil used in gasket construction is not from the car that is getting the freshly-painted cam-cover. Correct. I removed all the coils from their connectors during my first cam-cover removal on SpruceBruce and placed them to a box. He had one non-OEM coil fitted and a bit of a hitch at idle and possibly throughout the range, so I've got that to sort through. Remembering this fact, I found the coil box and grabbed one when I realized I needed a pattern. I do not recommend disconnecting the connectors from your coils if you do not suspect that you have any coil problems when you accomplish either a cam-cover R&R or fit new plugs, or both. Here's why, as alluded to in one of the linked-cam-cover posts:

See how the orange part of the connector doesn't really seem to be all there? It's not. Here's how it should look: (and you can see even the whole one has a crack – they are all brittle at this age)

For what it's worth, at the same time I obtained the first replacement cam-cover, I noticed all six coils on that car were the original, Lucas, made-in-Japan variety. I thought that may come in handy and snipped the wiring loom right at the takeout on the firewall harness and bought all six, still strung together by the wiring loom, like a mess of fish. Remembering these broken connectors on Bruce, I thought, "Hey, maybe I could take a pick and release the terminals in those connectors and move the whole shell and all its associated parts to Bruce?" So I removed a spare coil from the harness and the connector looked perfect! Until I barely touched it with a pick...then the orange bit began to immediately crumble. I decided to keep at it to see what would make the terminals release. Never managed it. I know they have a little spring-locking tab, but I couldn't actuate it. I decided if I ever need to use any of the other 5 coil plugs on that cut-harness, the ticket is to just snip the wires a few inches back and solder them onto the car harness!
