## Lamp Control module resistor values – early cars with separate module

## Security locking module resistor values – later cars with integrated module

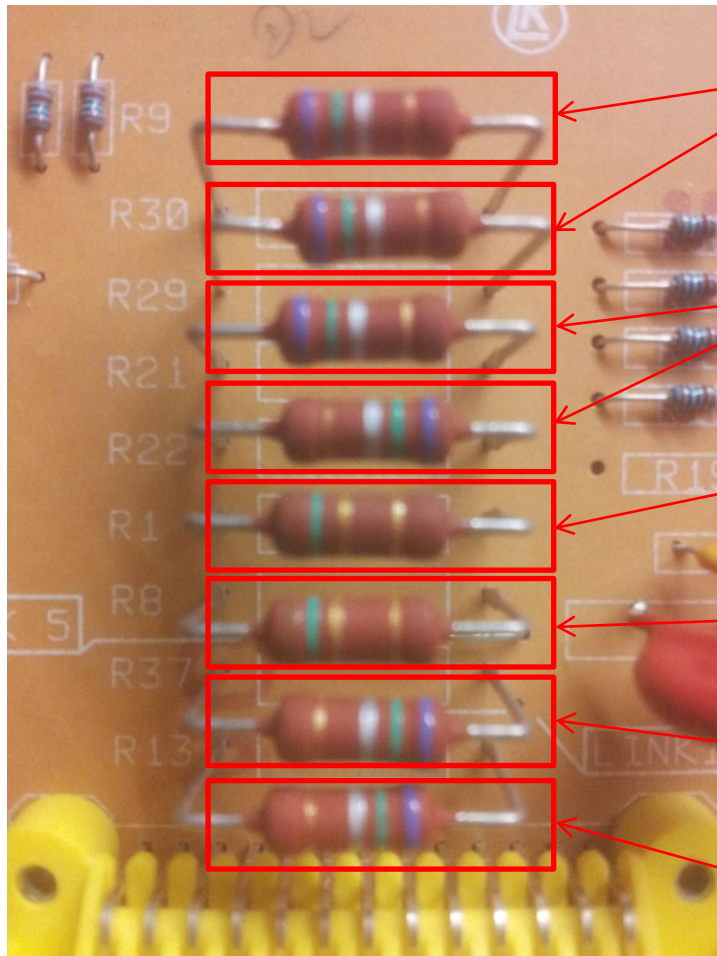
R30 & R29 Wired in parallel  
Marked violet green silver gold,  
0.75Ω or 0R75.  
RH stop lamp

R21 & R22 Wired in parallel  
Marked violet green silver gold,  
0.75Ω or 0R75.  
LH stop lamp

R1 Marked brown green gold gold,  
1.5Ω or 1R5.  
LH tail lamp

R8 Marked brown green gold gold,  
1.5Ω or 1R5.  
RH tail lamp

R37 Marked violet green silver  
gold, 0.75Ω or 0R75.  
Number plate lamps

R13 Marked violet green silver  
gold, 0.75Ω or 0R75.  
Rear side markers

All these resistors are 2W ceramic 5%

Note that while the number plate & rear side marker lights are fed via the Lamp Control module, a failure of either (or of R13, R37) will not throw a 'bulb fail rear' message: i.e. the lamps are not monitored.

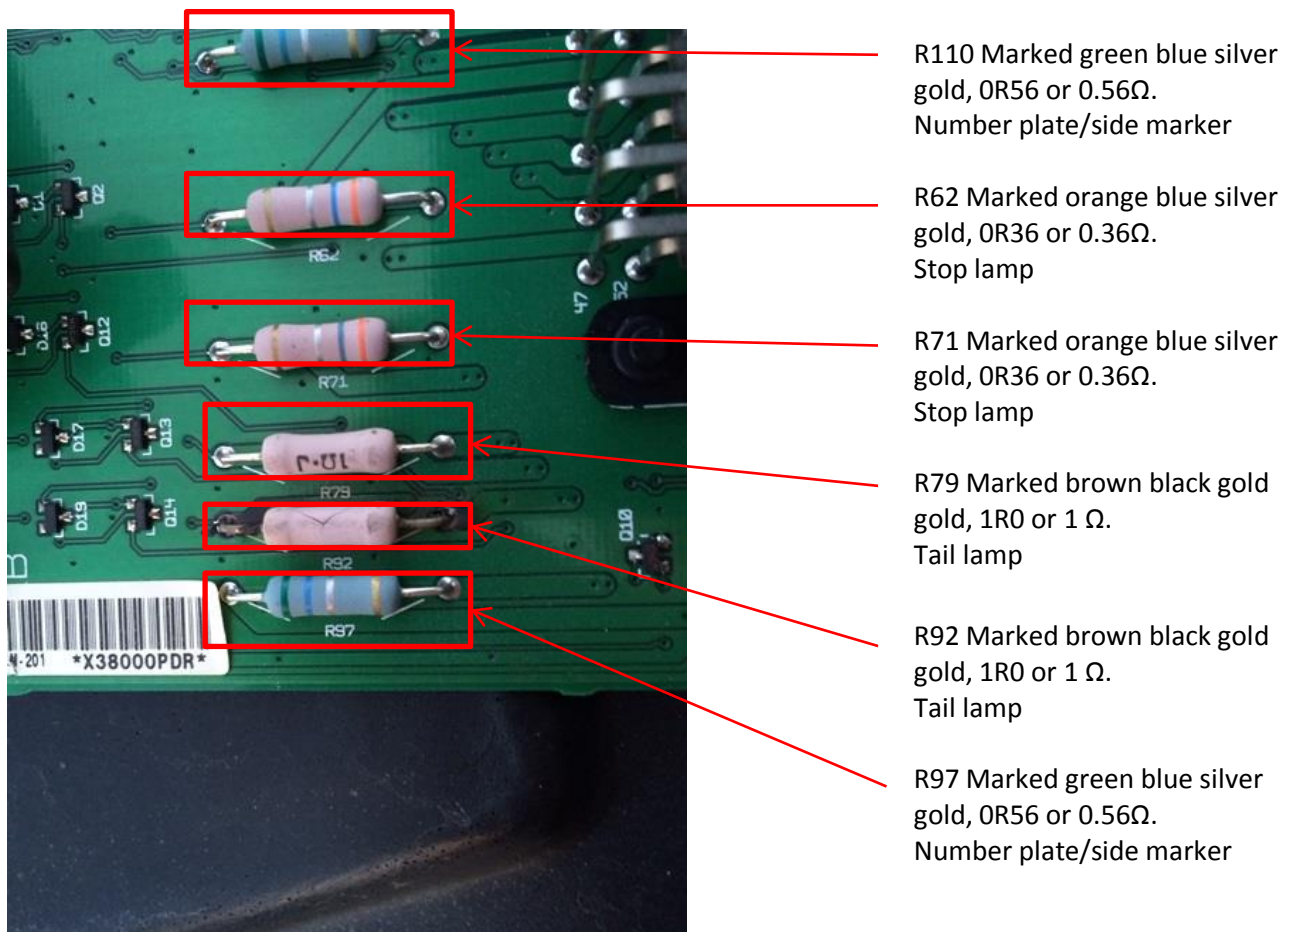
All resistors are 3W ceramic, 5% tolerance. There is no harm in using 5W as replacements, particularly for the tail lamps.

*N.B. In the absence of a later SLM to reverse engineer, I don't have sufficient information to determine which of R97/R110 feeds the markers/number plate lamps. Also, I can't differentiate between L & R for the stop or tail lights. In practice, where one has failed, the other may have been stressed so it makes sense to replace as a pair: they are not expensive items.*

One clue to a failure of these components is that *with the affected bulb removed* the voltage at the lamp socket may read almost normal on a multimeter.

Although the originals are mounted tight to the circuit board, I recommend leaving a gap of at least  $\frac{1}{4}$  of an inch underneath. There isn't a fan inside the SLM so there won't be much air circulation, but it will reduce the risk of board burning in future.
