Jaguar S Type 3.0 V6 Auto 2000MY (UK RHD)

Opening the bonnet (Hood) through a mesh grill after the small cross over cable has failed. (Part number XR8001957) Number 8 in the drawing.

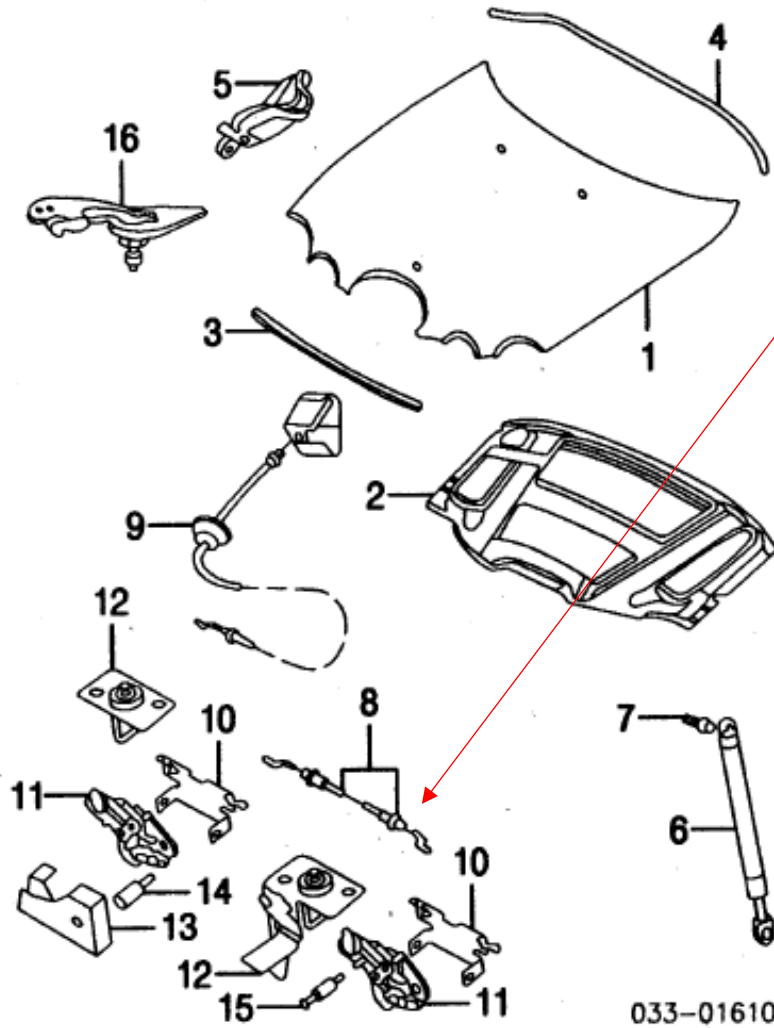
On mine, a section of one of angled end pieces had broken off, and the cable was no longer pulling.

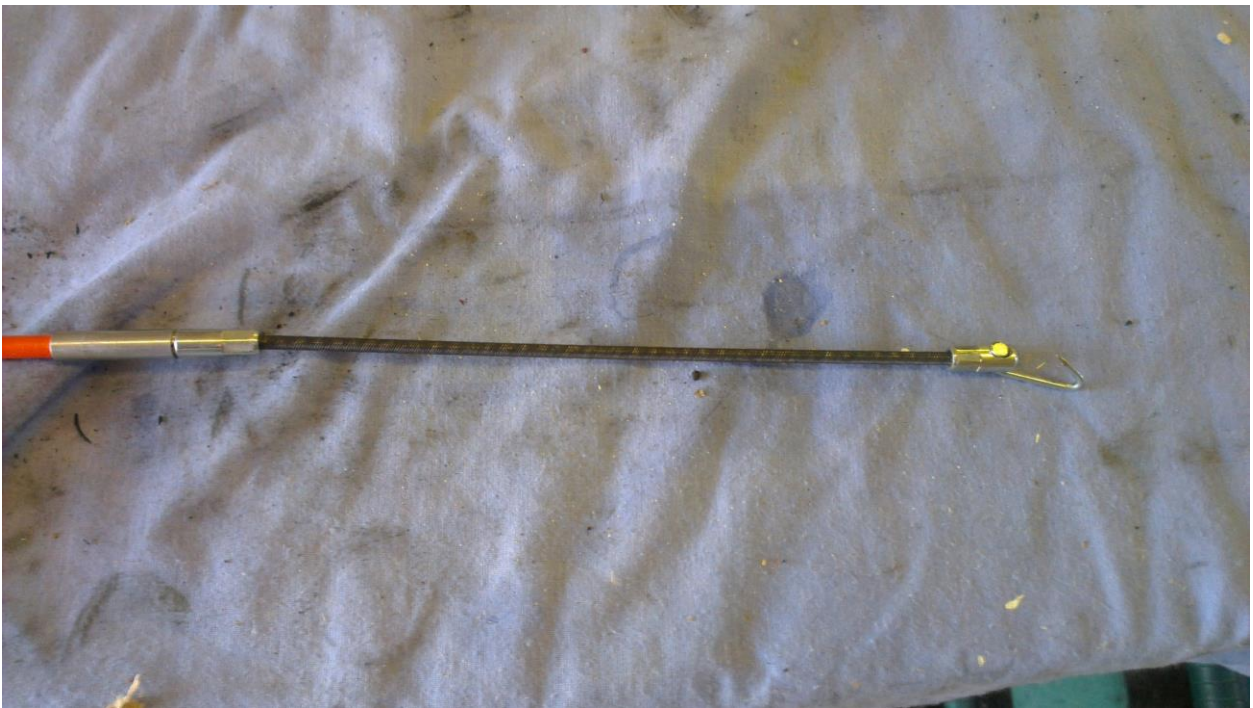
Picture showing the end of the cable puller with the bent nail in the end.

I used a electricians cable puller, which has a flexible end adaptor. On the end of this I put in a long small gauge nail which was then bent into a hook.

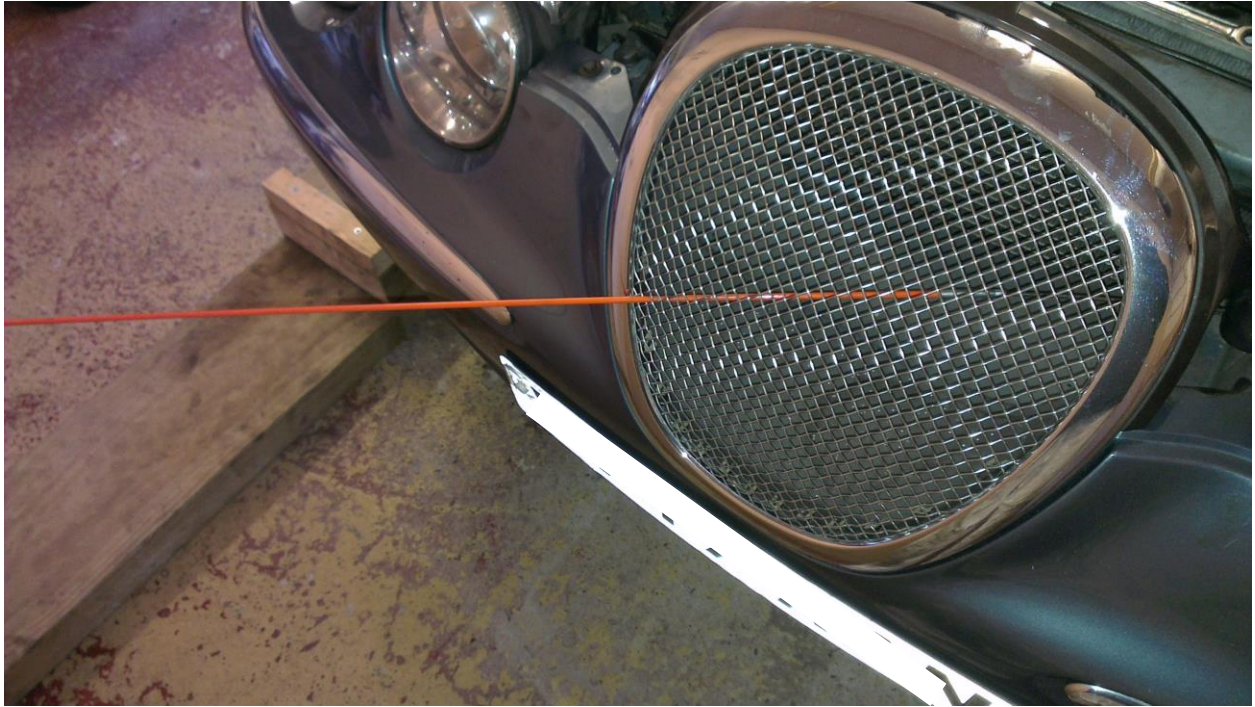
Cable Puller pushed through the mesh grill

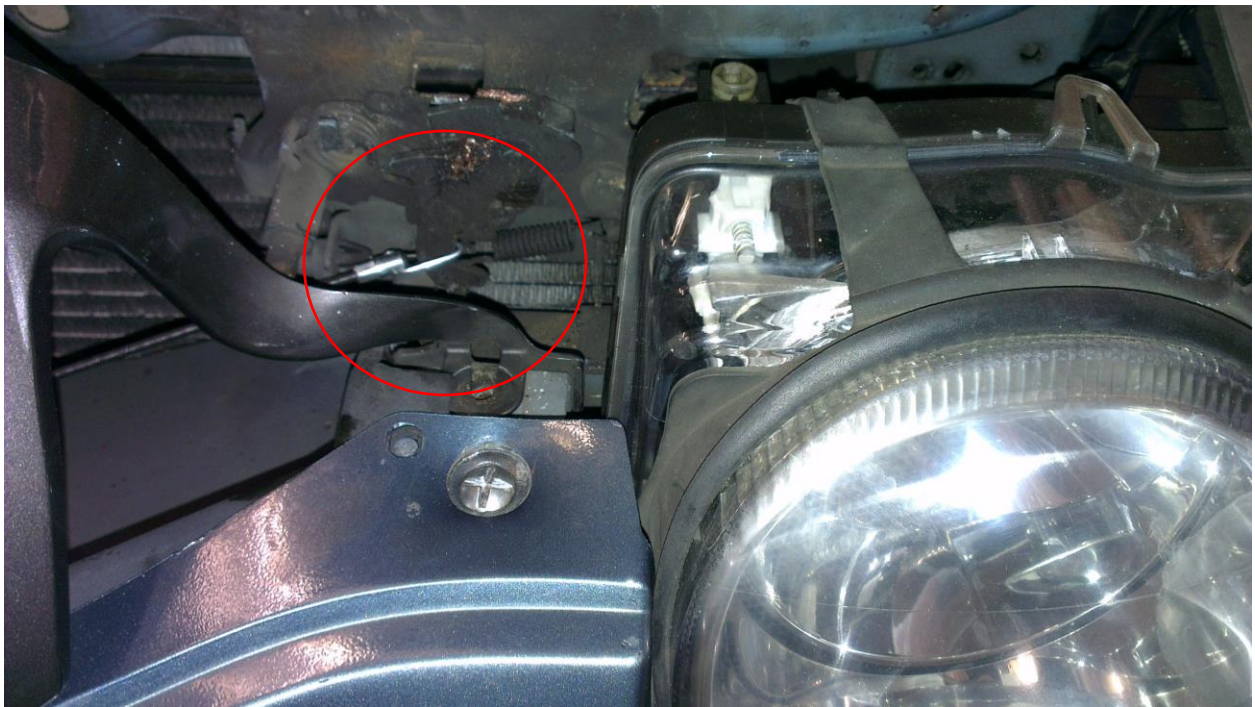
Hooked nail pulling on the latch release arm
