2002 Mazda MPV Transmission Repair

Intro:

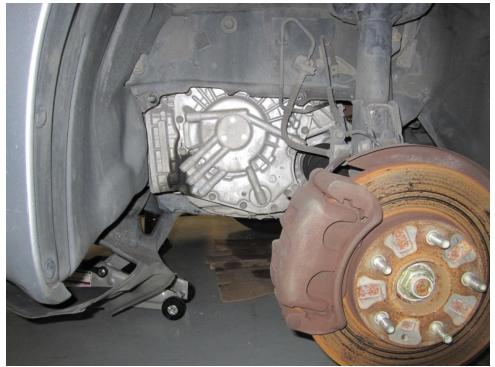
2. Remove the nut, bolt, and plastic body fastener, and fold the plastic splash guard forward, exposing the transmission end panel.

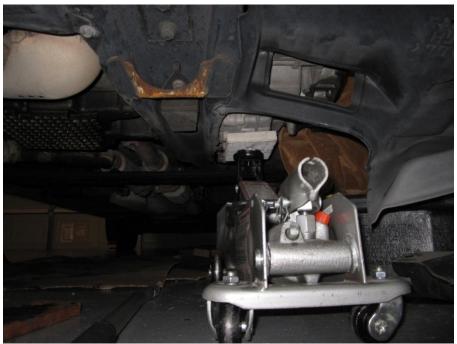
3. You will need to lower the engine & transmission a bit in order to fully access the end panel. Make sure your engine/transmission is supported. Since the engine mount member is still supporting the transmission, a jack may not be necessary, but I felt better with it in place. I originally had the jack on the oil pan, but found that wasn't far enough over on the driver's side to effectively lower/raise the transmission. I placed it on the driver's side of the engine mount member.

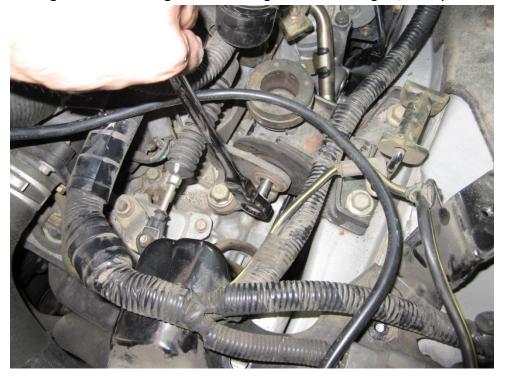
4. Remove the air filter, battery, and battery tray to expose the driver's side engine mount. Remove the engine mount through bolt. This might cause the engine/tranny to shift a bit.

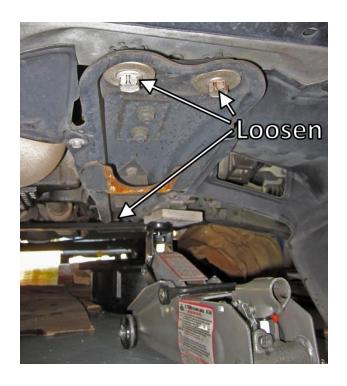
5. Loosen, but don't remove, the 3 bolts (2 front, 1 rear) on the engine mount member to allow the engine/ transmission to lower some. Even with the jack supporting the transmission, be careful here- there's not much supporting the driver's side of the transmission at this point.

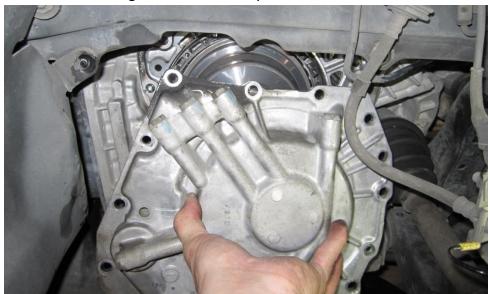
6. Put a pan under the end panel, as you will be soon have a few quarts of transmission fluid flowing out. Remove the bolts around the perimeter of the transmission end panel. The two larger bolts in the upper right-hand corner of the panel gave me the most trouble, because they were close together. After all bolts (16, I believe) are removed, give the end panel a few taps with a rubber mallet to break the gasket seal. After the drainage of fluid slows, pull the end panel off. You might have to rotate it to get clear of the body.

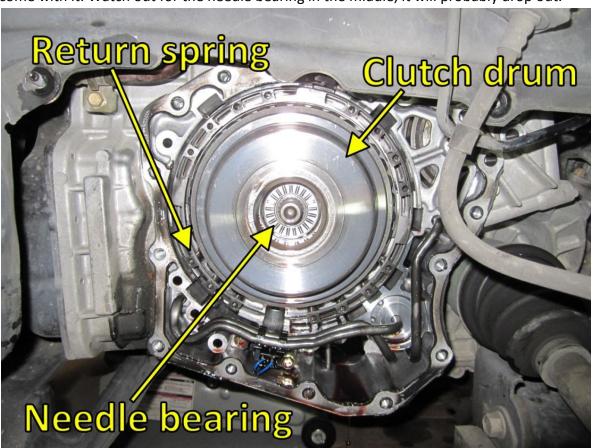
7. Here's where you need to keep things in good order, so that you can track the orientation and order of all parts removed. I found that in at least one example, the Mazda Transmission Manual had a bearing's orientation drawn incorrectly. Speaking of the Mazda Transmission Manual, I'm working from page K1-10 at this point. Depending on what's wrong in your transmission, different pistons/drums may stick together, so what you pull off at this point might not be the same as what came off when I pulled. **Remove the reverse/high clutch drum.** The return spring will probably come with it. Watch out for the needle bearing in the middle, it will probably drop out.

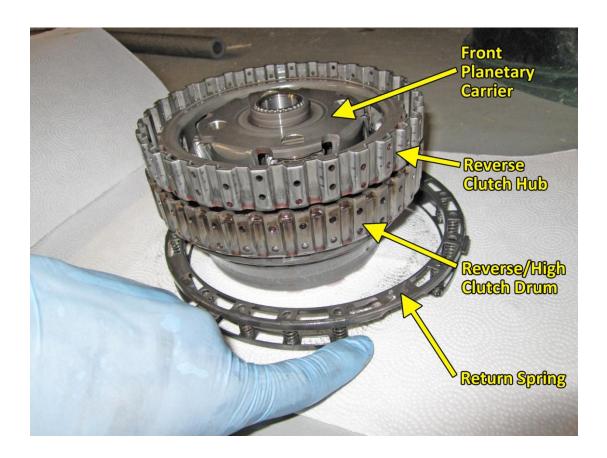
8. In my case, removing the reverse/high clutch drum pulled not only the reverse and high clutches, but also the high clutch hub, reverse clutch hub, and front planetary carrier. **Note that the high clutch hub drawing below has the race bearing facing the wrong way.**

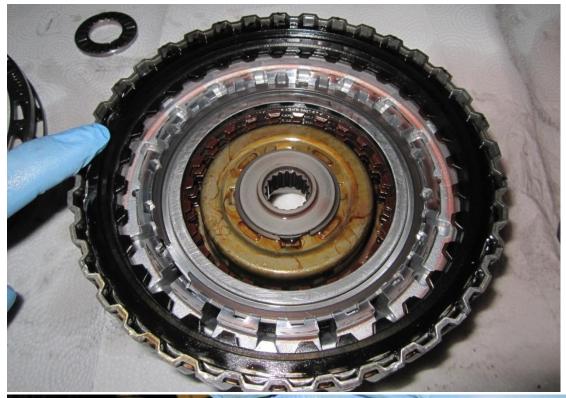
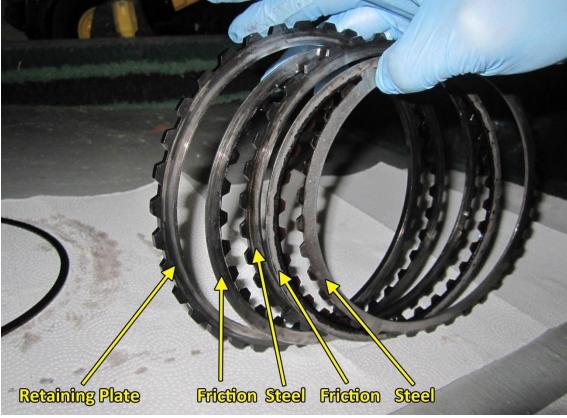
9. I didn't go any farther into the transmission, but instead focused on the reverse/high clutch drum, which had obvious signs of damage inside (in fact, the outside of the drum was darkened due to the burnt friction material). Start by removing the snap ring, the retaining plate (looks like a thicker "gear"), and the alternating frictions and steels. My reverse frictions were toast; complete loss of friction material, and one was bent. Steels looked grooved and worn.

Cost was somewhat higher for me, as well, as I discovered a burr on one of my high clutch steels, and decided to replace the entire pack. I also discovered that my reverse clutch snap ring was extremly loose, and needed to be replaced. I probably should have waited until I had disassembled the tranny before ordering parts, as I wouldn't have had to pay shipping twice (second time for high clutch parts). Total cost for parts and shipping, including fluid to flush the system at the end, came in at around \$250.

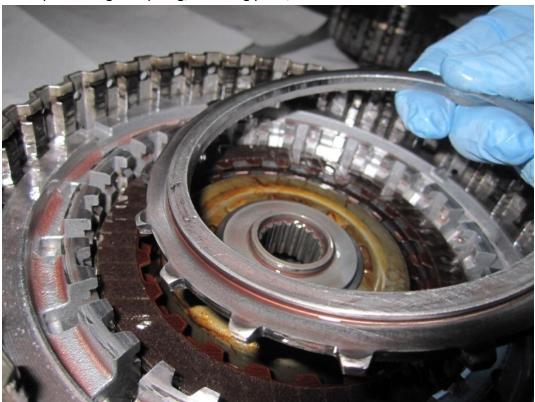
10. Next up is the high snap ring, retaining plate, frictions and steels.

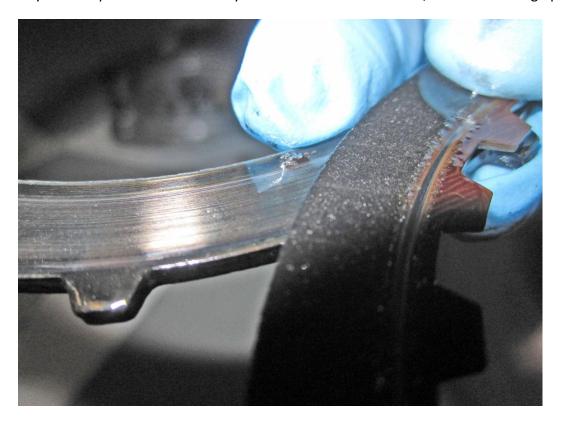
My high frictions looked a lot better, except for one which had a deep groove in it. I checked the cooresponding steel, and sure enough, there was a burr on it -- probably came from the factory this way. At that point I decided to buy a whole new set of frictions/steels for the high piston.

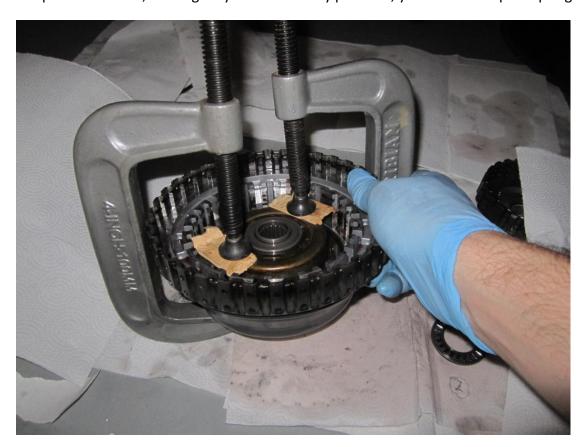
11. Next is the snap ring on the spring retainer. The spring retainer is that bronzish looking "hat" shape, and it's got a stout spring under it. To remove, compress the spring with a couple C - clamps until you have enough slack to pop out the snap ring. You risk damaging the edges of the retainer if you compress too much, although if you followed my parts list, you do have a spare spring retainer.

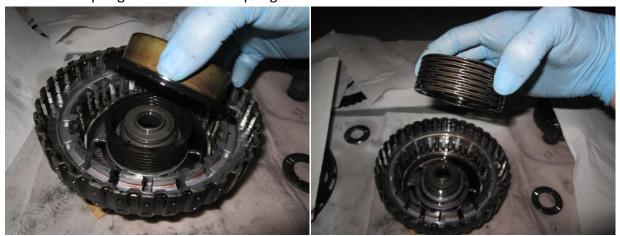
12. Remove the spring retainer and the spring underneath.

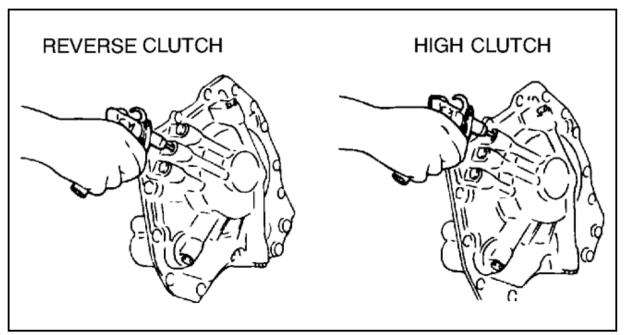
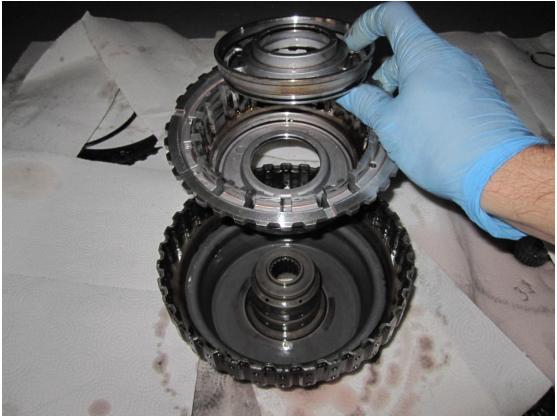
13. Remove the reverse and high pistons from the drum. To do this, place the clutch drum back in the end cover that you took off the transmission housing. Using compressed air, blow air into the proper hole to get the pistons to pop out. Take a break- now you've got the thing disassembled!

If your transmission suffers from loss of gears 3-5 (R, L, and 2 still work), than this repair may well work for you. It appears that a small crack develops in the high piston, allowing fluid to flow into the reverse piston. This causes the reverse piston's frictions to burn up.

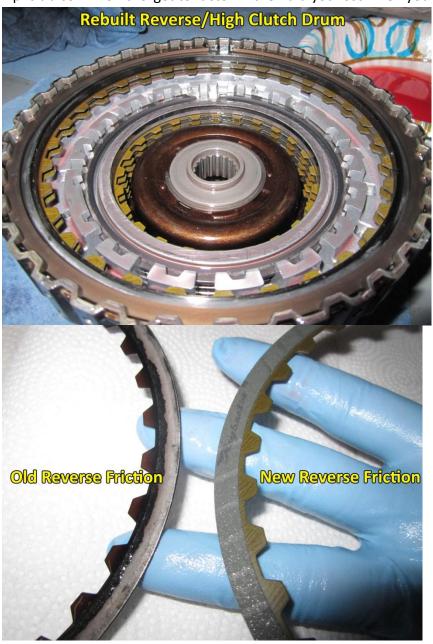
14. Install the D-rings on the high/reverse pistons (coat the rings with ATF). From this point on, basically it's just a reverse order of disassembly. Take your time, clean up components as you go along, and apply a nice coat of ATF to just about everything. Make sure the teeth of the frictions are lined up in each clutch pack, as this will allow you to slide all the components back together. After sticking everything back in the transmission housing, clean off the old gasket material, and place a bead of RTV silicone gasket maker (I used Permatex Black) around the mating face of the end panel. Tighten everything up, raise the engine & put other parts back on while the gasket is curing, let it sit overnight, then flush out the transmission using Bubba's method from mpvclub.com. Don't forget to factor in the fluid you lost when you cracked open the transmission.
