Instrument Panel and Console - Glove Compartment

Removal and Installation

Climate Control - In-Vehicle Temperature Sensor

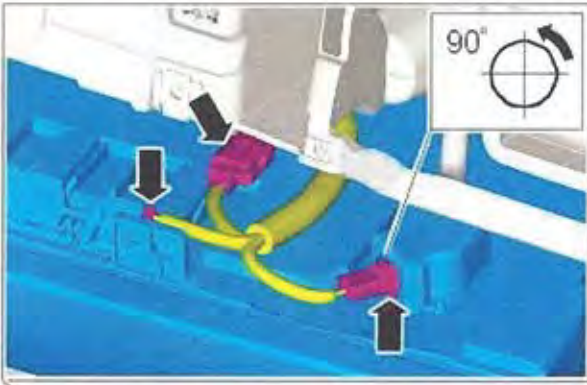
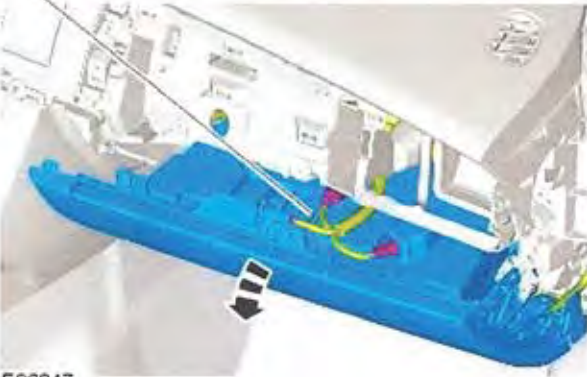
E96847

CAUTION: Fixings must be started by hand to avoid damaging threads.

- Upper 3 bolts.

- Torque: 2.5 Nm
- Lower 3 bolts.

Torque: 9 Nm

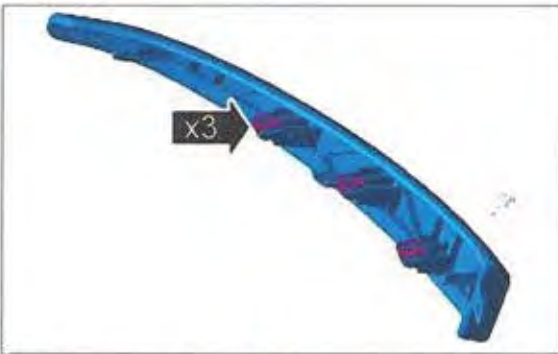
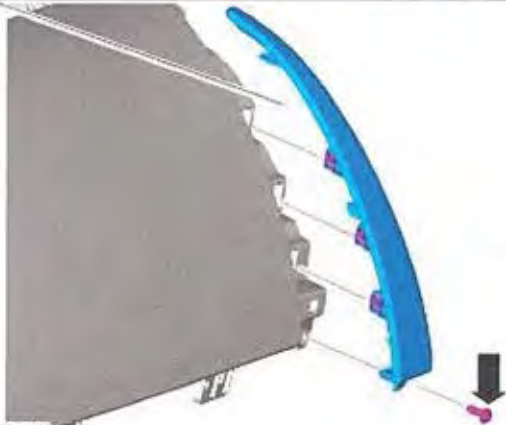
E96848

5. **5. NOTE:** Do not disassemble further if the component is removed for access only.
