Fault finding an X250 heated windscreen

A guide determining the reason for a failure

The X250 heated windscreen is a dual zone system with each half of the windscreen having a dedicated heating element. This guide provides information on how to troubleshoot a fault in the system.

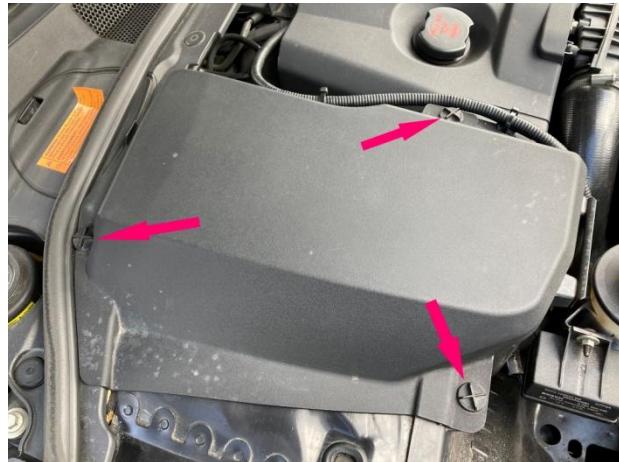
To gain access to the engine junction box, remove the three screws indicated below

Watch out for these. They can easily go 'ping' into the bowels of the engine bay as you pull the cover off

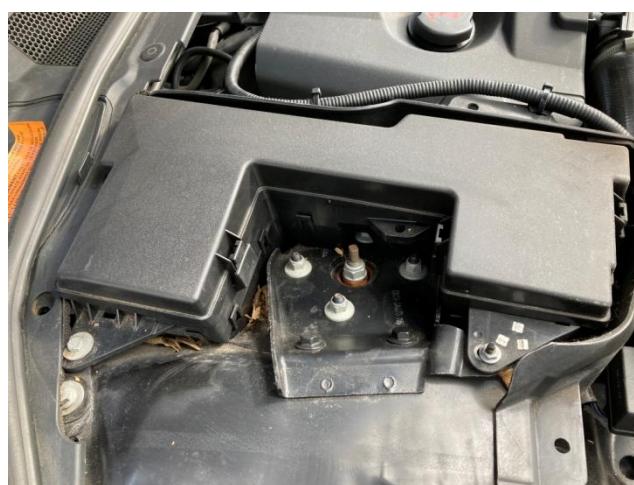
This reveals the cover to the EJB.

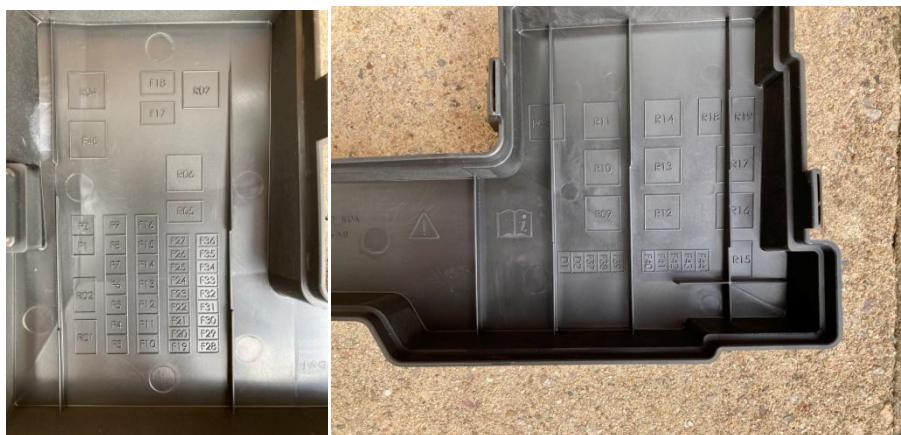
The positions of these fuses and relays are actually shown in the lid.

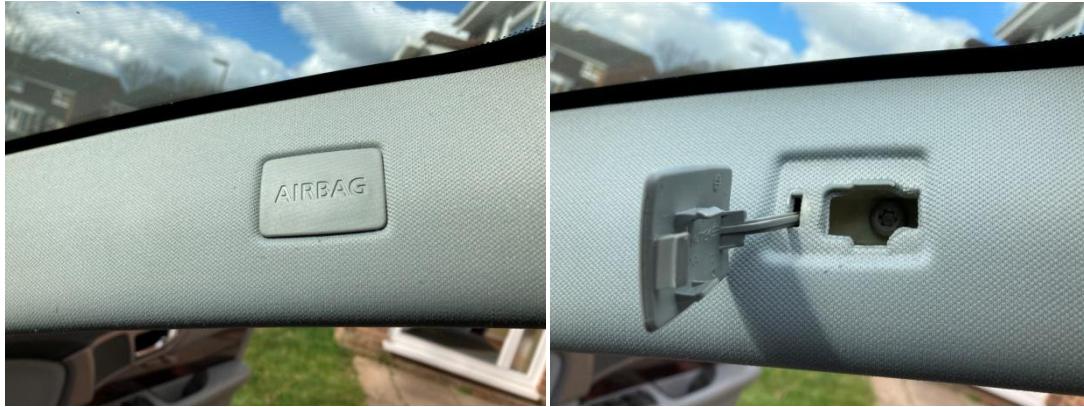
To gain access to the heater element connections the A pillar trim will have to be removed. This is achieved by first removing the plastic cover with the Air Bag logo on it.

This will reveal a T30 Torx bolt which will need removing.

The trim can then be removed. Easing the door seal off where it overlaps this trim makes this a bit easier. Pull it outwards from the pillar at the top and then wiggle it upwards to release it from the bottom.

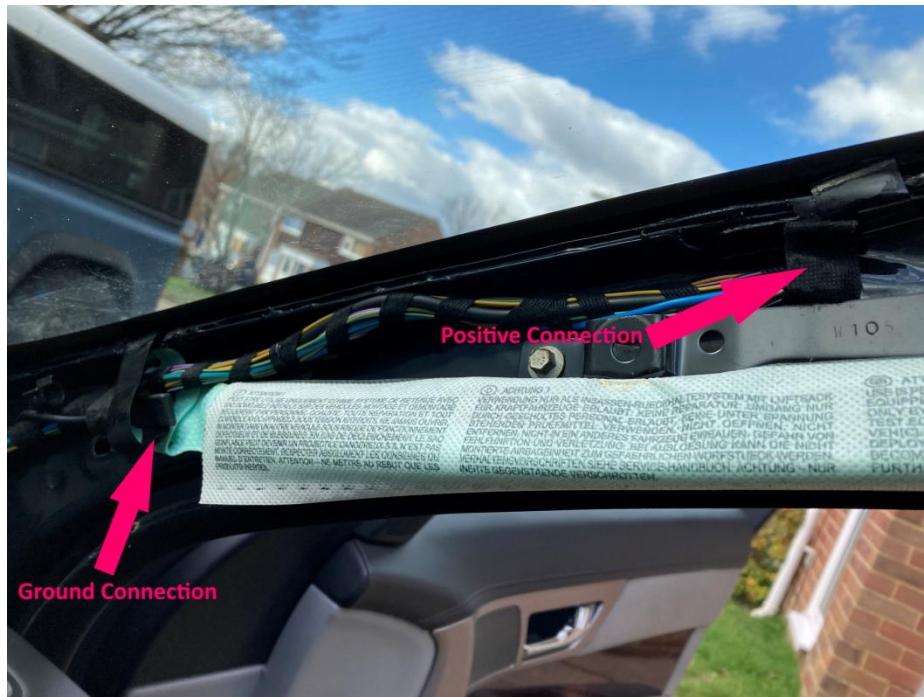
Once off this will reveal the air bag and the two connections to the heater element.

The positive connection is tucked behind the metal bracket you can see. It should be eased out for access. Care should be taken doing this to ensure the ribbon cable is not damaged.

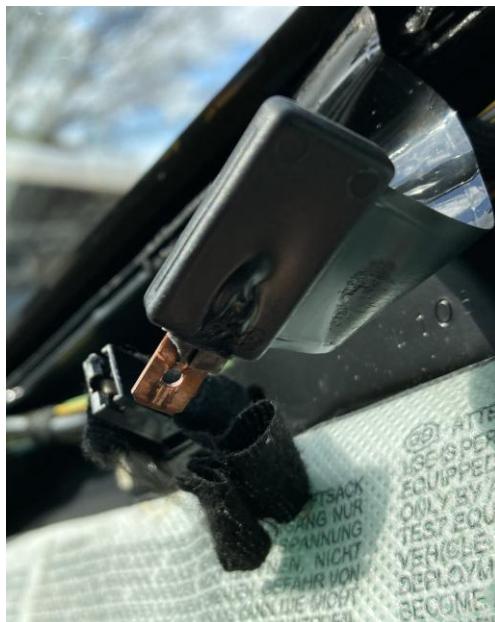
Oxidised Connector

In my case I had 12V present at the heater element connector and the continuity test gave a value of 20 Ohms for the heater element.

Even before I carried out these tests, I already knew what the problem was, due to the heat damage done to the insulation on the connector.

The connection had oxidised and caused a high resistance connection. This in turn had generated a bit of heat (due to the high current flowing in this circuit). The oxidation and heat damage can be seen in the picture below.

Cleaning the connector proved a 100% cure to my faulty heated screen.
