## X308 Jaguar Sovereign

## Instrument Cluster Bulb Replacement Guide

- Complete Guide for the replacement of 8 External Rear Inc. Bulbs and 2 Internal Inc. Bulbs -

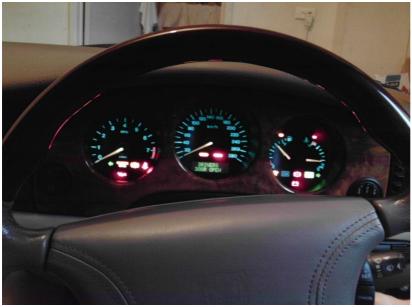
The final outcome

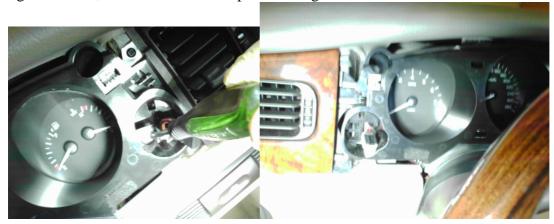
Insert a small screw driver at the 12 oclock position on each and press down on the flange, it will then release. Disconnect the cables to them both. Remove the 4 screws that secure this entire black plastic facia. One each located in the voids left behind the trip computer and fog light switches, the other 2 in the top left and right corners.

Note when replacing these screws, secure the screws on the phillips head with some tape, otherwise you will spend 1 hour changing the screw near the firewall.

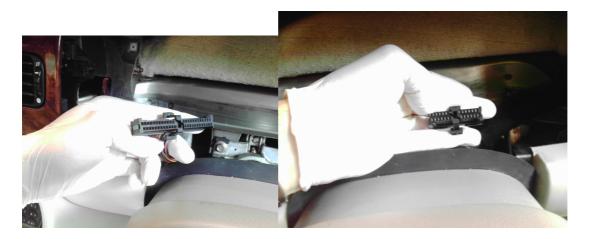
There are 2 large PIN connectors that need to be disconnected from the instrument cluster in order to get it out. You can see in the next photos that there a top and bottom tab to press in order to release them, the bottom tab on each is not easily seen from the multitude of wires. See photo of the disconnected connectors below.

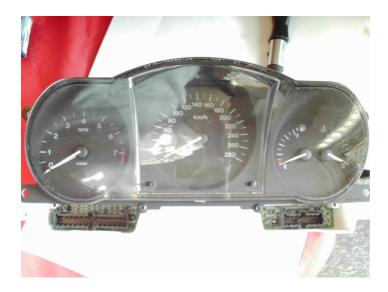
Once they are disconnected you can lift the instrument cluster out on your work bench.

The 8 incandescent bulbs, 4 big and 4 small are located on the rear in twist sockets.

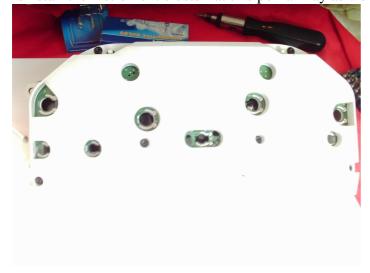
Clean the contact areas on the socket and circuit board with contact cleaner and reinstall if you wish to stop here. BUT as i mentioned there are 2 more incandescent bulbs inside the circuit board. These 2 bulbs control the GREEN side light icon on the instrument cluster and the BLUE high beam light icon.

So if like mine, the side lights and high beam lights function on the car, BUT the associated green or blue icons do not show up on the dash, you must replace the bulbs inside the circuit board.

Also note that these 2 bulbs on the circuit board were functioning properly on my car, but the motions of extracting the instrument cluster actually broke them, they are fragile. So i had to replace them. You may find these 2 bulbs do not function (green icon and Blue icon) if you reinstall the instrument cluster at this point. May as well replace them while you here.

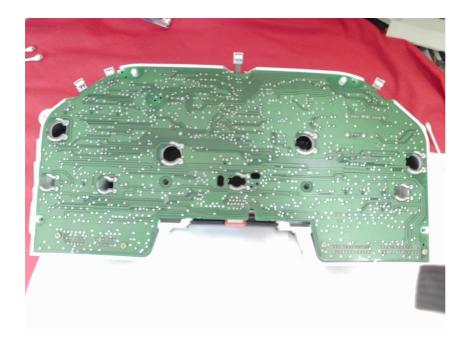
Remove the bulb sockets as shown above (anti clockwise twist less than 45 degrees), and then the 4 black Torx screws on the perimeter of the white casing. Lift the white casing off to reveal the back of the circuit board, BUT do not remove the circuit board, it is attached with connectors.

There are 4 white cable connectors along the top of the perimeter of the circuit board and a RED Pin connector at the centre base.

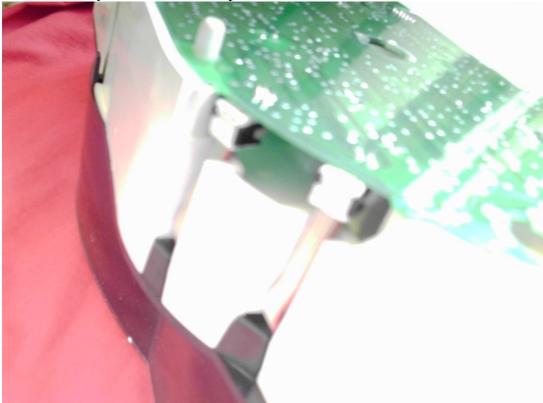
The white cable connectors shown above pull straight out, but do not pull on the black portion, only on the white, see below how they disconnect. They disconnect by pulling the white plastic connector toward the camera position in the photo below.

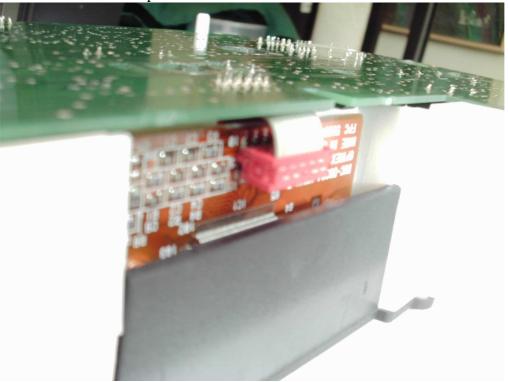
Then there is the RED pin connector at base.

To remove this just pull it straight out, or better, wiggle it out slowly. There is NO clip on the side that is holding it in or anything, despite it looking that way.

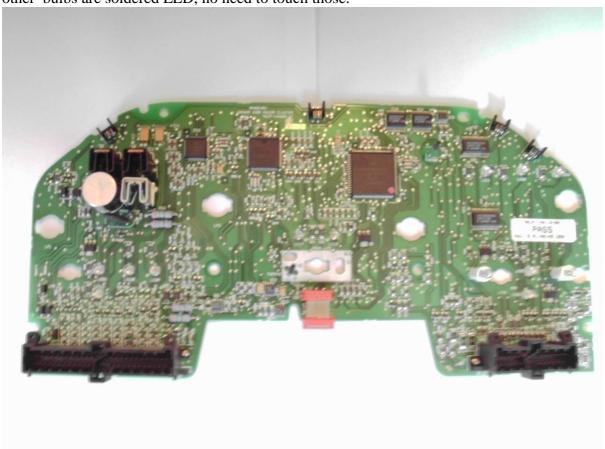
You can now lift the circuit board out, lay it down on a clean piece of paper, note the 2 incandescent bulbs that pull straight out of the sockets on the right hand side below, all other bulbs are soldered LED, no need to touch those.

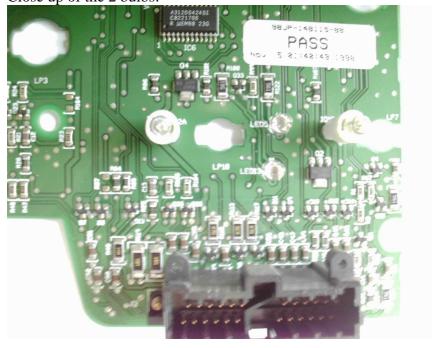
Close up of the 2 bulbs:

Pull them straight out and replace with Wedge 12v 1.2w T-5mm.

When replacing these bulbs, best clean them with contact cleaner and where disposable rubber gloves to avoid finger oils on the bulbs. This way you wont have to do this procedure

again for a long time as oils on bulbs tend to unevenly disperse the heat of the bulb, leading to premature failure.

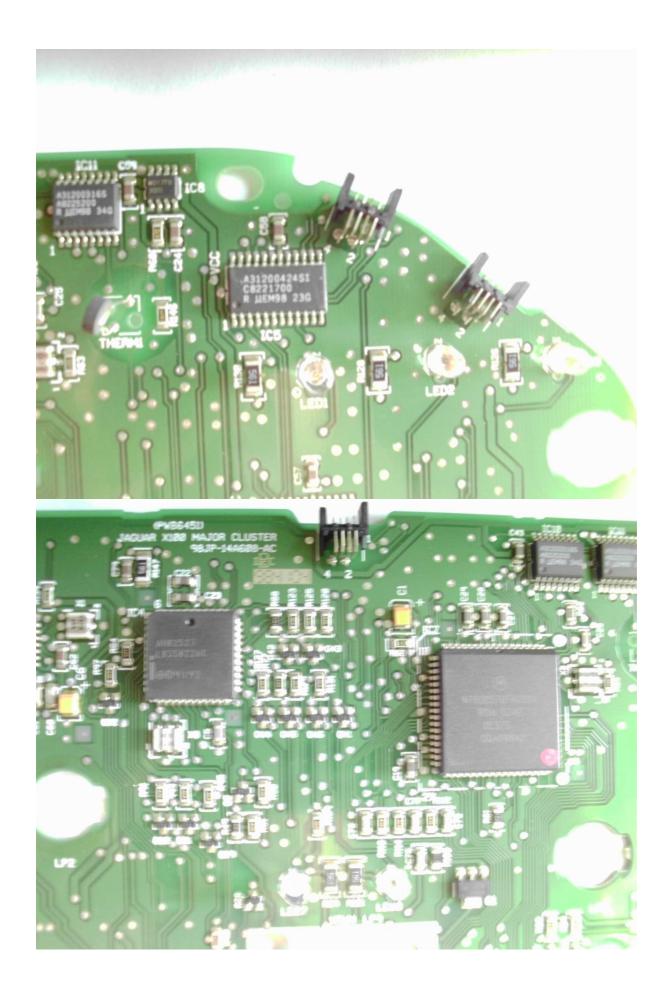
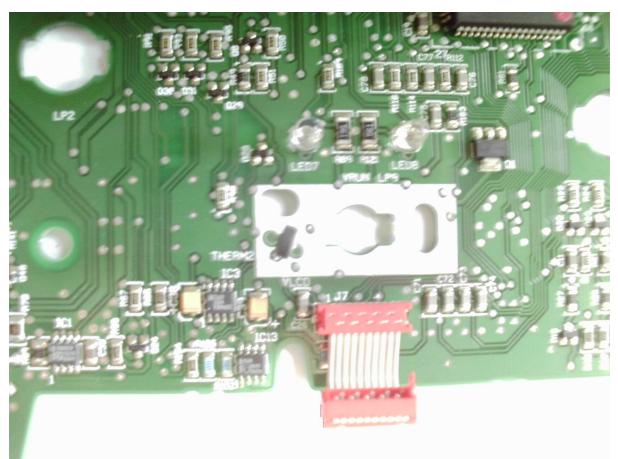
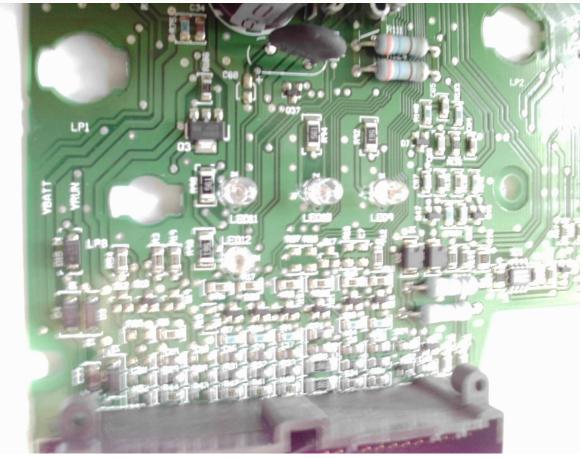
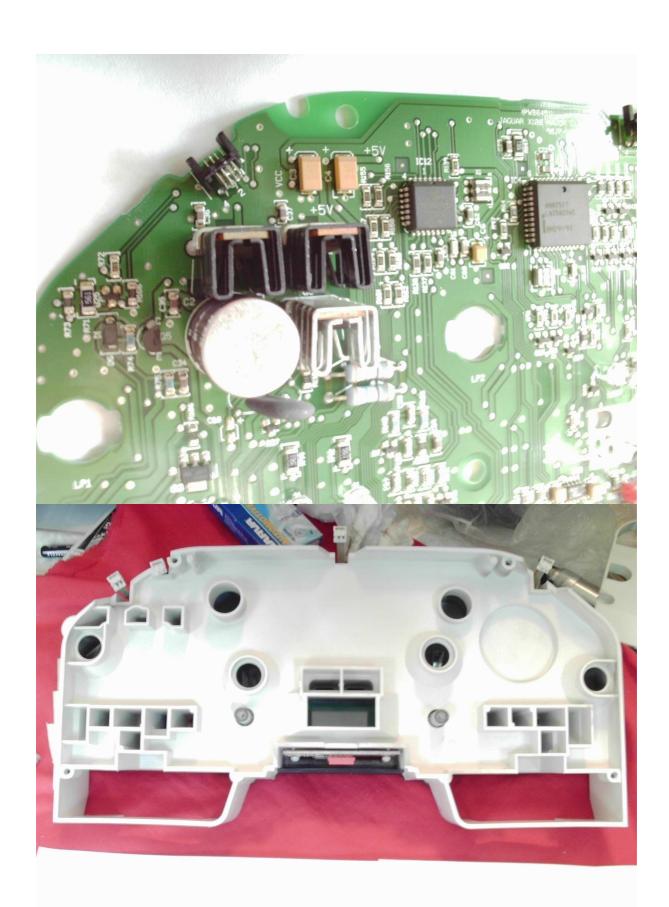
The following includes a few photos of the circuit board in case someone wishes to reference it. How often do you get to see it!

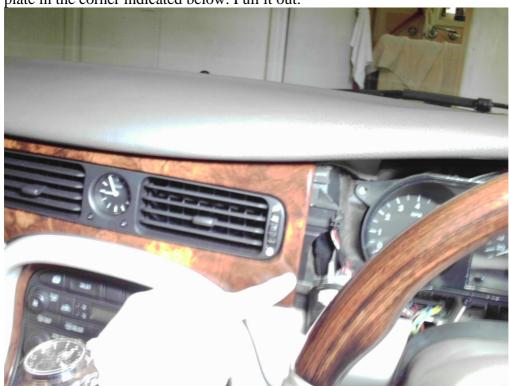
The clock veneer panel lifts off very easy, just grab it on the underside on the metal backing plate in the corner indicated below. Pull it out.

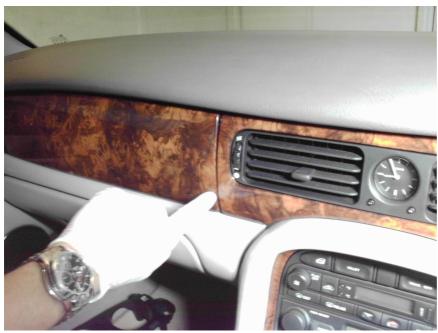
Then the toughest of all is the passenger side wood veneer. After the clock veneer has been removed, you should insert a large metal screwdriver bent at 90 degrees, say 3 cm from its end under the passenger wood veneer and give it a yank (I can here you gasp!!!) and insert it in the corner indicated below. Be warned that it is very hard to remove this, pressure is required. I have the centre clock wood veneer reinstalled in the photo below but it must be removed to gain access.

The portion indicated in the above photo is where the large retaining flange is located behind the passenger wood veneer (insert bent screw driver on the underside, the clock veneer should have been removed unlike the picture above), there is another retaining flange in the corner directly above but it is not tight in that corner.

There are 4 torx screws that secure this plastic air vent fascia, once removed the entire unit can be lifted out with only the right hand side of the passenger wood veneer (in photo show above, LH drive car reverse).
