Connector Face

Harness CABIN RH HARNESS

Description Junction box-Central

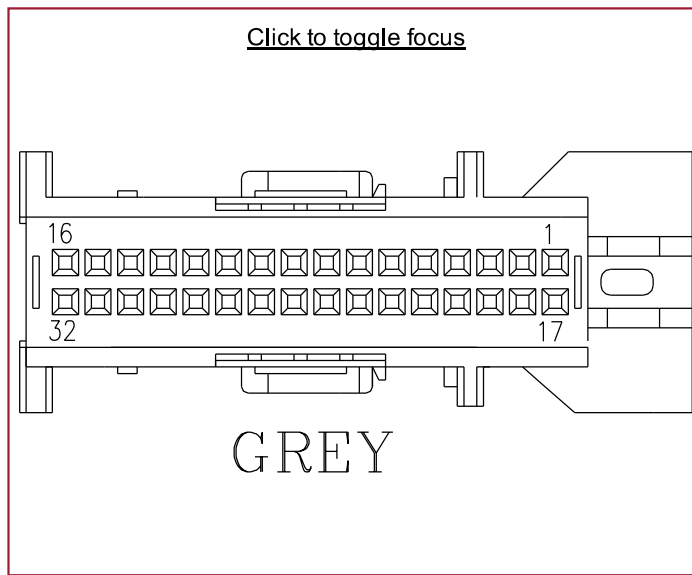
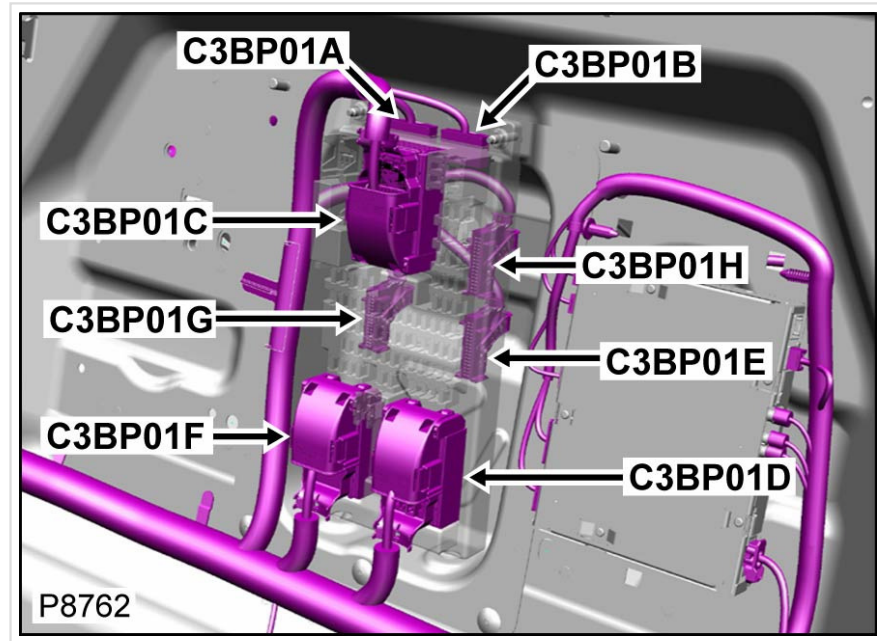
Engineering Part Number 3M5T-14489-BRC

Colour GREY

Cavities 32

Location Behind rear seat backrest - Left side

Wire chart and service repair kit information

CAV	CSA	COL	CCT	DESTN	Pre-Terminated Lead	Crimpers	Wire Stripper	Heat Shrink Sleeve	Ident Sleeve	Splice
3	0.35	BN-VT	ALL	C33-F	-	-	-	-	-	-
4	0.35	VT-GN	ALL	C33-F	-	-	-	-	-	-
5	0.75	GY-VT	ALL	C32-B	418-411-45	418-116A	418-117	418-104	418-112	418-107
6	0.35	GN-BN	ALL	C33-F	-	-	-	-	-	-
8	0.35	VT-BN	ALL	C33-F	-	-	-	-	-	-
9	0.35	WH-BN	ALL	C33-F	-	-	-	-	-	-

CAV	CSA	COL	CCT	DESTN	Pre-Terminated Lead	Crimpers	Wire Stripper	Heat Shrink Sleeve	Ident Sleeve	Splice
10	0.35	GN-VT	ALL	C33-F	-	-	-	-	-	-
11	0.35	GY-BN	ALL	C33-F	-	-	-	-	-	-
12	0.35	BU-GN	ALL	C33-F	-	-	-	-	-	-
13	0.35	BN-YE	ALL	C33-F	-	-	-	-	-	-
14	0.35	WH	ALL	C33-F	-	-	-	-	-	-
15	0.35	WH-GN	ALL	C33-E	-	-	-	-	-	-
16	0.35	WH-VT	ALL	C32-E	-	-	-	-	-	-
19	0.35	GY-YE	ALL	C33-F	-	-	-	-	-	-
20	0.35	YE-BU	ALL	C33-F	-	-	-	-	-	-
21	0.5	GN-OG	ALL	C32-D	418-411-45	418-116A	418-117	418-104	418-112	418-107
22	0.5	BU-WH	ALL	C32-B	418-411-45	418-116A	418-117	418-104	418-112	418-107
28	0.35	WH-BN	ALL	C33-F	-	-	-	-	-	-
29	0.5	GN-VT	BWKAD	C33-BF	-	-	-	-	-	-
29	0.5	GN-VT	BWKAA	C3R123	-	-	-	-	-	-
30	0.5	WH-VT	ALL	C3R124	418-411-45	418-116A	418-117	418-104	418-112	418-107
31	0.5	BU-BN	BWKAA	C3R125	-	-	-	-	-	-
31	0.5	BU-BN	BWKAD	C33-BC	-	-	-	-	-	-
