Connector: **C3BP01D**

Description: **Junction box-Central**

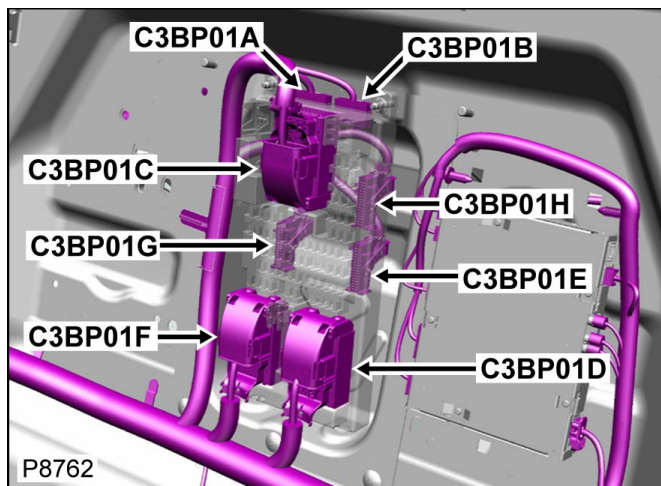
Location: **Behind rear seat backrest - Left side**

Part No.: **YPC801110**

Colour: **GREEN**

Cavities: **41WY**

Harness: **CABIN LH HARNESS**
