Technical Service Bulletin

No.B501-13
17 February 2005

Subject/Concern: Water Ingress Roof Opening Panel Area

Models:

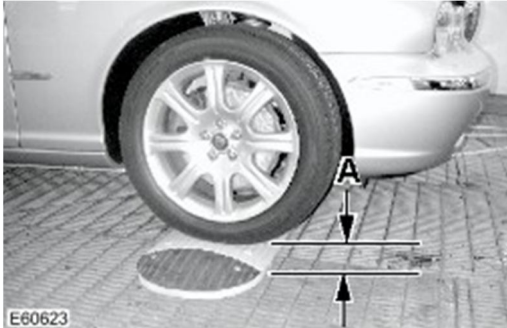
- 1 . Drive the vehicle onto a suitable raised surface so the front wheels are approximately 75mm (3in) higher than the rear wheels.

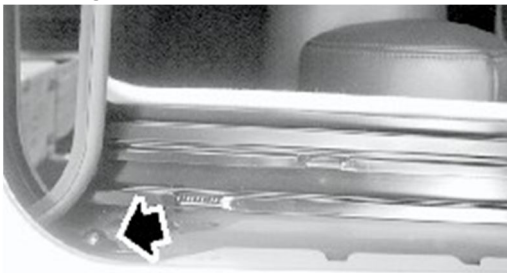
- 3 . Using a suitable container/bottle slowly pour water into the roof opening panel drainage channel.

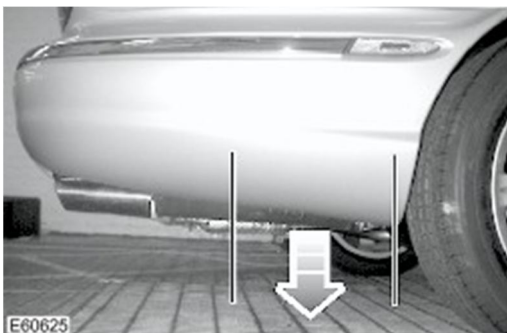
- 4 . With assistance, look for water flowing onto the floor from the drain tubes located behind the rear wheels.

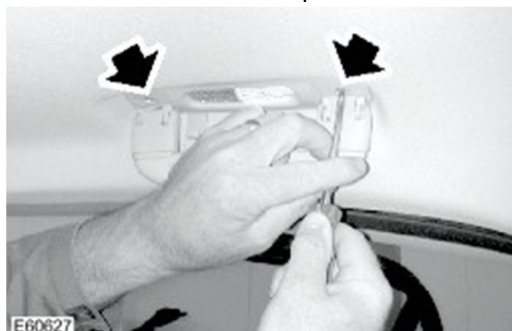
- 11 . **NOTE:** Note the fitted position of the washers prior to removal.

Remove the rear occupant assistance handle.

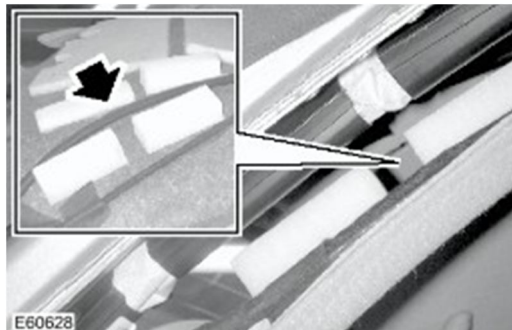
- 12 . Carefully lower the rear corner of the headlining sufficiently to gain access to the drain tube.
- 13 . Remove and discard the adhesive tape securing the drain tube to the roof panel.
- 14 . Reposition the drain tube between the white foam blocks.

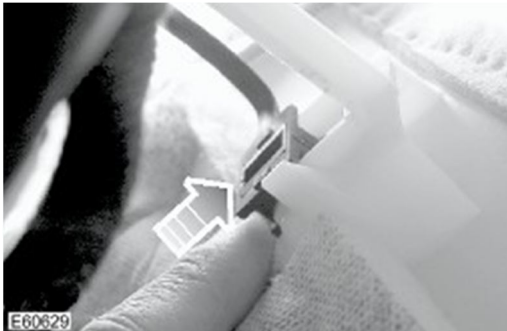
21 . Install the retaining strap to the C-pillar upper trim panel, install and fully seat the upper C-pillar trim.

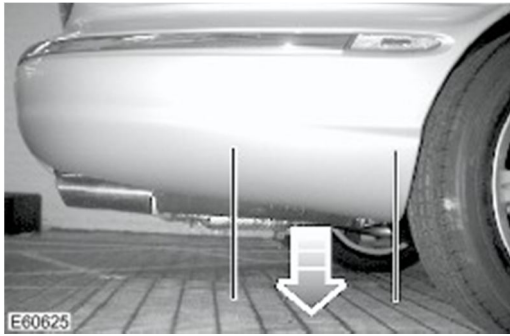
27 . With assistance, look for water flowing onto the floor from the drain tubes behind the rear wheels.
