## Cleaning Up a Corroded Cover

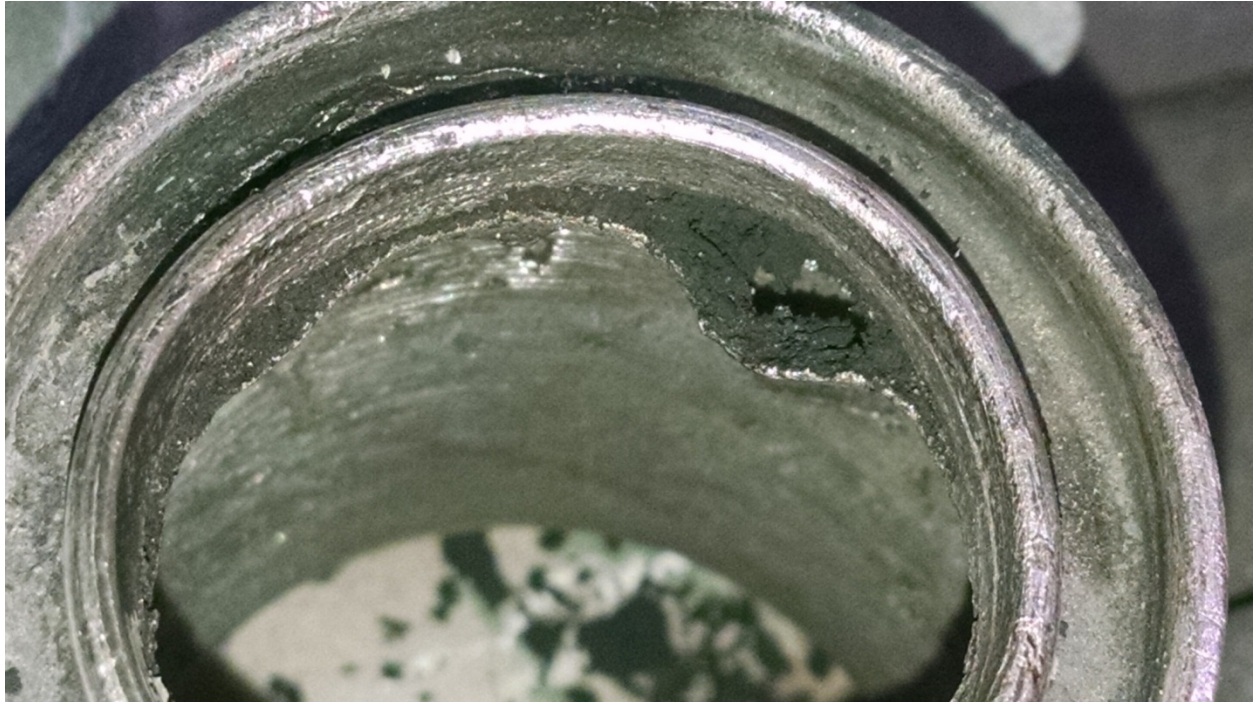
Unfortunately, during removal, I found #4 and #6 full of oil, with significant corrosion in #4, though not quite as bad as the #5 SPB in the one I removed from Bruce. Well, at least I didn't drop this one! But back in-the-hunt, because I need 3 serviceable cam-covers:

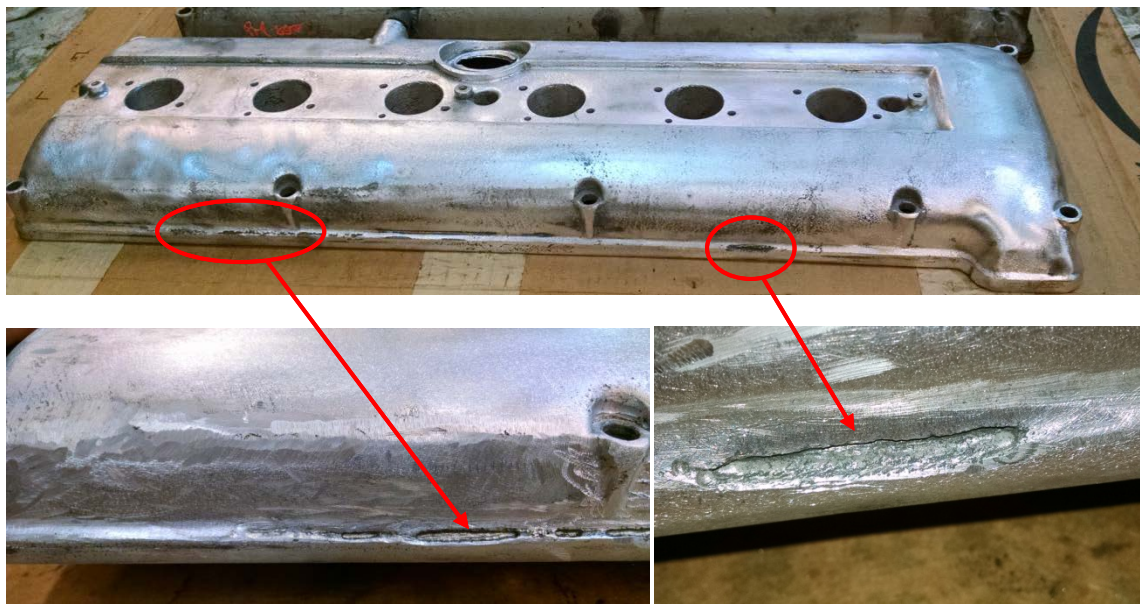
The spark plug wells are my main concern. I don't believe there is a whole lot of material left there to withstand future corrosion. Furthermore, the attack is hidden-away and seldom-inspected. I hope to find a solution that will prevent the corrosion in that area. As I've spent more time cleaning up the surface of the cam-cover, I'm becoming less and less persuaded that it is an arcing problem. I found little pock-marks surrounded by black dust after a bit of sandblasting, and when I took a small grinder to the edges, the

black area grew...it was like there were several layers of metal clad upon one another with layers of corrosion by-product (the black dust) in between. In the end, I put away the Dremel rotary tool in favor of the 4 ½" angle grinder! And this is on the outside of the cam-cover, all over, really, but worst along the outside of the groove for the gasket. In other words, same or worse corrosion as seen in the spark wells but certainly no electrical arcing going on out here. Still a greater threat in the plug wells, where it can grow, un-noticed and even breach, filling the plug bore with oil and your attention may yet still not be drawn to it. Don't count on misfires to alert you that your cam-cover is kaput; my car would have sputtering misfire events on startup on rare occasions, particularly if it sat unmolested for 4 or 5 days, but randomly-occurring, not after every prolonged rest period. And not very frequently, maybe 4 per year, or so, and lasting a total of maybe 30 seconds before smoothing out. The sole time it registered a code, it was P0303. Upon disassembly, it was #4 and #6 that were full of oil; #3 was dry and clear.

In several places, I was fearful that I may be about to punch through a wall with the grinder! But I reasoned, "Hey, if the only thing between the cam-workings and the outside environment is a bit of black dust, it isn't really a salvageable cover, is it?" (Despite the labor hours invested thus far)

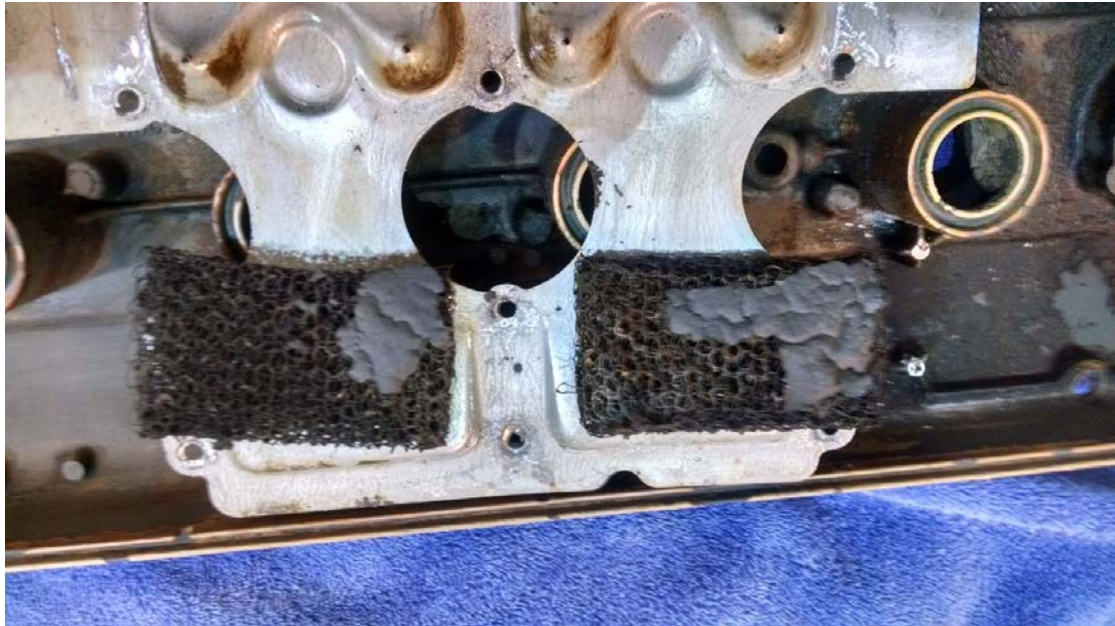
I've managed to skip some important steps in the process in my excitement to describe the corrosion. Upon removal, I suggest spraying it down thoroughly with a formidable degreaser and then, after that has soaked a bit, turning the hose on it, inside and out. I also tried brake cleaner with limited success. A pressure washer would be most helpful but mine is seized currently, not sure if it is the engine or the pump. If you do have an operable one, make sure you figure out a way to clamp or anchor it to the working service prior to turning the pressure-washer on it because it is a very light piece and brittle, so it doesn't bump into stuff very well at all. Whatever method you use for initial cleanup, you will still want to find a long, shallow container suitable for soaking it in. I found about a week in an industrial degreasing solution, maybe one part degreaser (straight degreaser better, but I'm too cheap to buy that many gallons) to two parts water, with daily turning and sloshing and a solution-change after day one to be seemingly effective. What I was after was to get the filter mesh, securely tucked away under the

permanently-affixed splash shield, somewhat cleaned out, at least to dissolve the oil-cakes that I found when I deconstructed the previously-mentioned broken one.

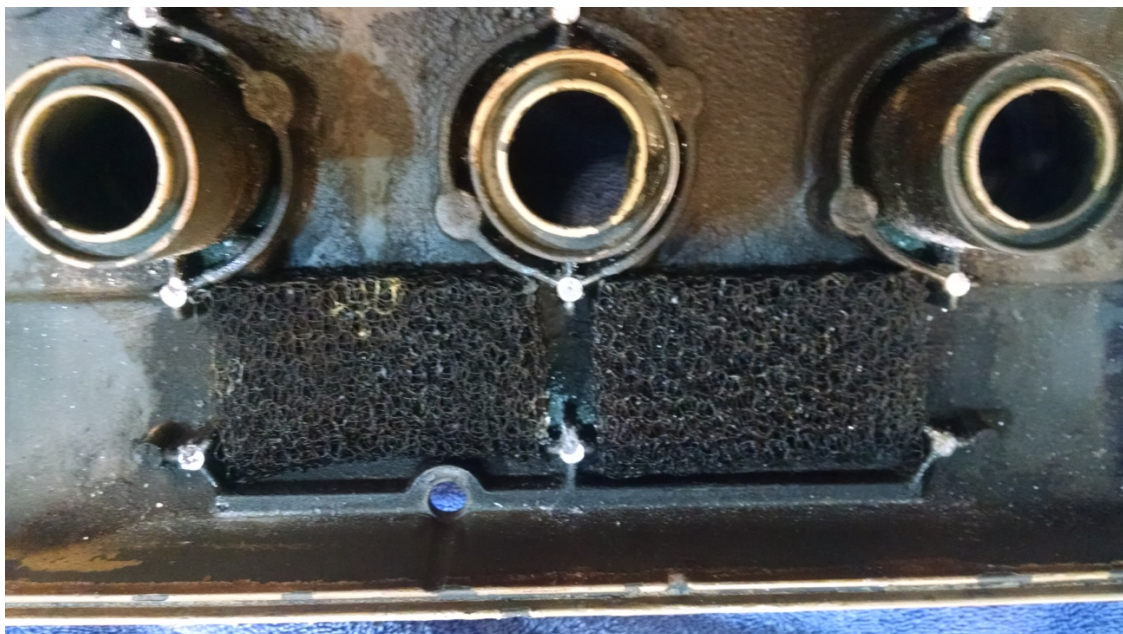
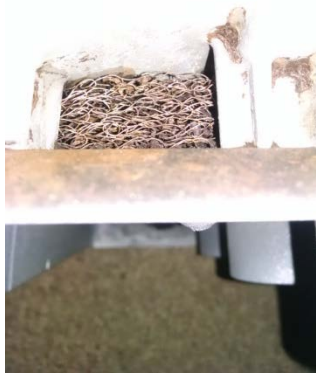
Don't imagine, "Hey I'll just grind out the rivets, take 'em out for cleaning and then put it all back." Before you do that, give some thought to how you are going to reattach the splash shield. Yeah, I suppose you could drill and tap small holes into the rivet-bosses, but do you want small screws suspended above your cam-workings that may back out and fall into the midst of it? As you see, the only one I took apart was already broken with no further plans for use. However, if you insist on thoroughness, I will tell you these are mesh pads and they are pliable/flexible. Here is a shot of them in-situ with the shield removed:

It *may* be possible to grasp each one on the outboard end and scrunch it together enough to pull it out between the two bosses, but you will be severely restricted on workspace on the one on the right, as the end-wall of the cam-cover is just off the right side of the picture. You could then clean them and the cover separately, perhaps much more effectively, then stuff them back in place. On the left is a shot of the one that went through the powder-coater's stripper. Sorry about the washout but I needed the flash to illuminate it and camera had to be right up against the piece, or in other words, I tried several times and this is as good as it gets, at least with my photographic talents. I didn't try to remove the pads on either of the two covers I've cleaned up so far, and probably won't on any future attempts.

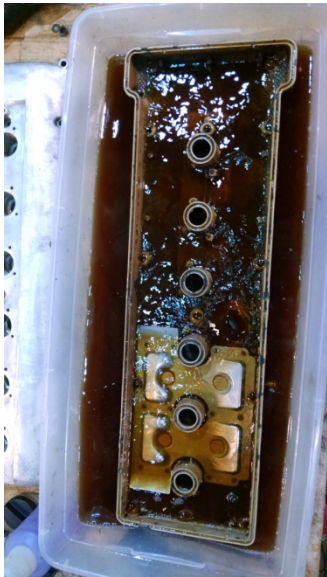
I found a plastic storage bin languishing in the cargo trailer that was ideally suited for the purpose. I believe it originated at Walmart, the only marking on it was "Stearlite." I jostled and turned the piece every evening, and occasionally sprayed it down with the hose and then plopped it back in the solution. You need to get the oil residue cleaned off inside so you can properly inspect its condition. There is a yellowish primer coat of some sort in there, which I found was also prone to bubbling, flaking and concealing more of the black dust. So no point making it all pretty on the outside and fitting it back to your engine only to puke all that mess out into your lubrication system.
