## X300 and 308 Boot Lock Overhaul

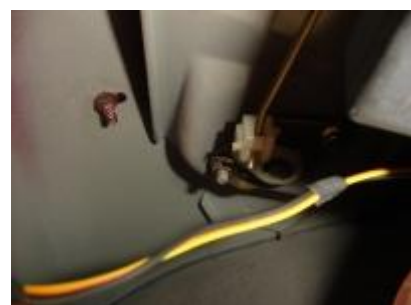
The next task is to carefully remove the control rod from the actuating arm. See the picture below. You can see that the clip 'A' is shown in the closed position. To move it to the extracted position press on tang 'B' toward the rear of the boot/trunk lid and press up on tang 'C' and extract toward the top. Now move the rod clear by moving it to the left (front edge of boot trunk lid).

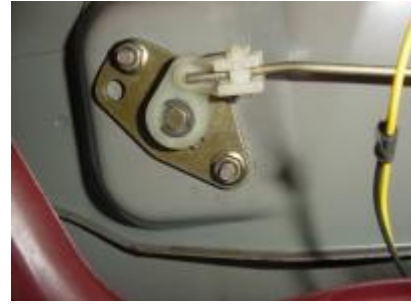
Next remove the two 10mm nuts and extract the lock from its location collecting the rubber spacer in the process, which should be found around the forward edge of the lock around the outer edge of the lock mouth.

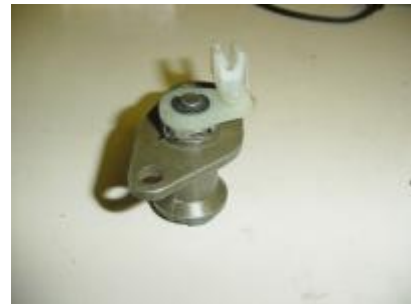
The next step involves removing the C-Clip so you can get the whole thing apart. But mark the location of the cam and note the spring fitment first.

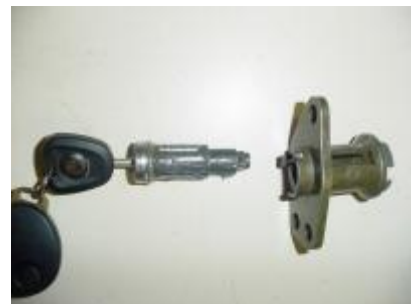
With the lock now moving its full 90 degree of travel using the key, it is possible to turn the key clockwise very slightly and press on the rear of the barrel to extract it from the casing. This allows removal of the small rod and access to the barrel drum for further cleaning.

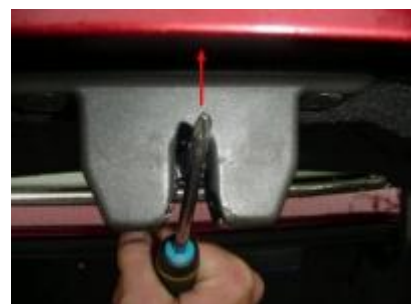
Test this before closing the boot lid by using a screw driver to flip the catch (see picture right) then use the key to ensure that it unlatches. If it does not adjust the rod again.

Re assemble in reverse sequence When refitting ensure that the rod is located and adjusted as follows: With the lock at rest (no key inserted) hold the opened clip and insert the rod into the receptacle, move the rod until there is no slack before snapping the clip closed.
