Building an X300

Let's start at the beginning.

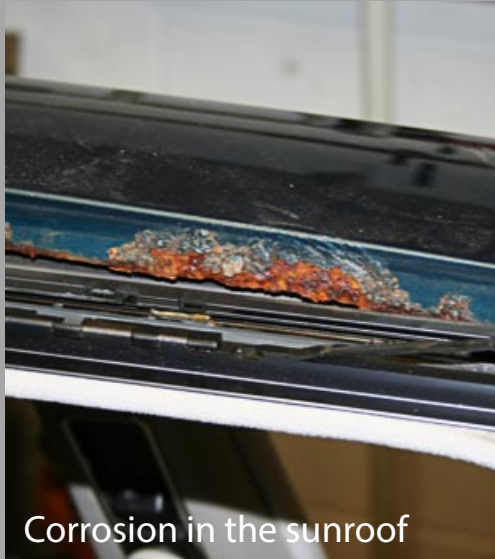
Corrosion in the sunroof

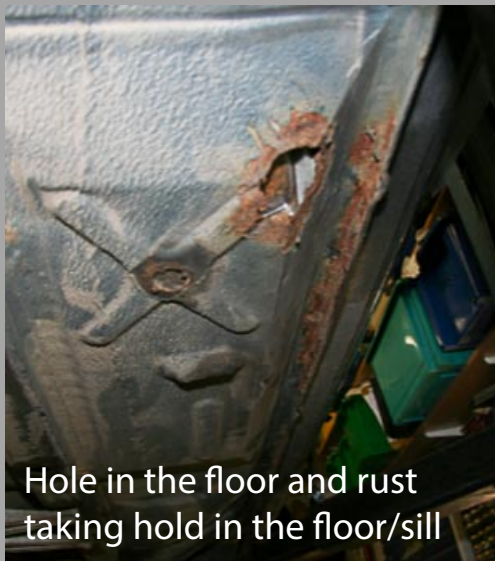
Hole in the floor and rust taking hold in the floor/sill

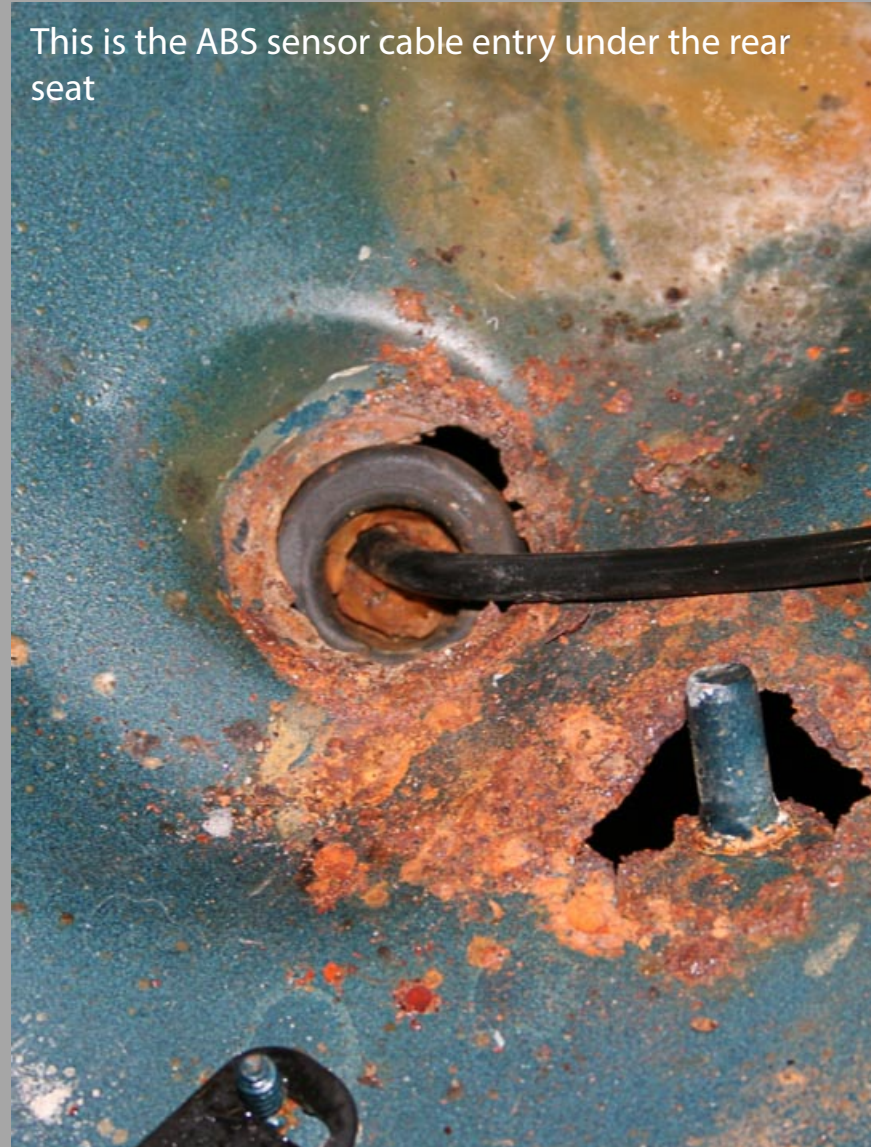
This is the ABS sensor cable entry under the rear seat

The X300 achilles heel in damp climates. Corrosion was evident in a number of areas. Rear wheel arches were also starting rot.

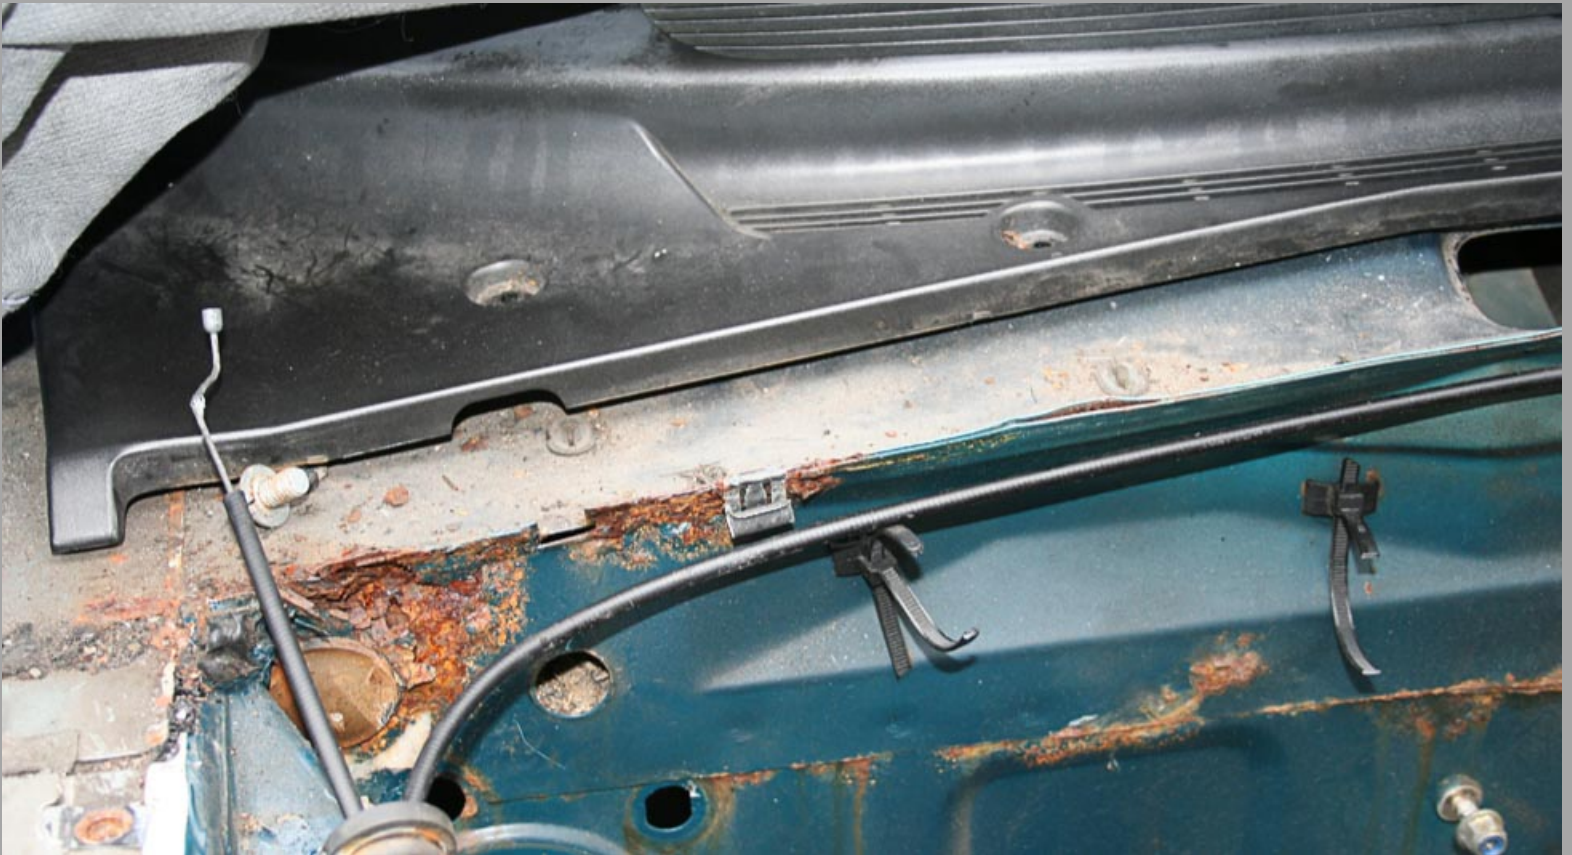
More rust. Bulkhead on both sides and the Radiator panel.

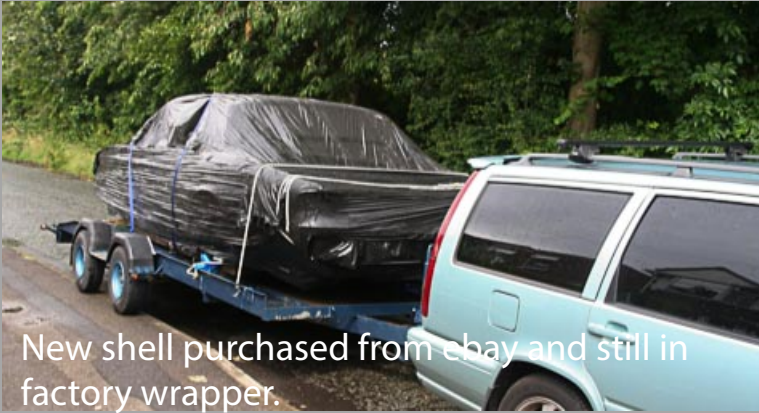
New shell purchased from ebay and still in factory wrapper.

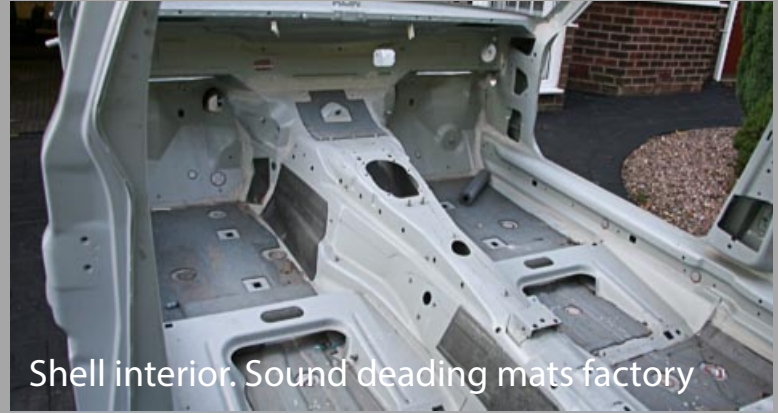
Shell interior. Sound deadening mats factory

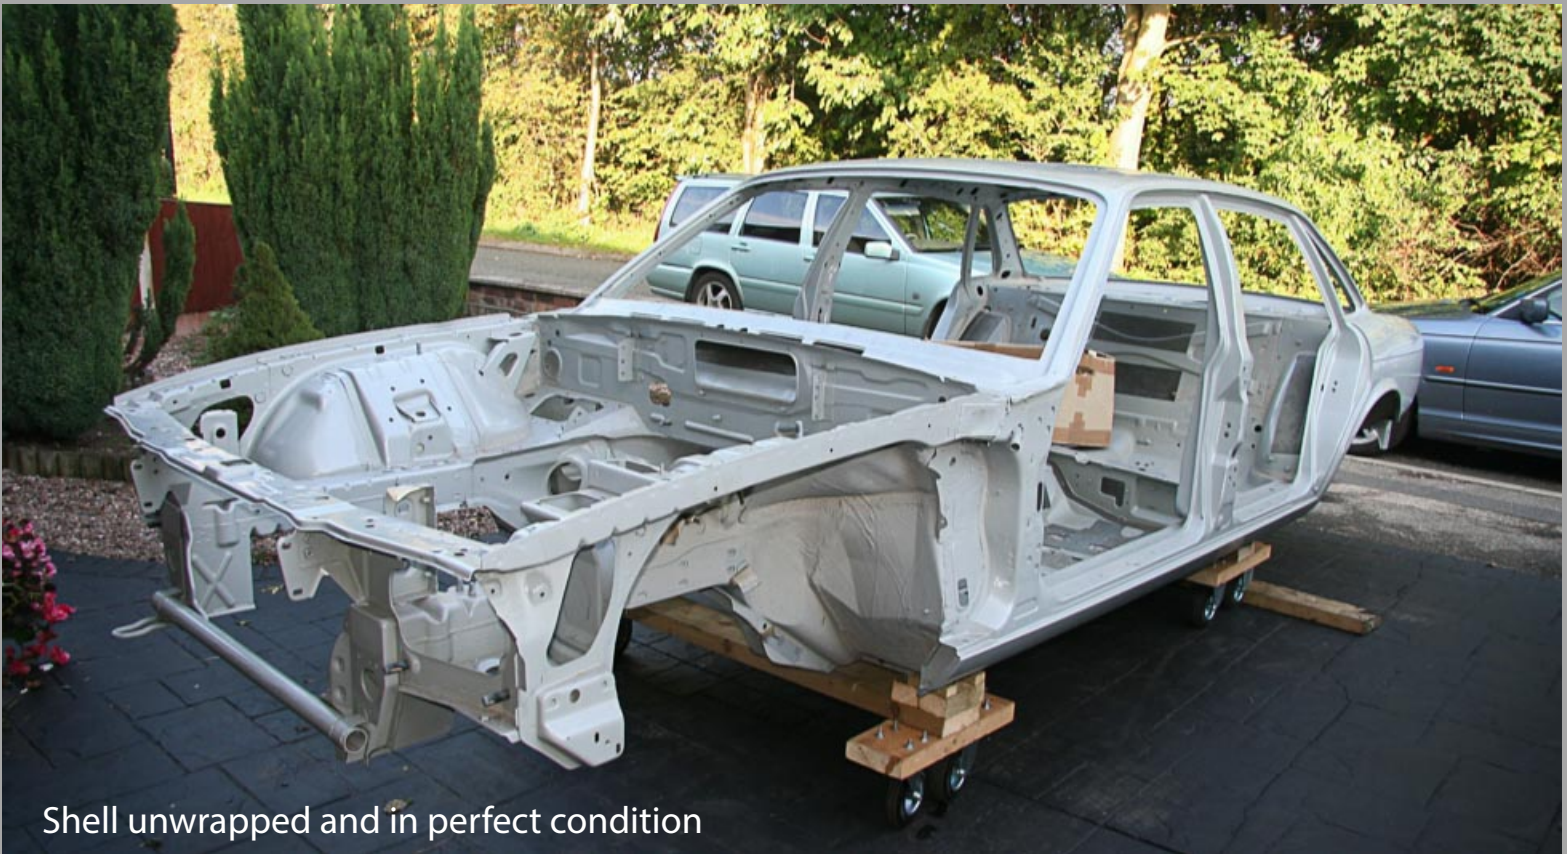
Shell unwrapped and in perfect condition

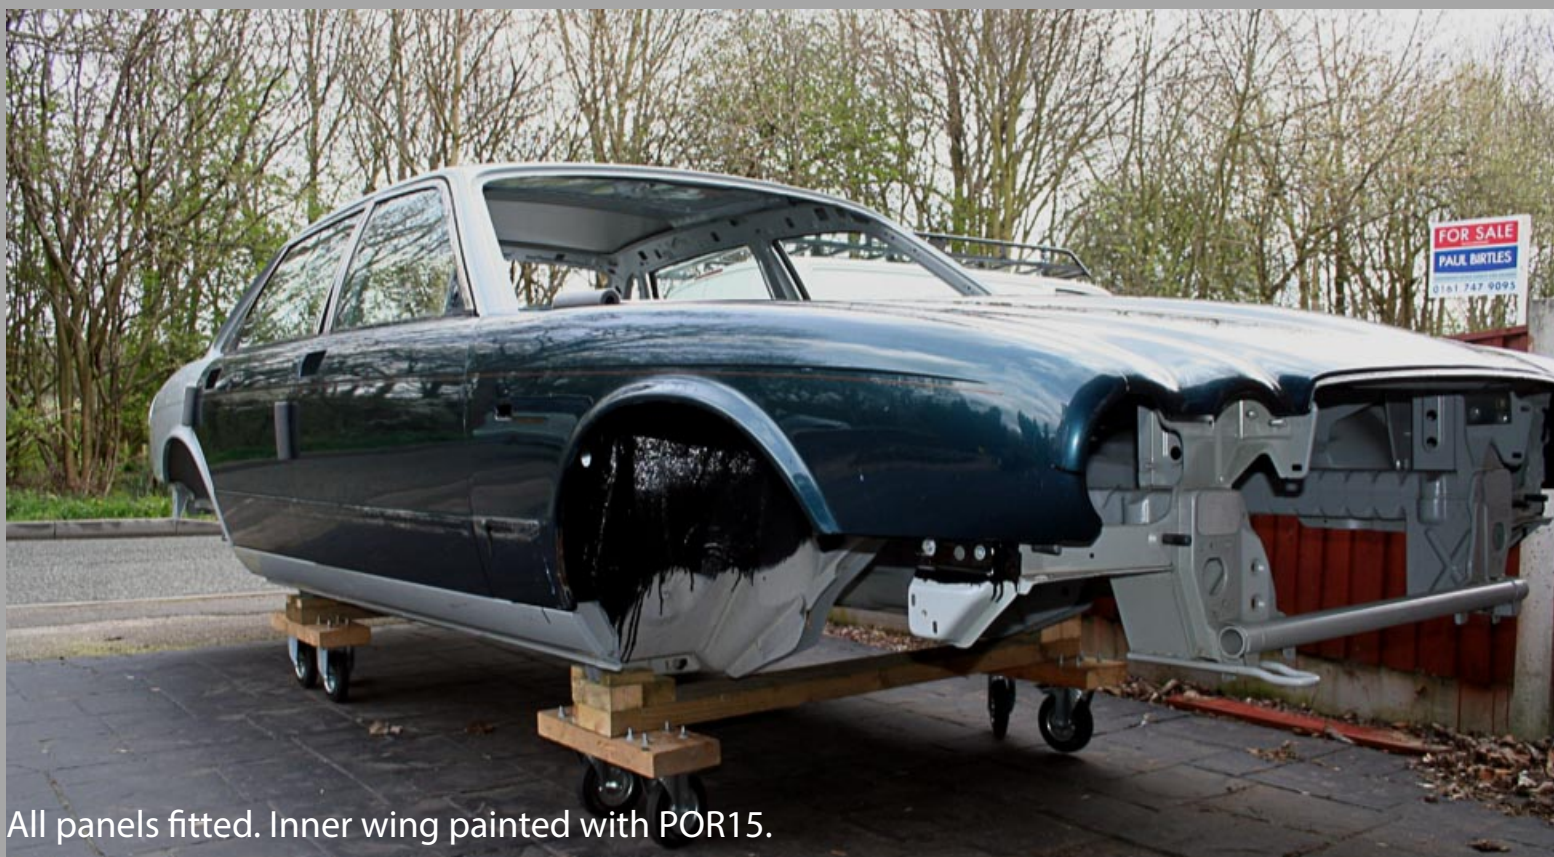
All panels fitted. Inner wing painted with POR15.

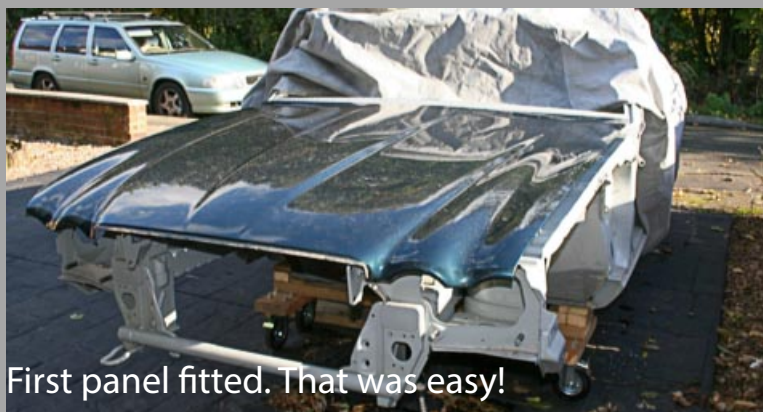
First panel fitted. That was easy!

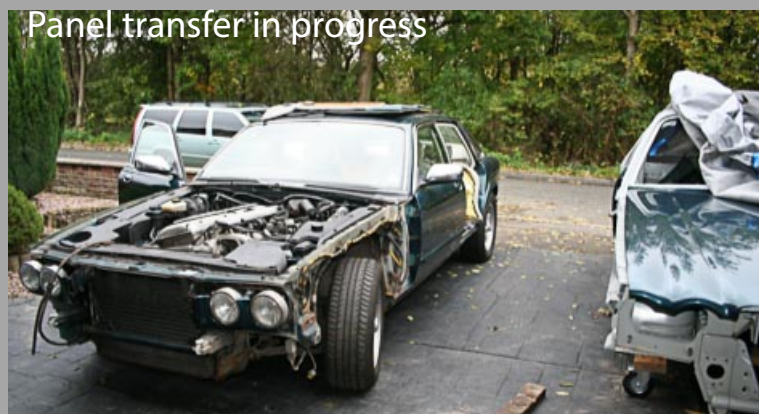
Panel transfer in progress

All panels on the original car were good and had no corrosion. A simple cut and paste operation although alignment takes some time.

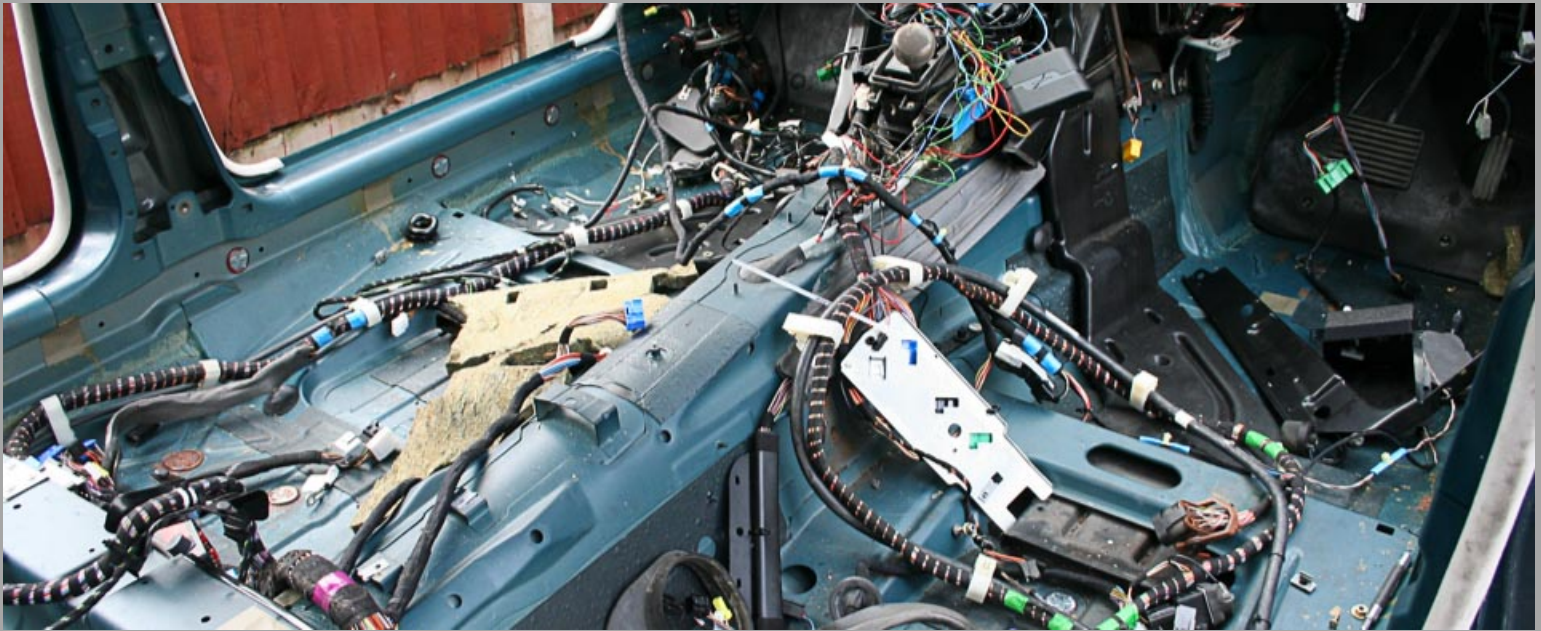
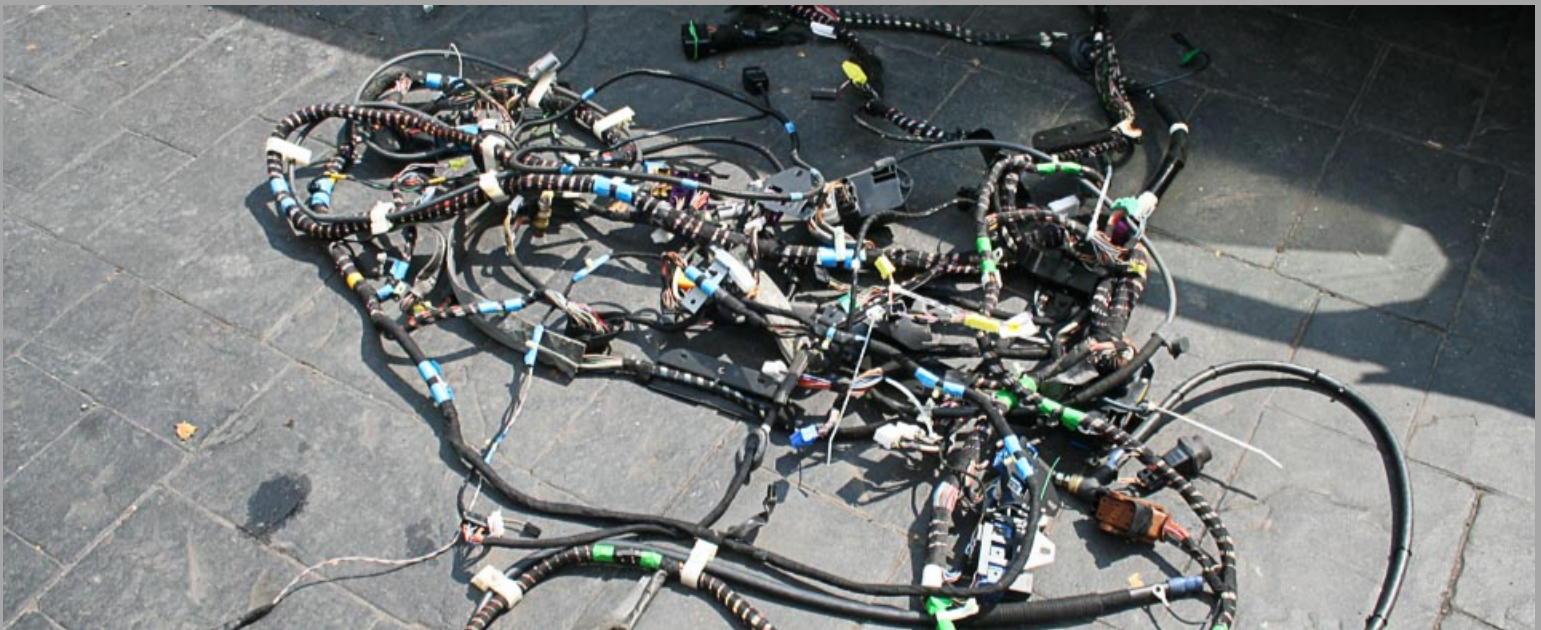
The wiring appears to be the most daunting task, but lots of pictures and careful labeling makes it fairly straight forward.

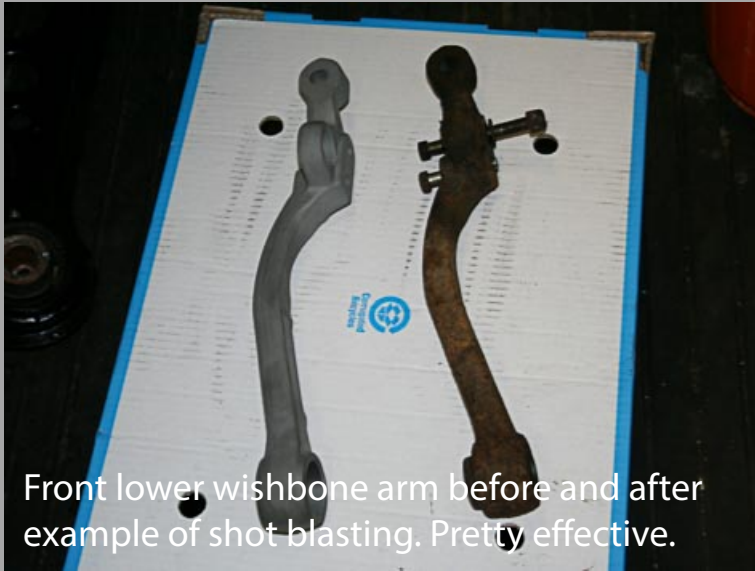
Front lower wishbone arm before and after example of shot blasting. Pretty effective.

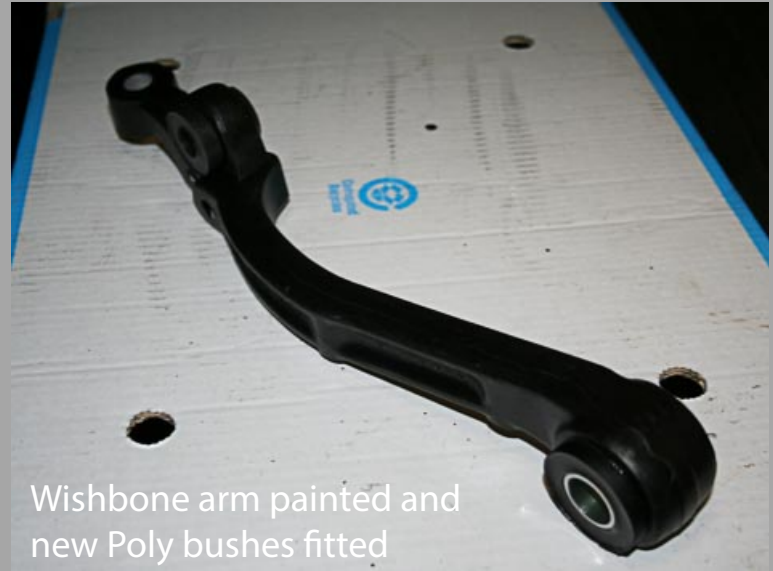
Wishbone arm painted and new Poly bushes fitted

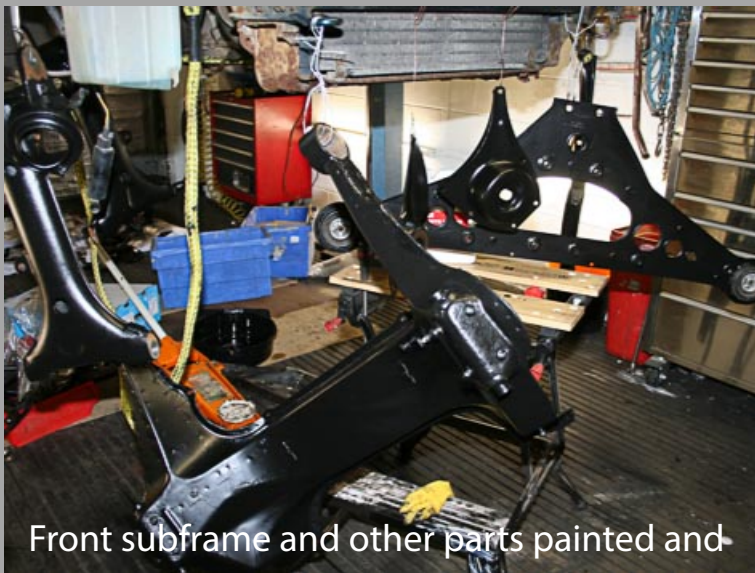
Front subframe and other parts painted and

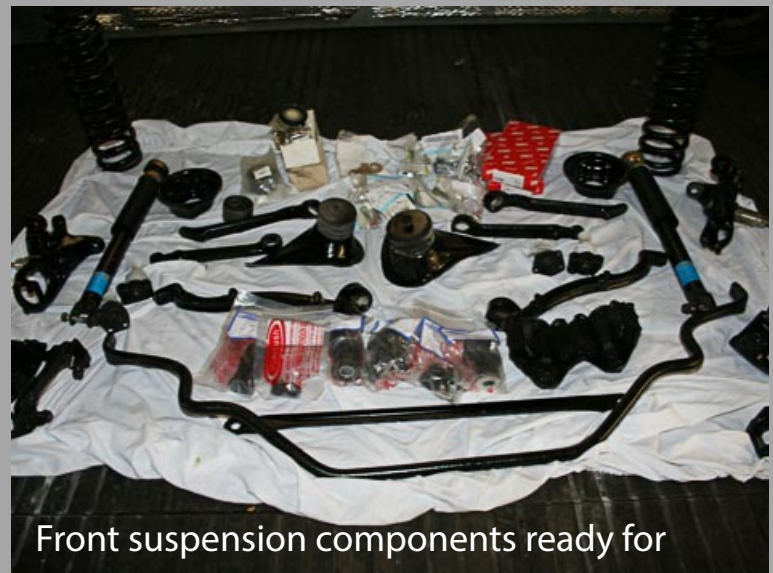
Front suspension components ready for

All suspension components were shot blasted and painted or replaced.

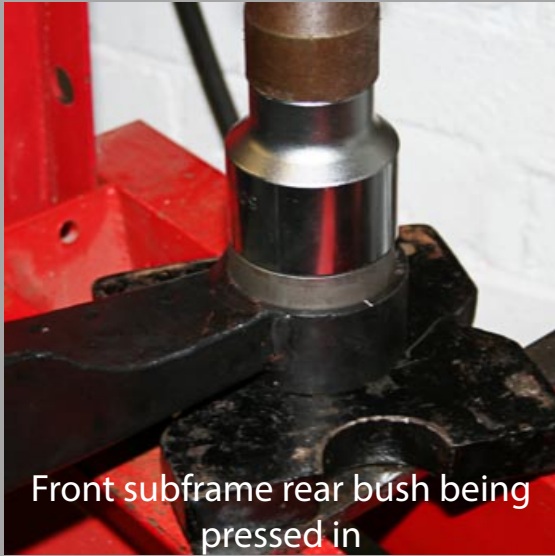
Front subframe rear bush being pressed in

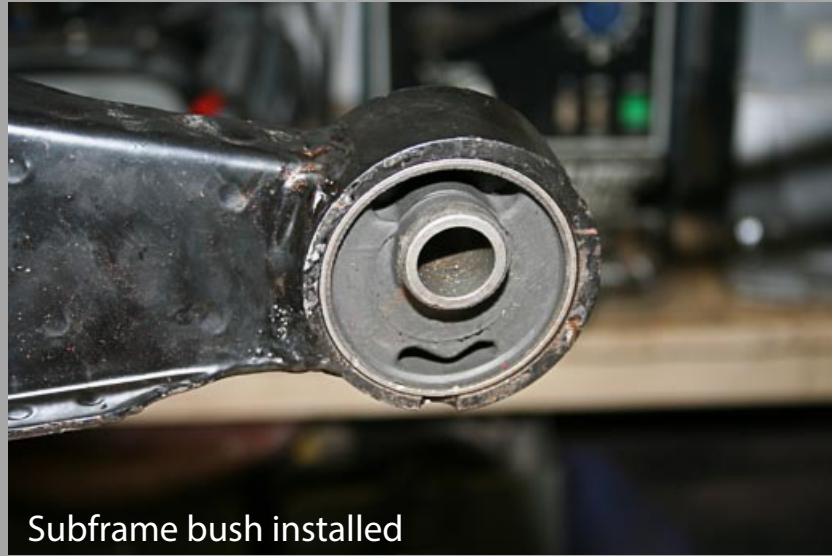
Subframe bush installed

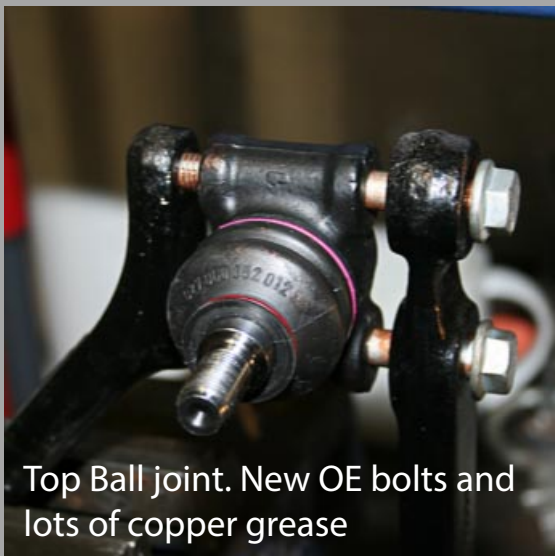
Top Ball joint. New OE bolts and lots of copper grease

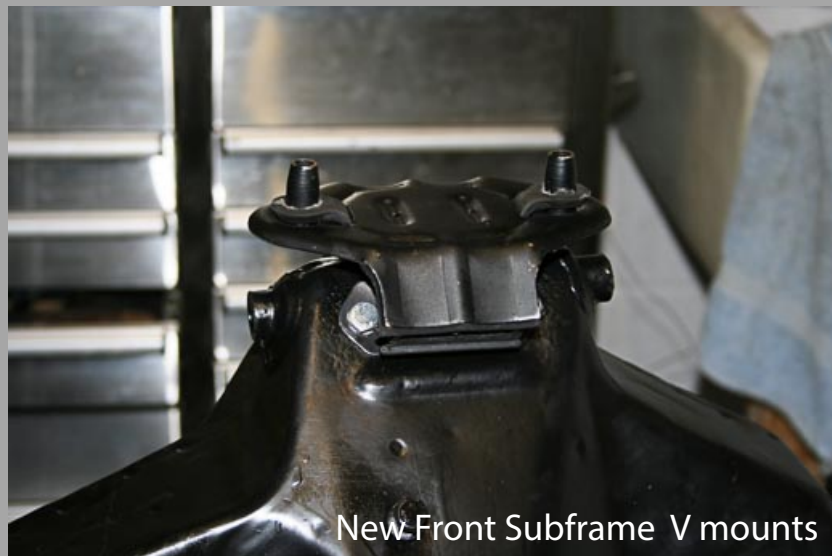
New Front Subframe V mounts

All suspension bushes, bearings and joints were replaced as a matter of course.

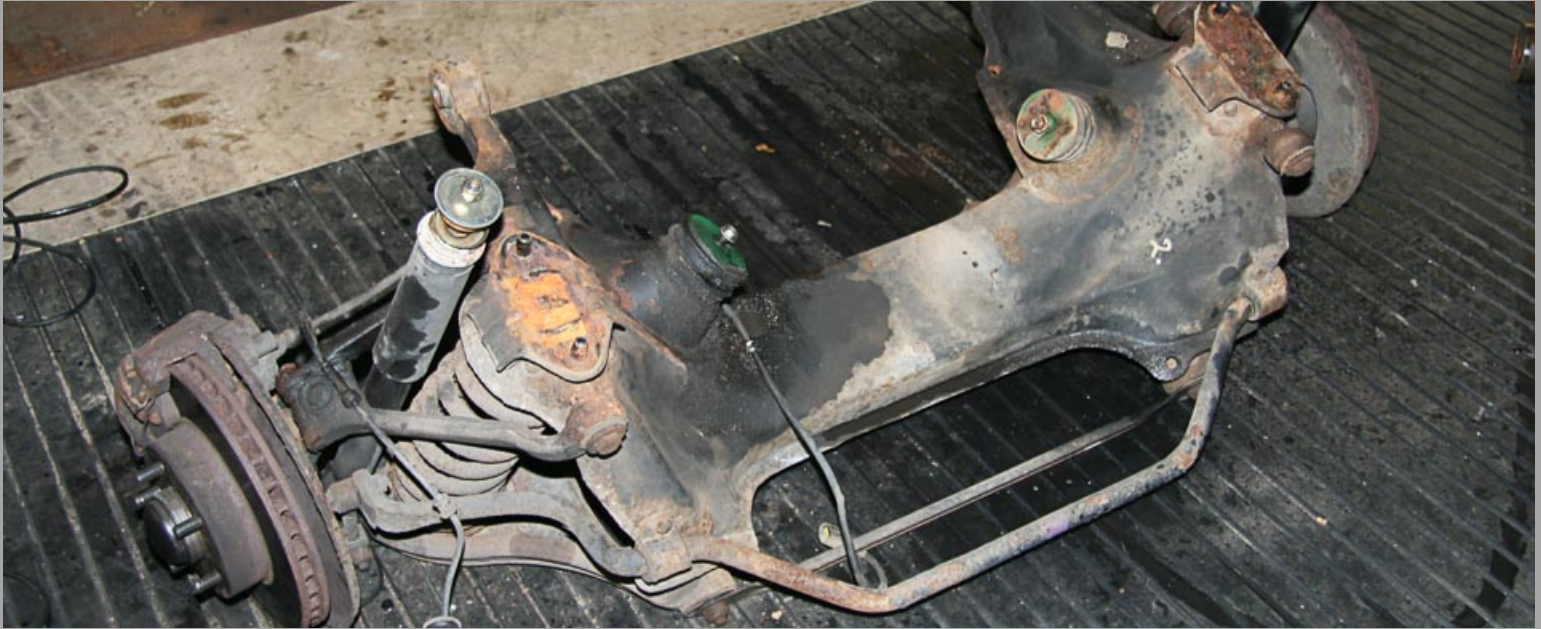
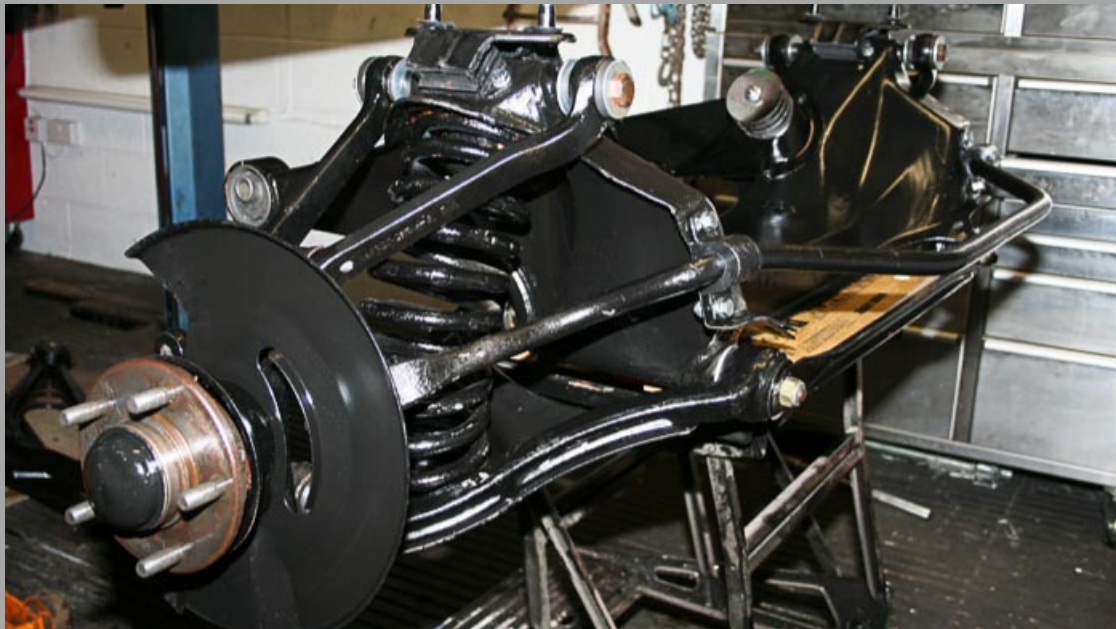
Before and after views of the Front Suspension assembly.

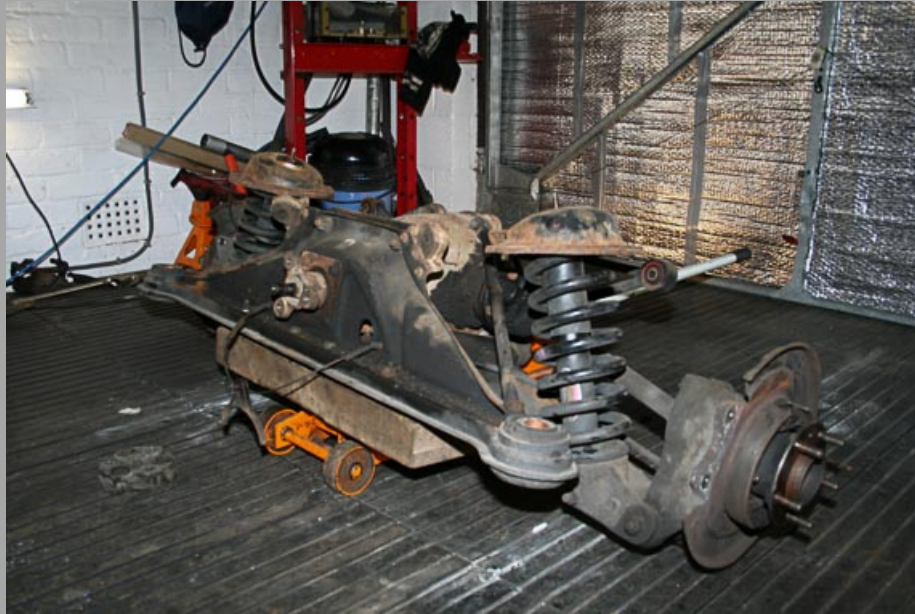
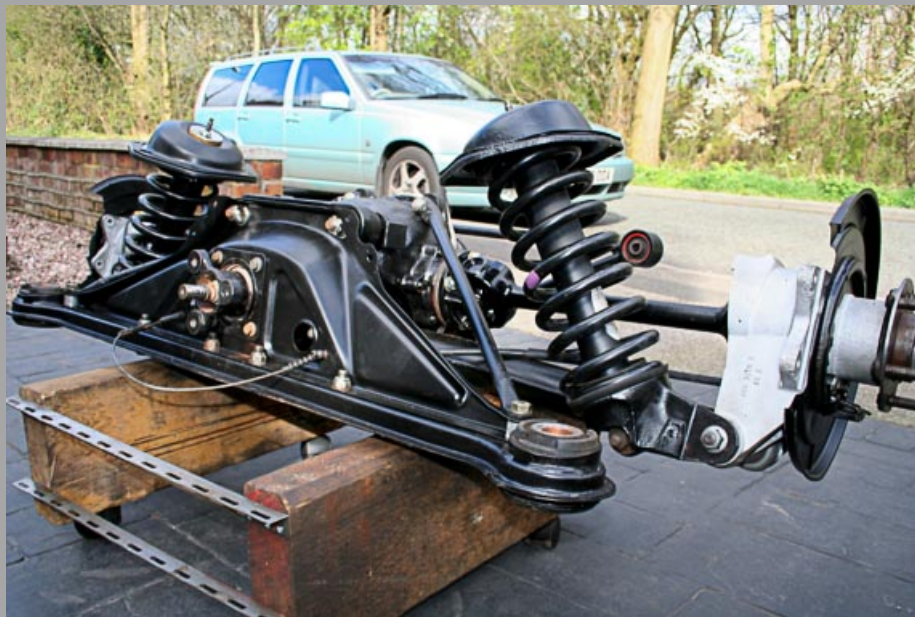
Similar before and after pictures of the rear axle/suspension.

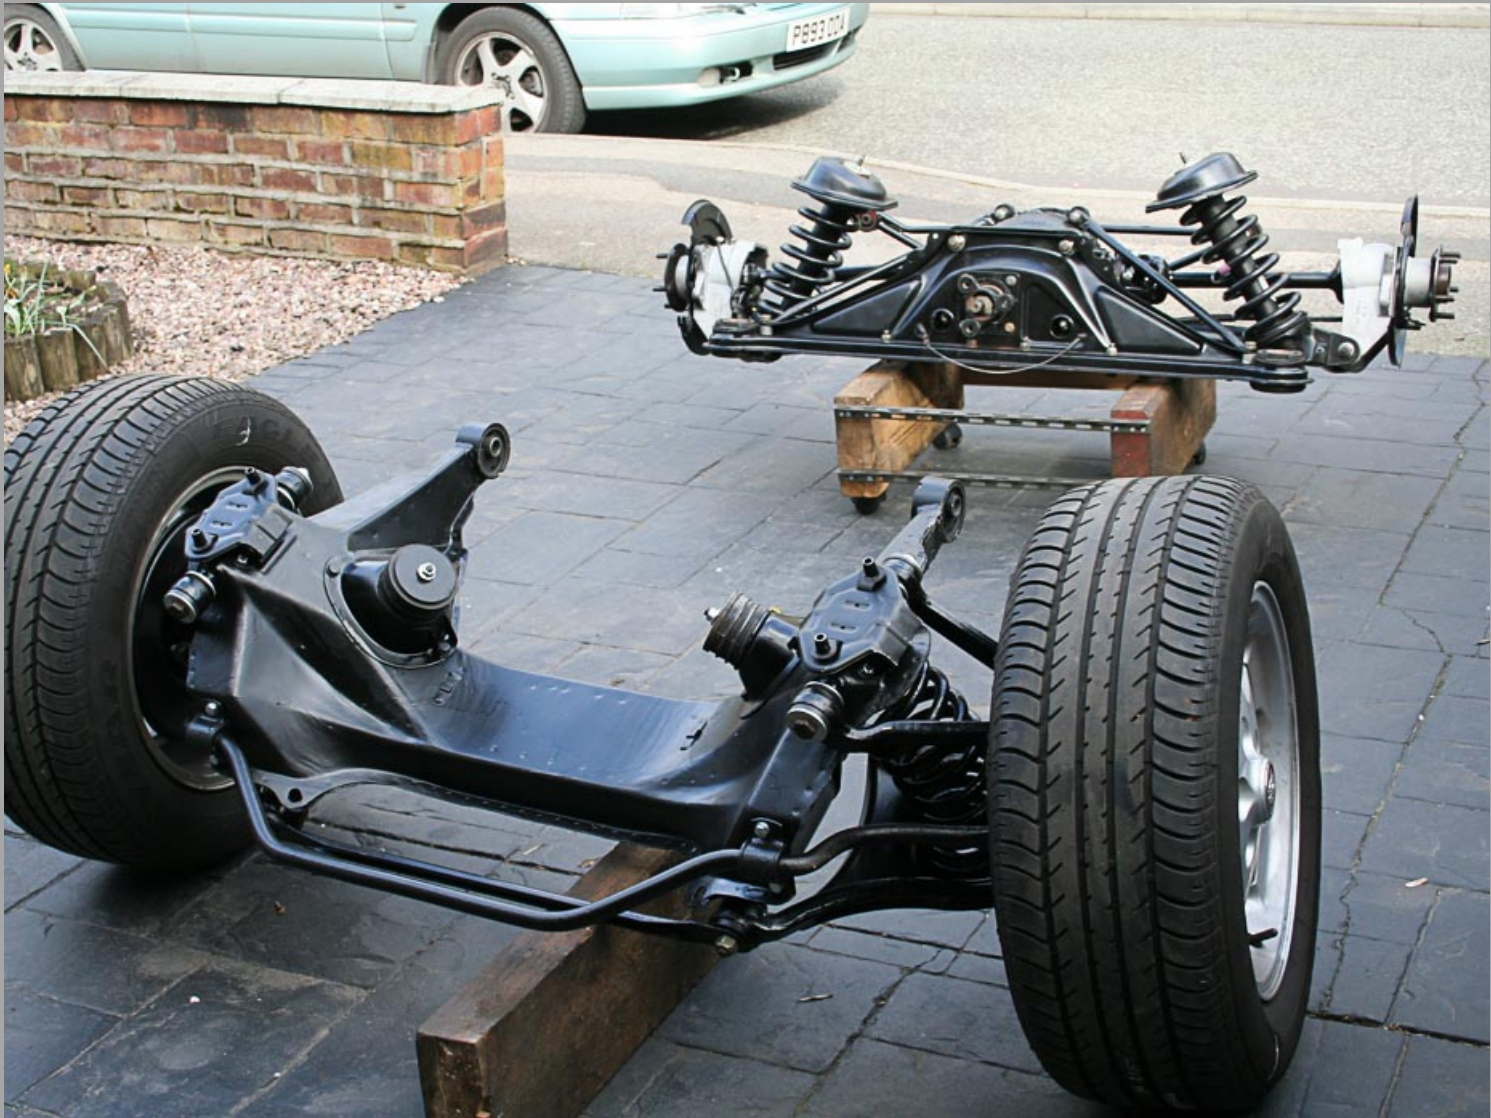
Suspension assemblies ready to be bolted on and get the shell mobile so it could be transported to the paint shop

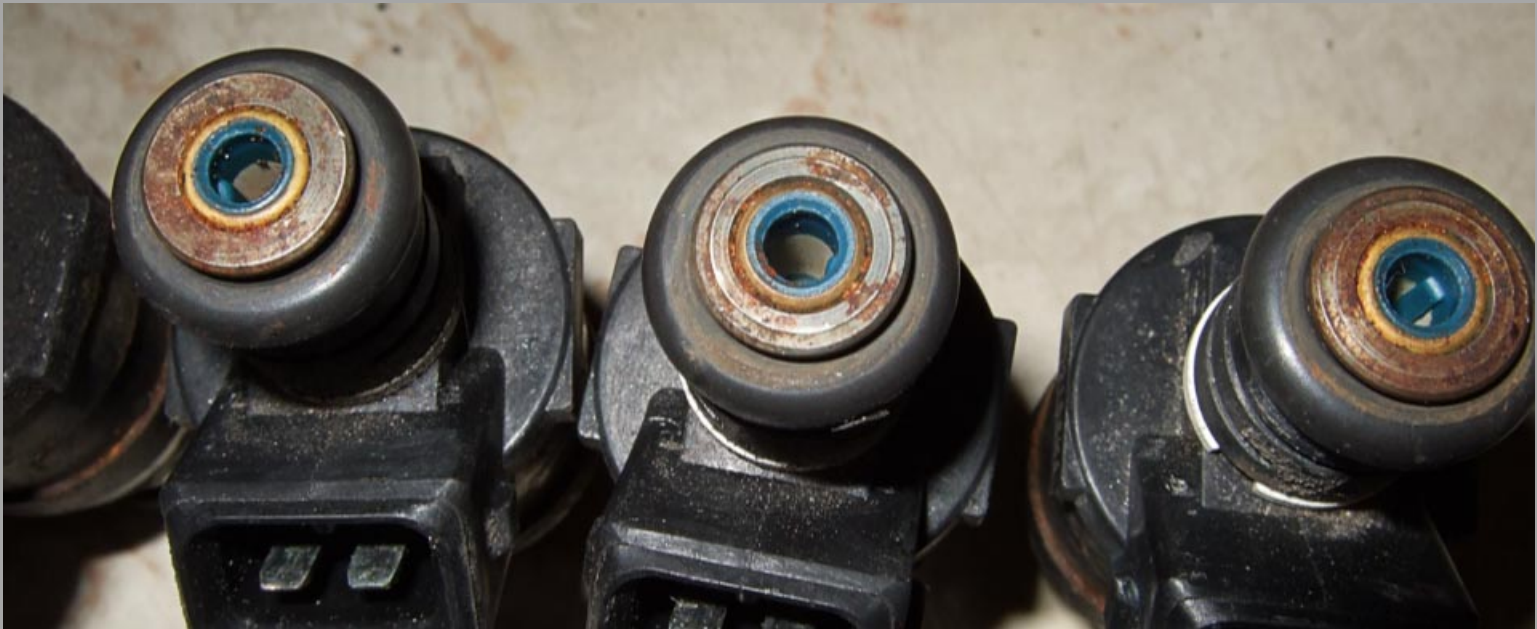
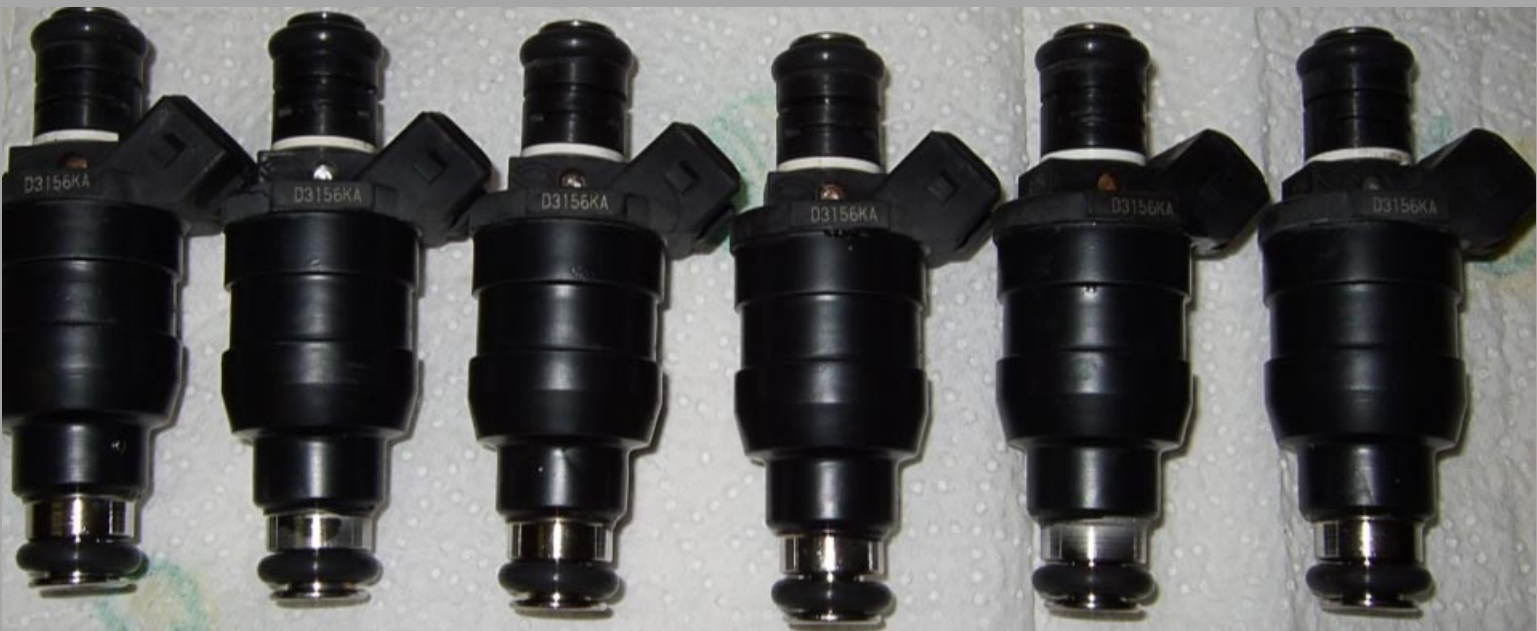
Injectors were sent off for cleaning and flow testing. A great refurbishment job by a contact from a Volvo forum.

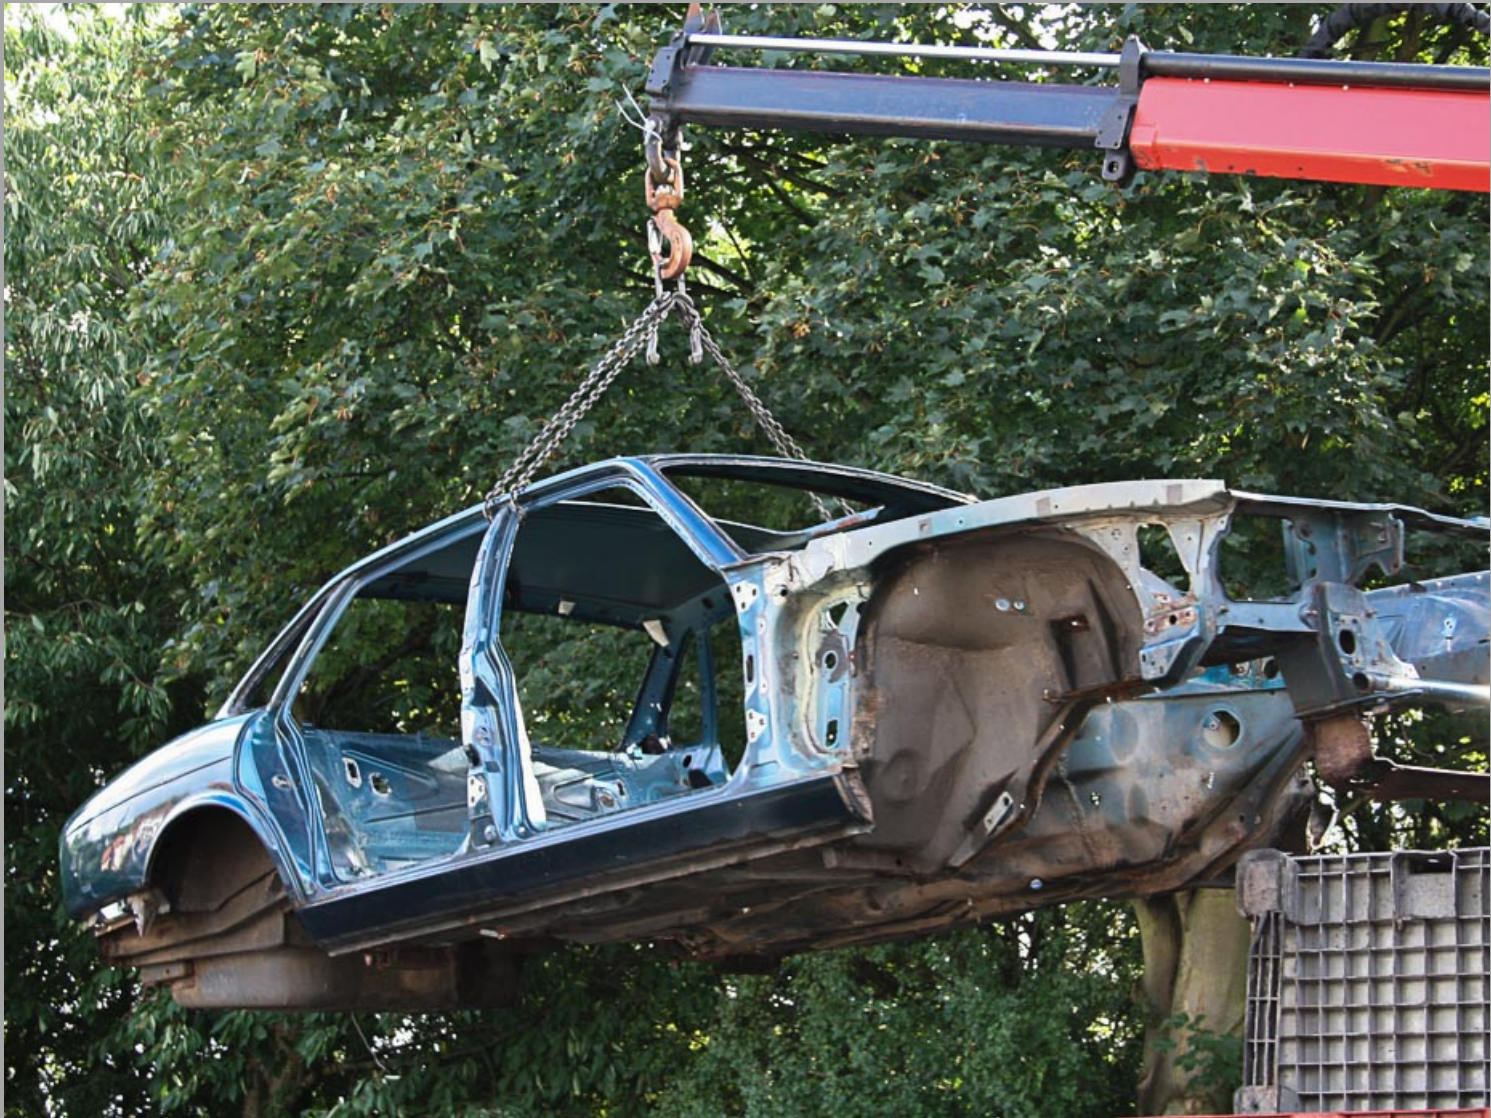
Every last bolt, clip and grommet removed from the shell before disposal. It's probably now a microwave.

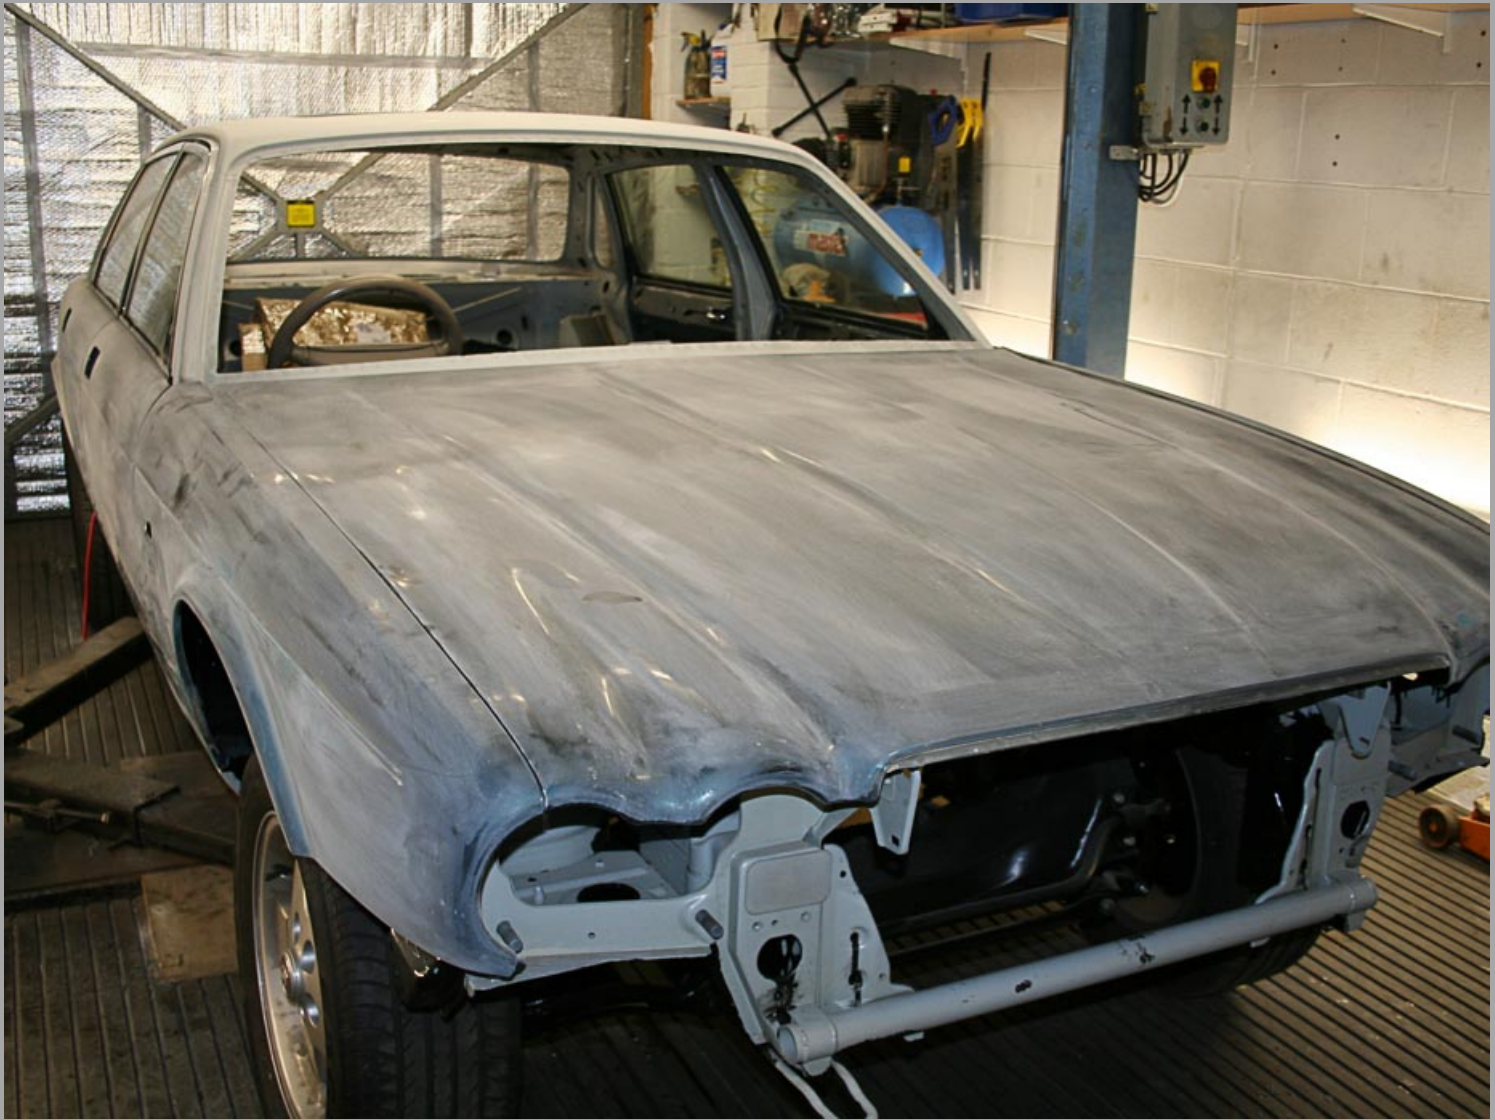
Getting ready for paint
