Building an X300

Let's start at the beginning.

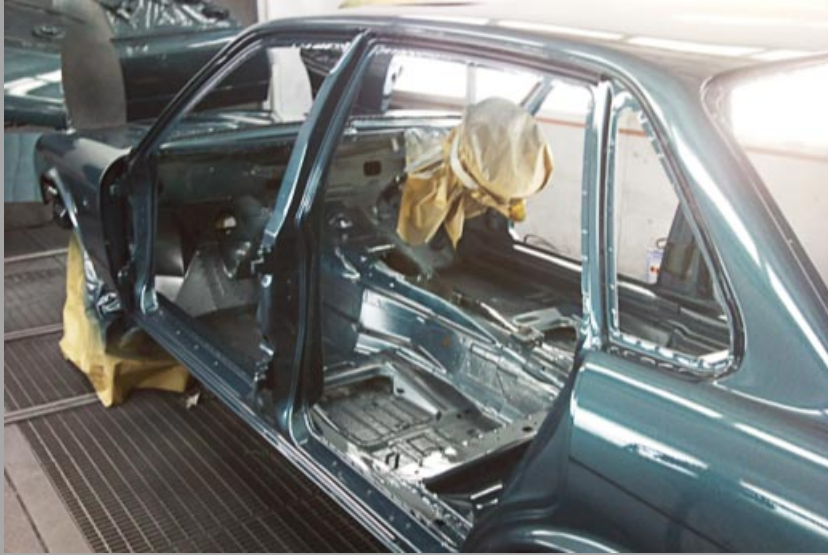
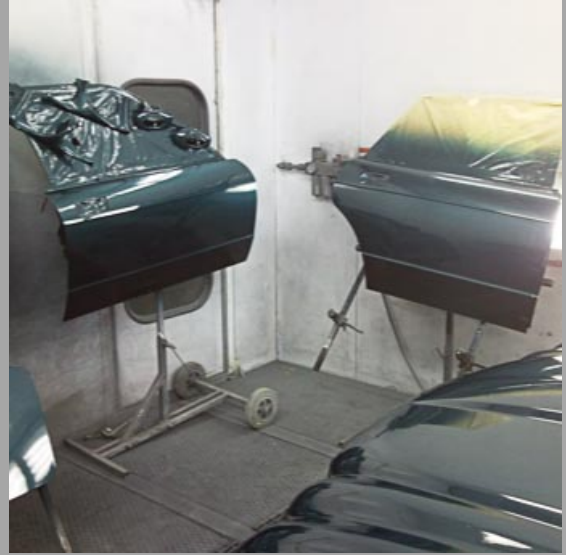
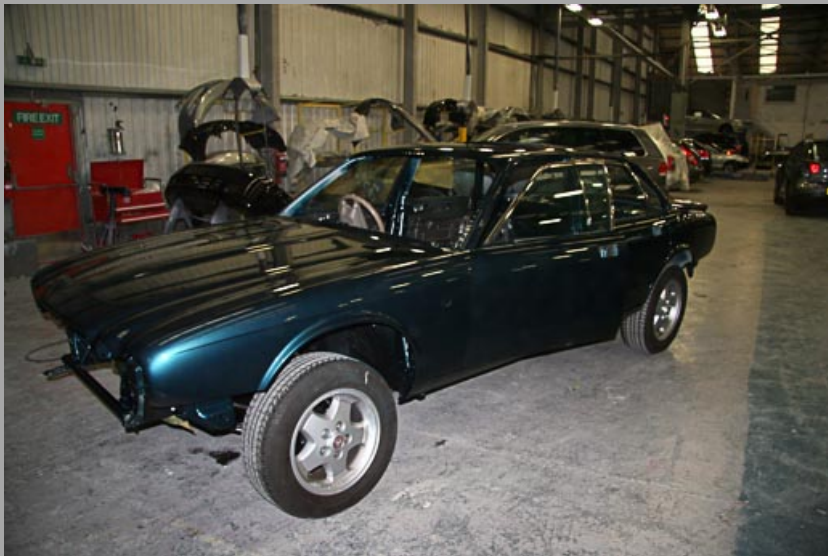
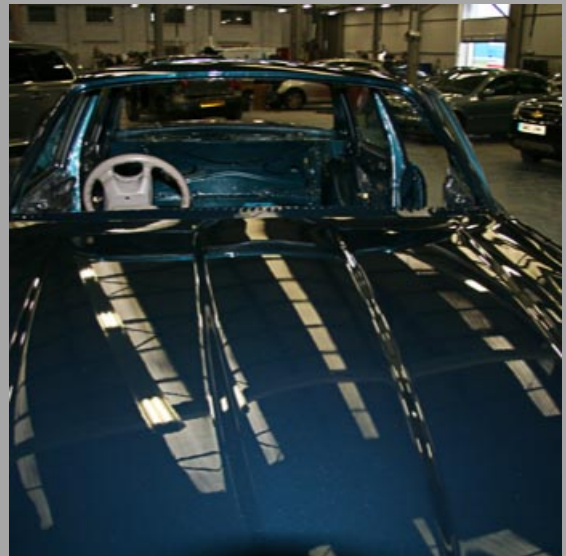
Painted by my nephew at his bodyshop. Nice finish straight from the gun.

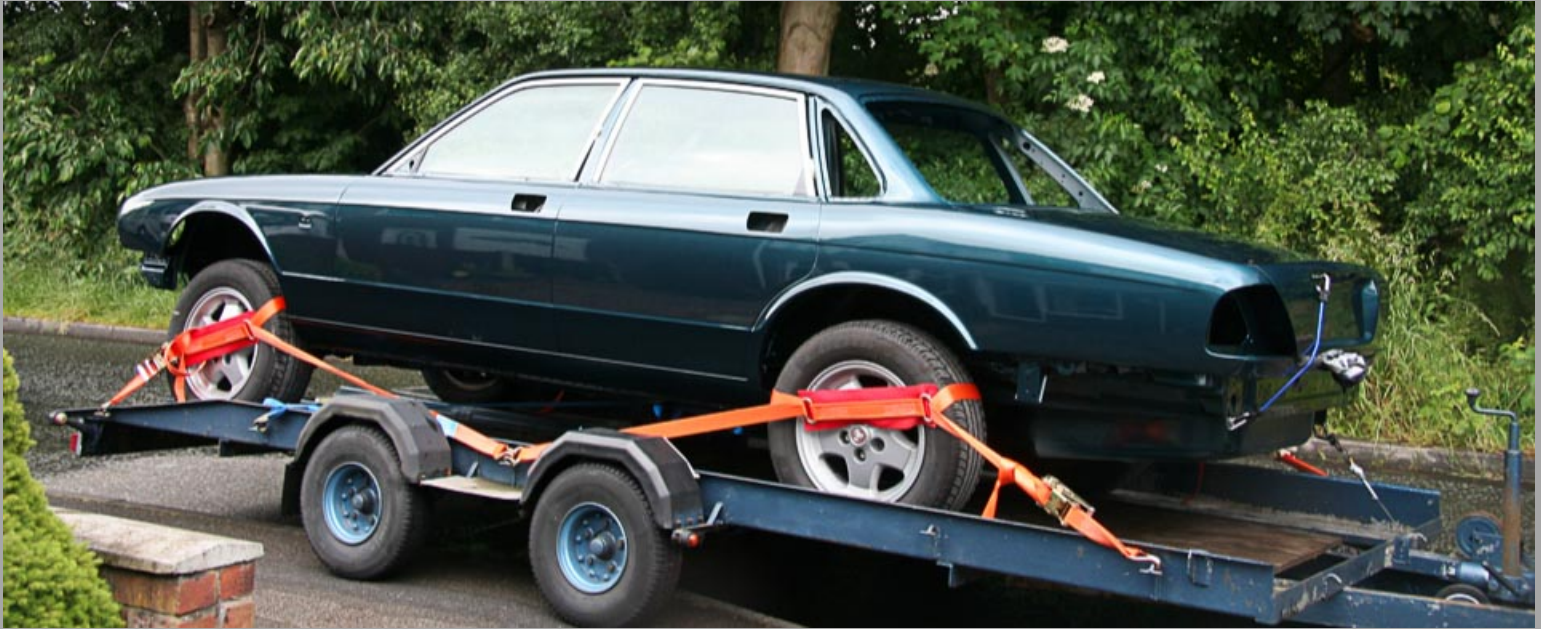
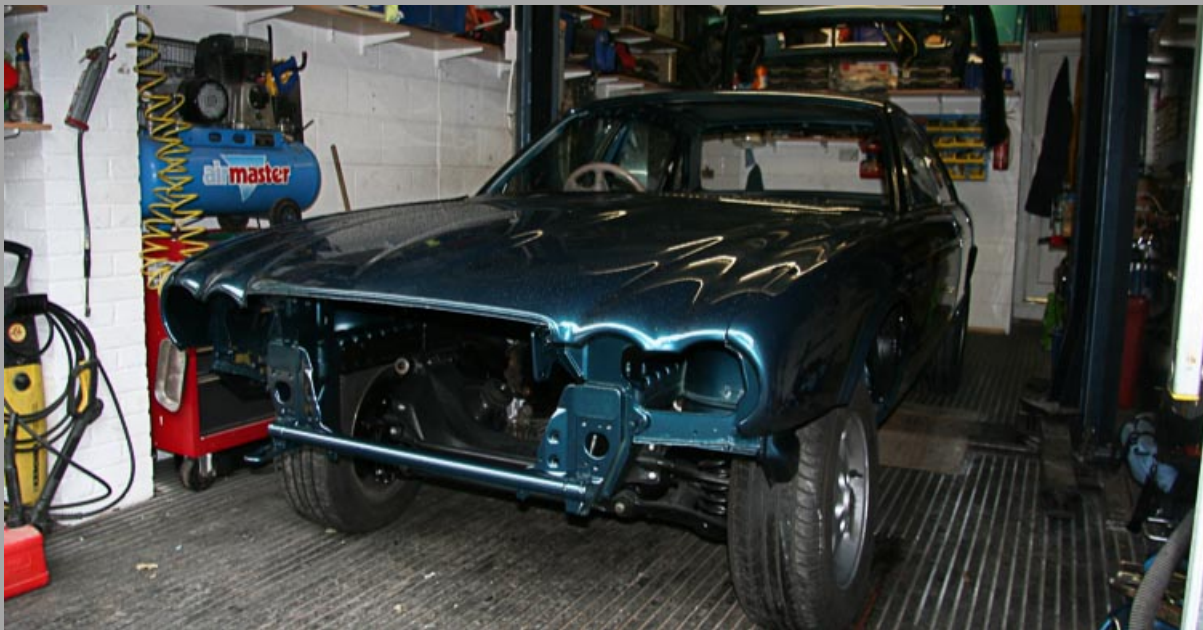
Painted shell returns home, and sits waiting for things to be bolted back on.

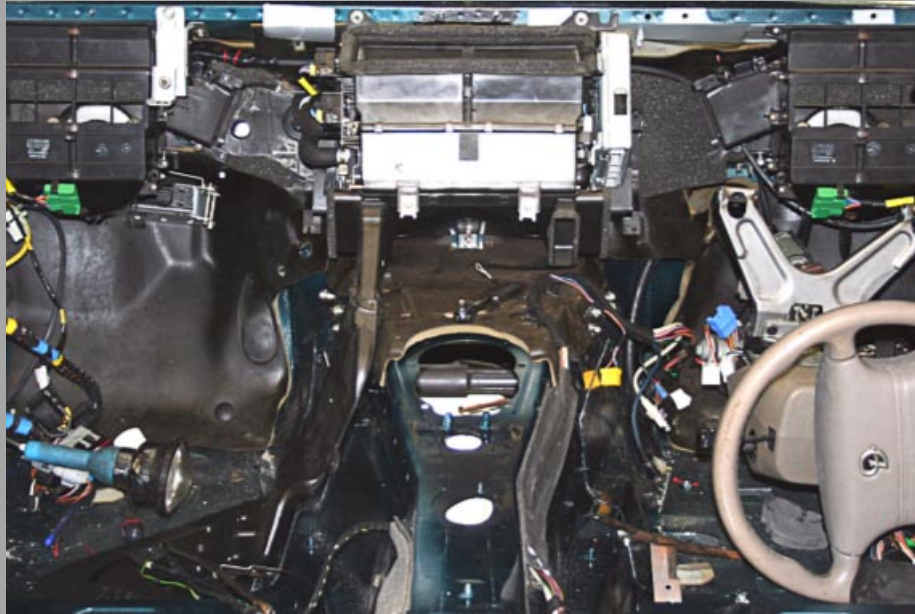
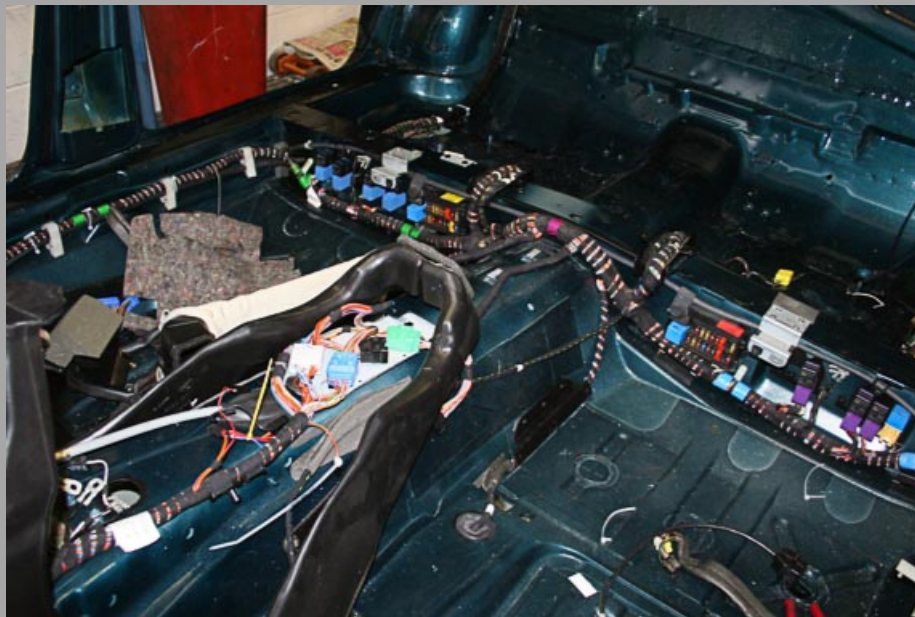
Interior fit out starts with the Air Con unit and blowers and soundproofing mats. Wiring loom and rear fuse boxes back in place.

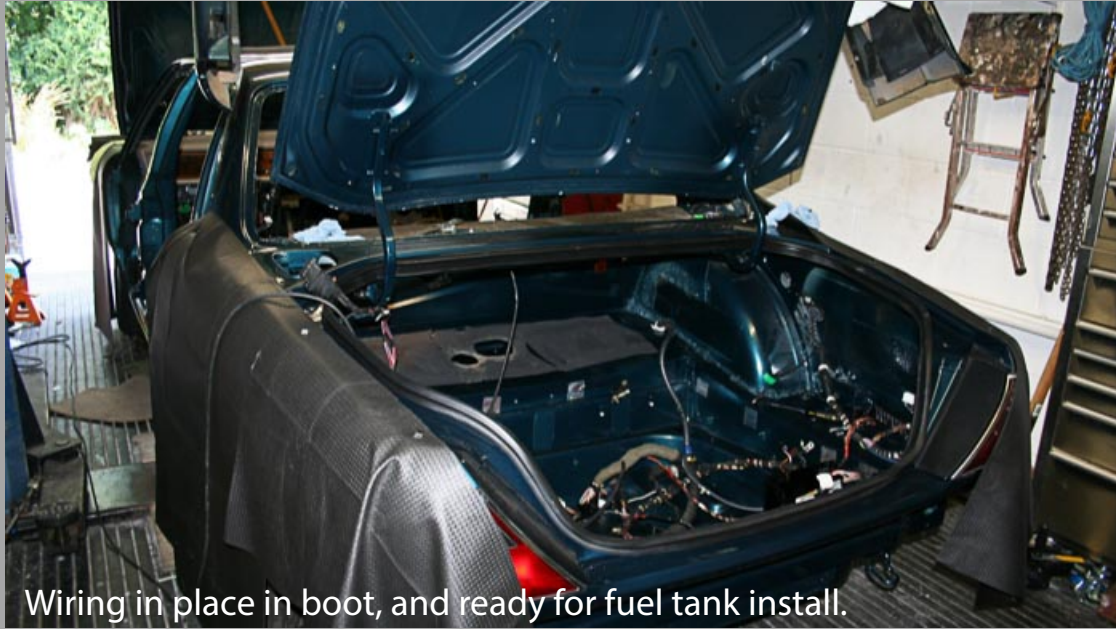
Wiring in place in boot, and ready for fuel tank install.

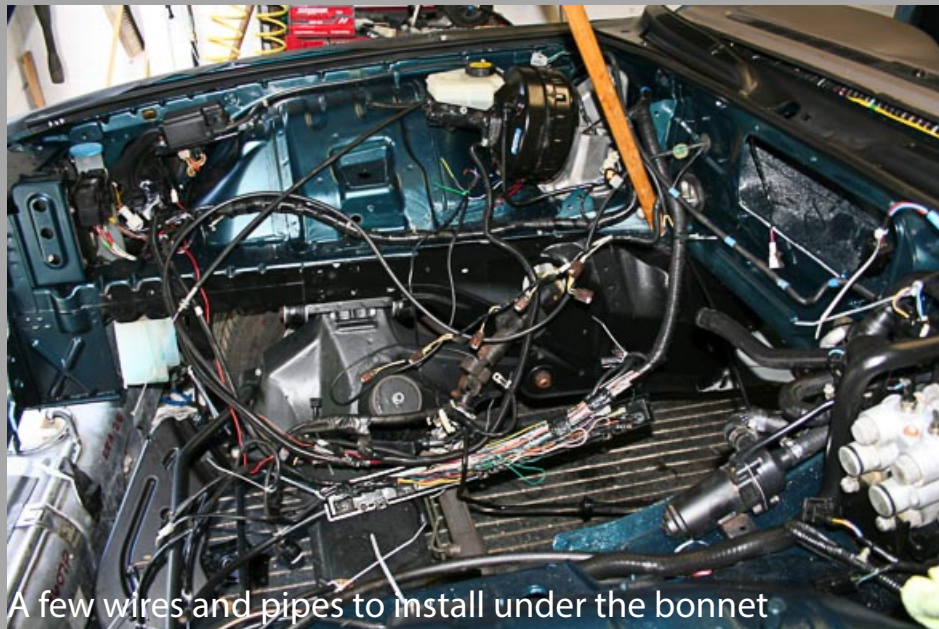
A few wires and pipes to install under the bonnet

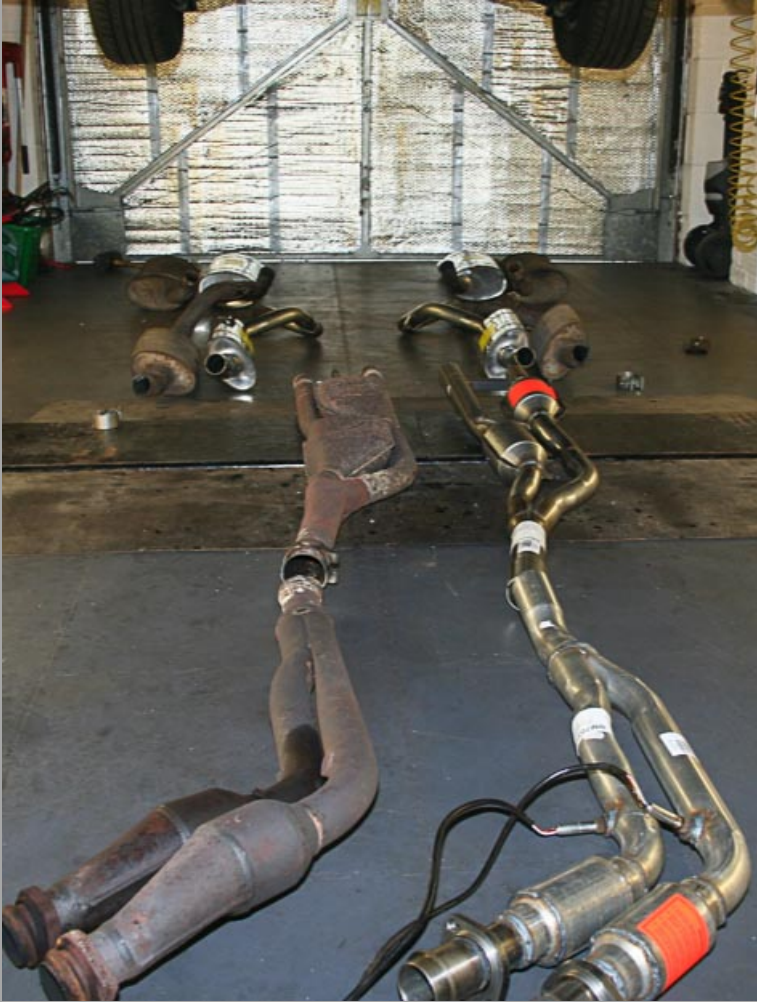
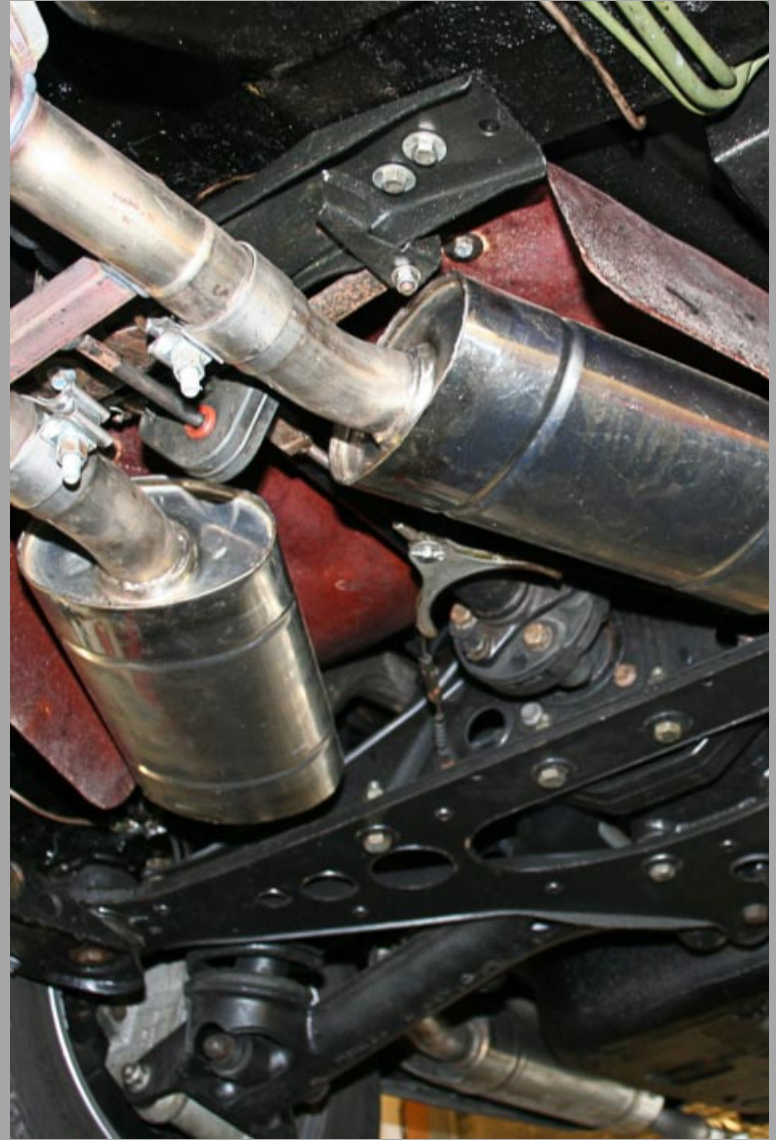
New stainless steel exhaust and cats installed

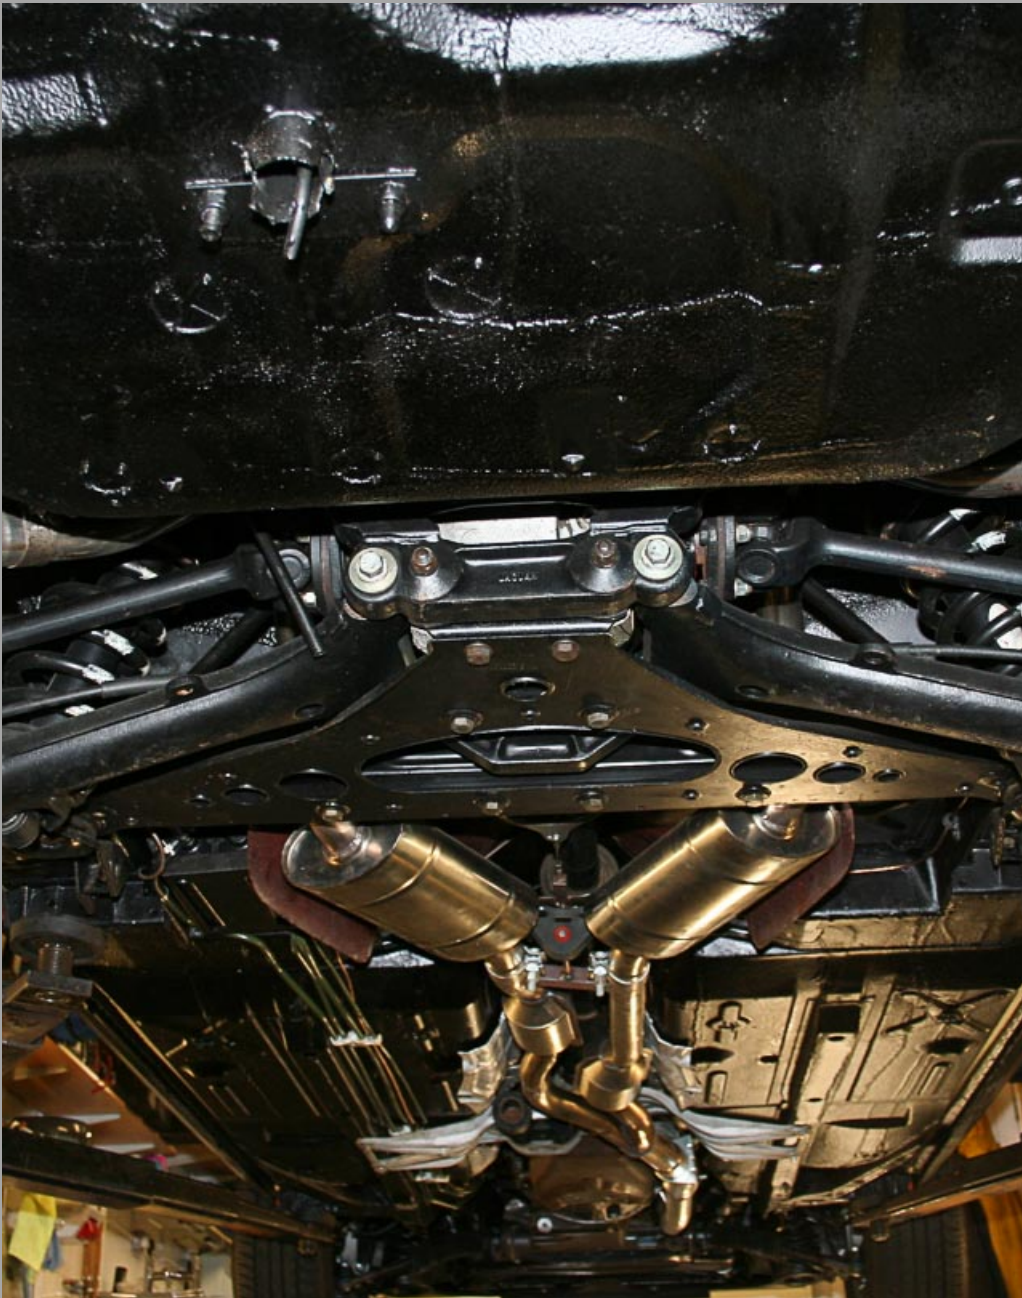
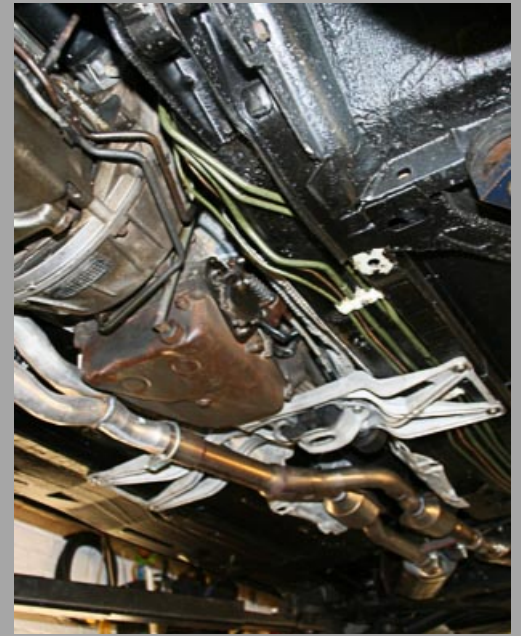
Underside view. You can see my home made Kunifer fuel pipes painted original green that replaced the rusty leaking originals.

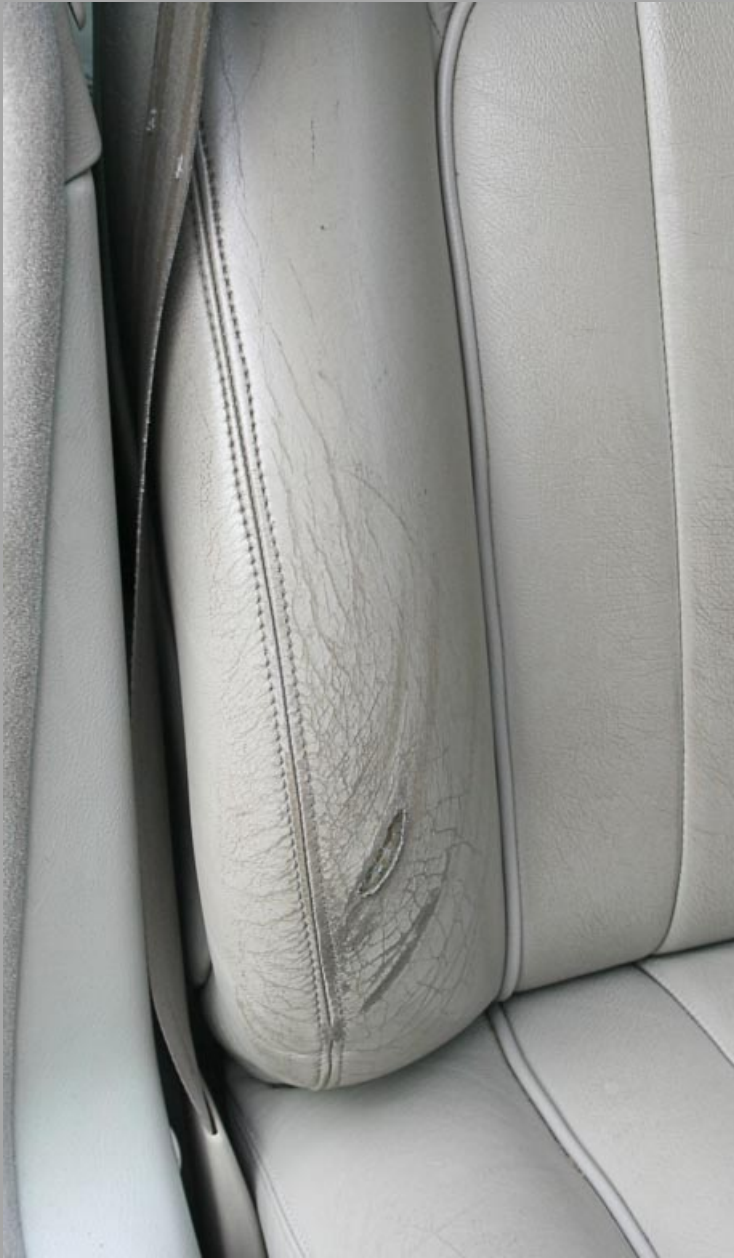
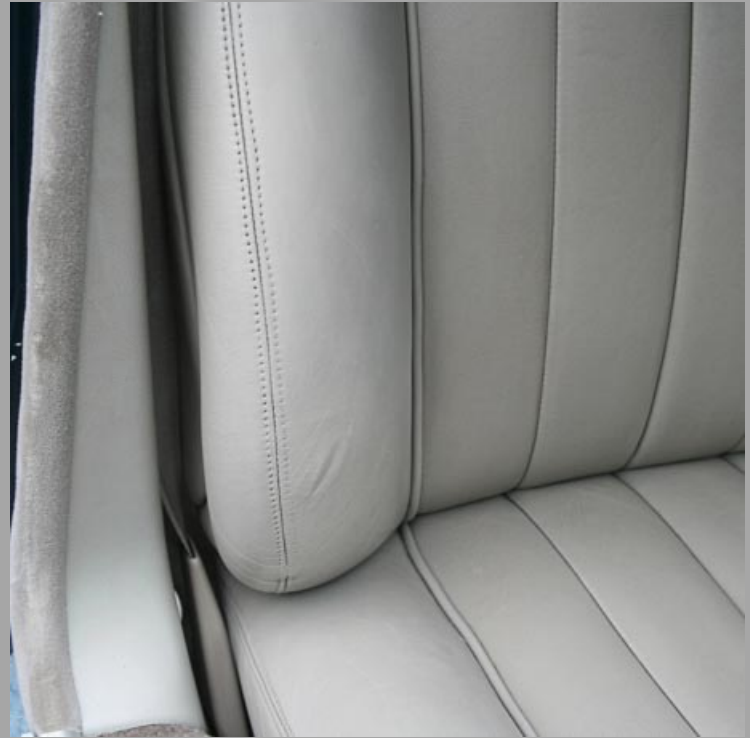
Front Seat bolster was worn to a hole. The second picture shows the repaired seat. Not like new but a big improvement.

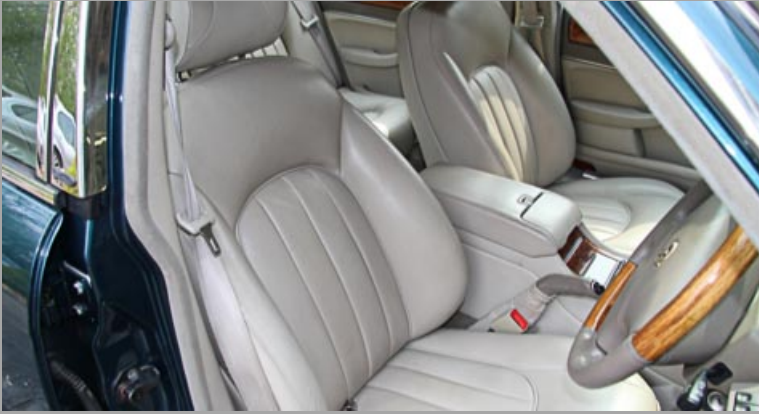
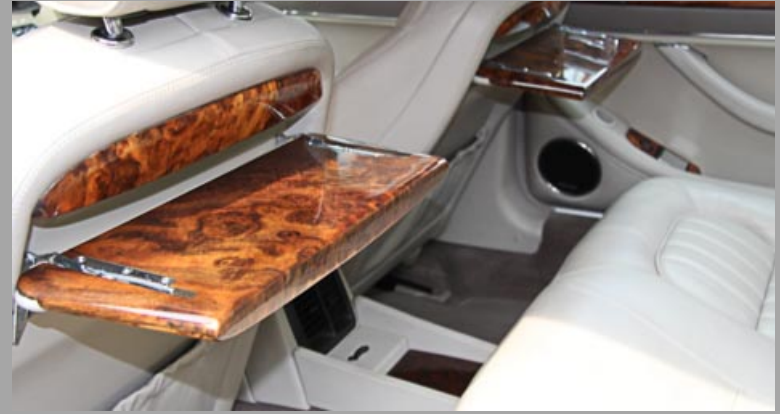
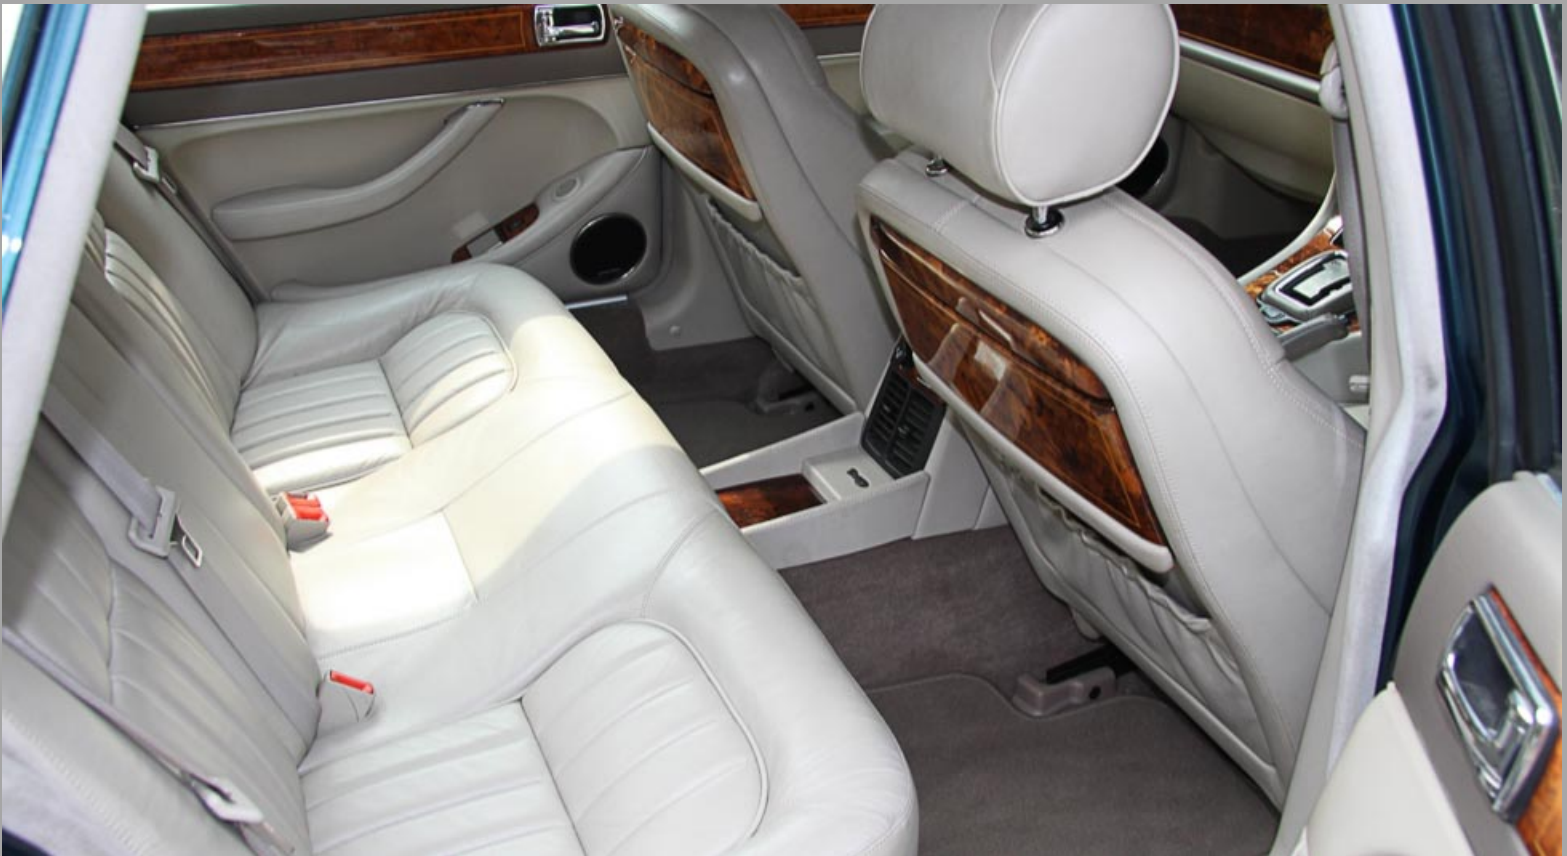
You may notice the rear seats have five pleats and the front four. The rear seats are from an XJ8 as the seat belt configuration on the XJ308 shell (and later X300) is different and my original seat would not fit. Still looking out for some Daimler style seats with center 3 point belt!

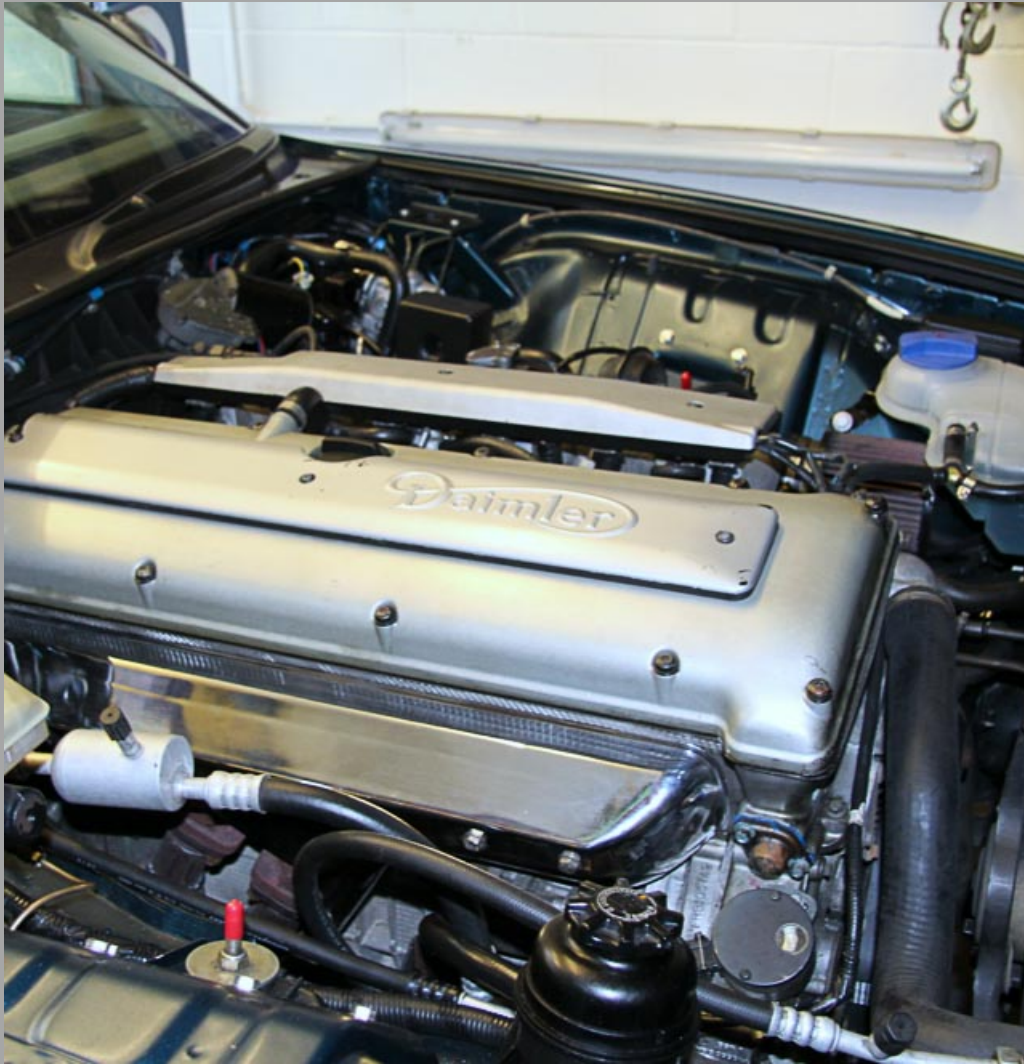
Difference in the X308 shell required some customisation under the bonnet. Note the Audi A6 header tank.

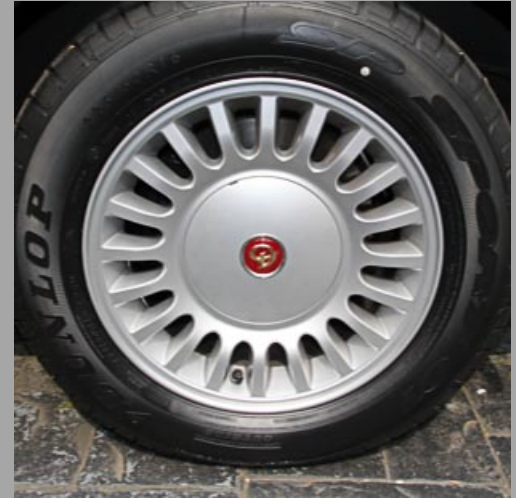
Later refurbished XJ8 wheels fitted by choice .
