Pad wear sensors

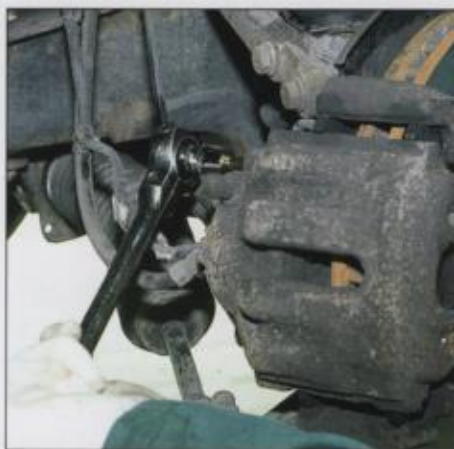
The calliper slides on two stainless steel pins, they have a hexagonal socket requiring a 7mm Allen key and are protected by a rubber plug. To replace the disc, remove both. To change only the pads, remove just the lower pin. (XJ40 note: LH front and RH rear callipers will have a pad sensor to unplug – see panel below).

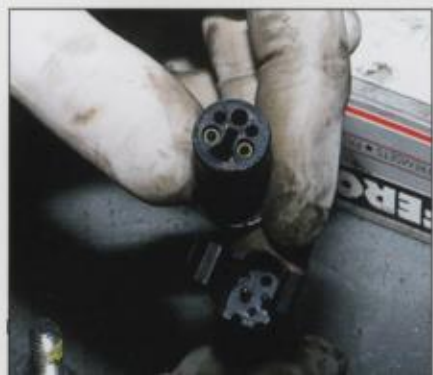
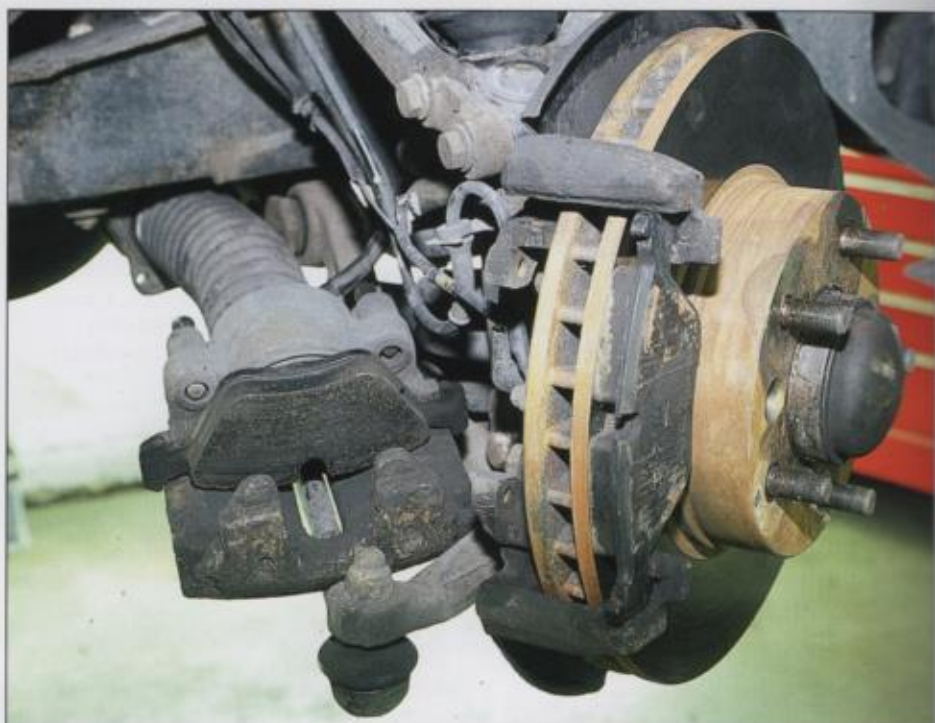
When replacing the pads only, the calliper can be pivoted on the top pin. When changing the disc as well, remove the calliper altogether. The outer pad just sits there, but the inner one is secured to the piston with a spring clip.

If replacing only pads, reverse the above procedure, pumping the pedal to seat the new pads before moving the car.

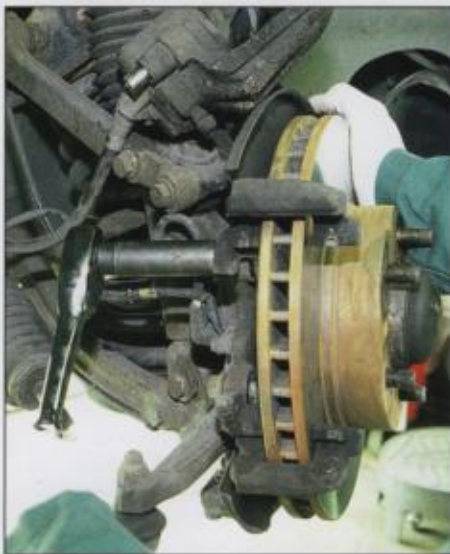
The calliper brackets are sometimes lock-

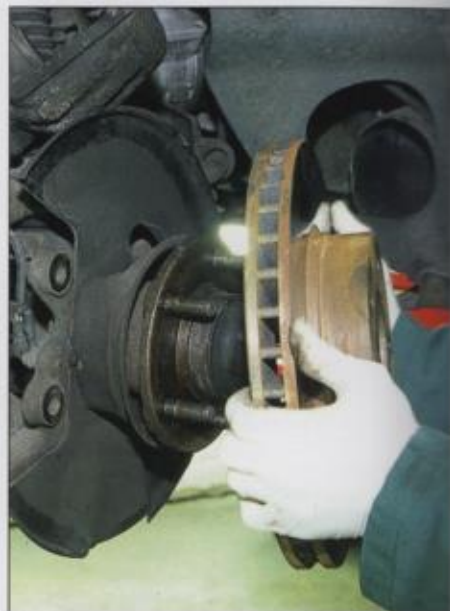
The disc should now slide easily off the wheel studs. If it has corroded to the hub centre, a few taps from behind should free it, but make sure the hub is then cleaned thoroughly with a wire brush to remove any remaining corrosion.

XJ40s secure the disc to the hub with a grub screw, while X300s, as a rule, do not. If a screw is not co-operating, try drifting it around with a sharp
