1998 Jaguar XJ8 headliner board recovering and replacement instructions.

## WLS HEADLINERS

The car in this headliner tutorial is a 1998 Jaguar XJ8 with sunroof. The headliner wasn't in too bad of shape, with the exception of a big sag in the rear of the car. The XJ8 Jaguar car headliner isn't really all that hard to replace; the most difficult part is removing the headliner board from the car. Unfortunately we didn't get a shot of the board being removed from the Jaguar XJ8, but it comes out through the rear drivers side door (with the drivers seat let all the way forward and the back of the seat let up as far as it will go). The headliner board will have to be bent to remove it, at times you may think you will break it, but the Jaguar headliner boards are very resilient and will recover quite nicely when reinstalled. The headliner in the Jaguar XJ8 can be recovered [this way inside the car](#), but it makes it harder to fold the material over at the front and back of the board; otherwise it makes the job much easier.

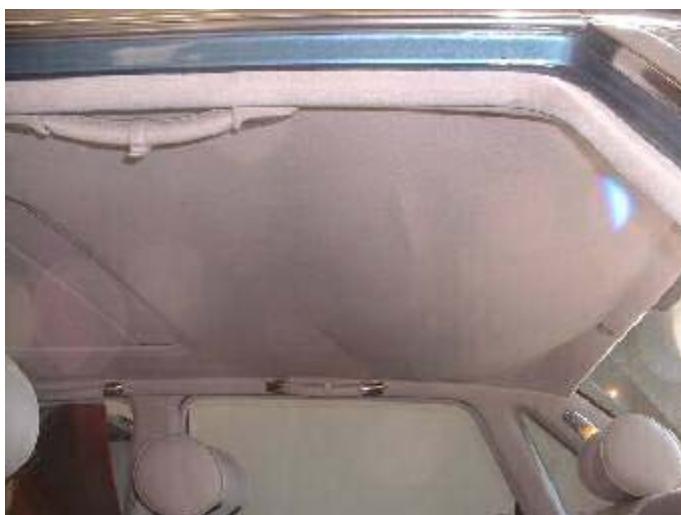
You can see the sag in this pic at the rear of the headliner.

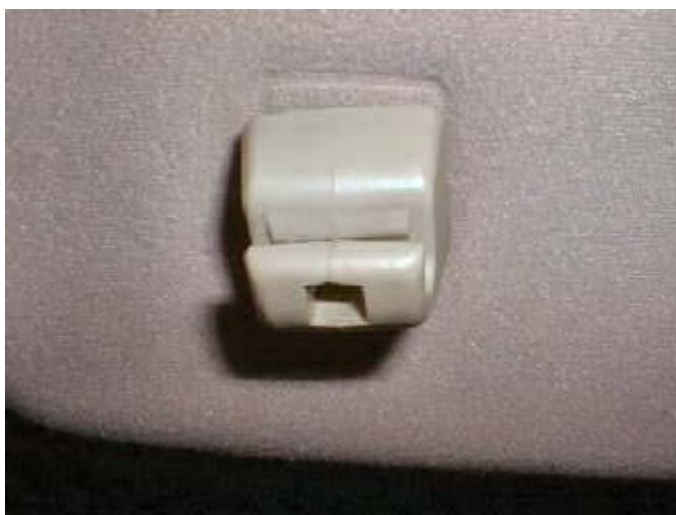
Remove the visor screws and this support on the opposite end of the visor. It has a phillips head screw holding it on (can be removed through the hole).

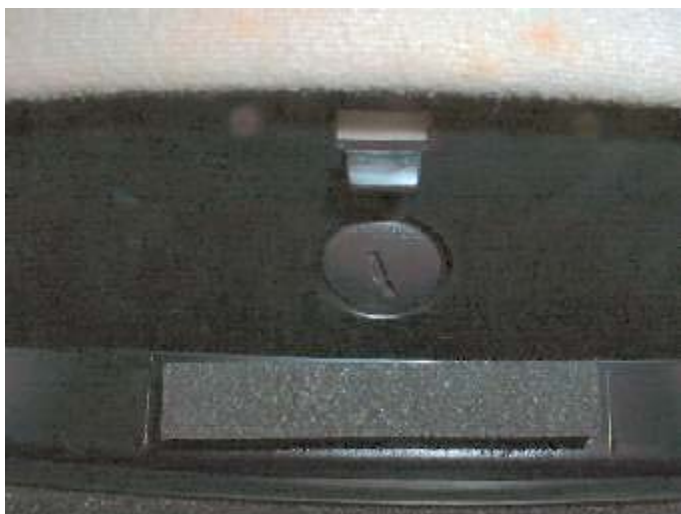
To remove the console, flip the sun visor holder down and use a screwdriver to twist the plug you see in this pic.

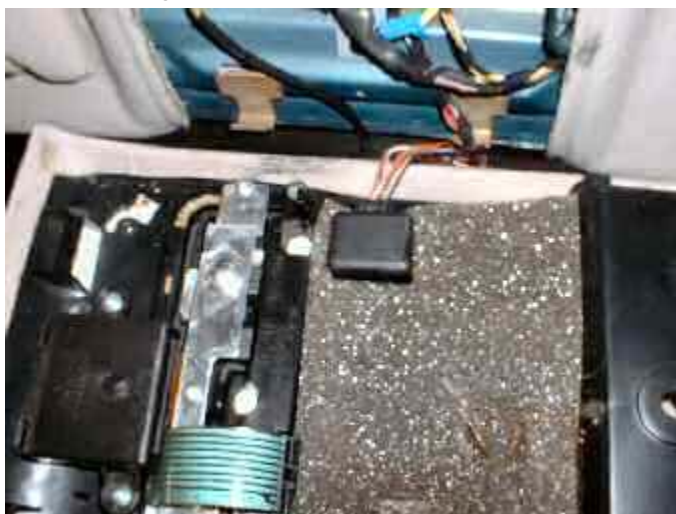
There is only one electrical plug to the console usually.

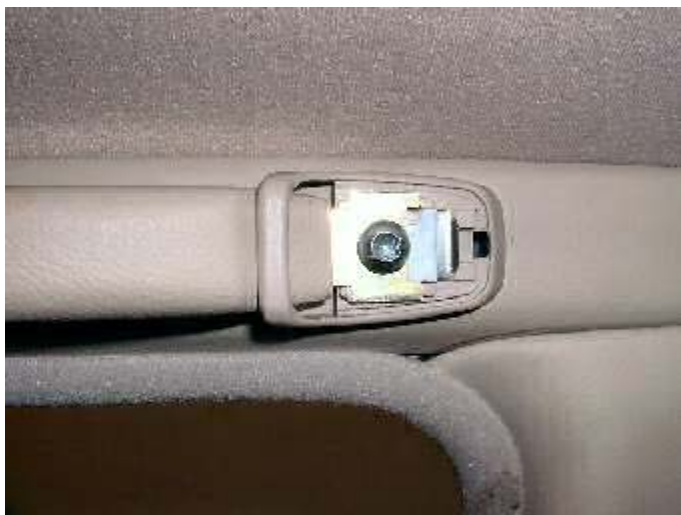
To remove the pull handles, pry the metal trim up and out at the end of the handle. It pops right out.

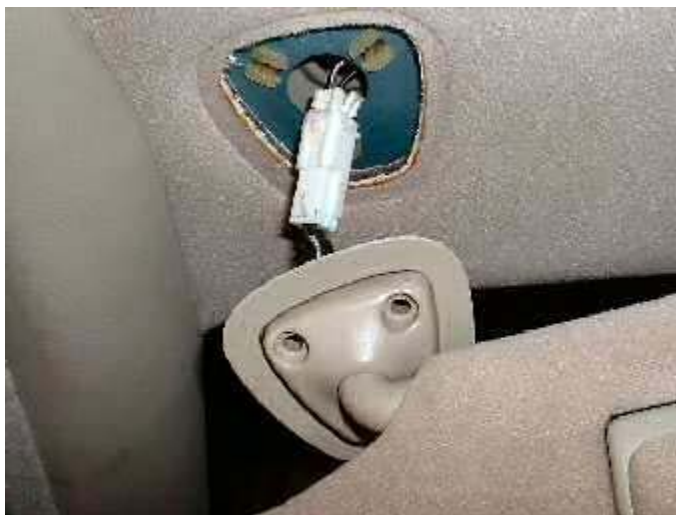
This shot shows the Jaguar XJ8 visor electrical plug

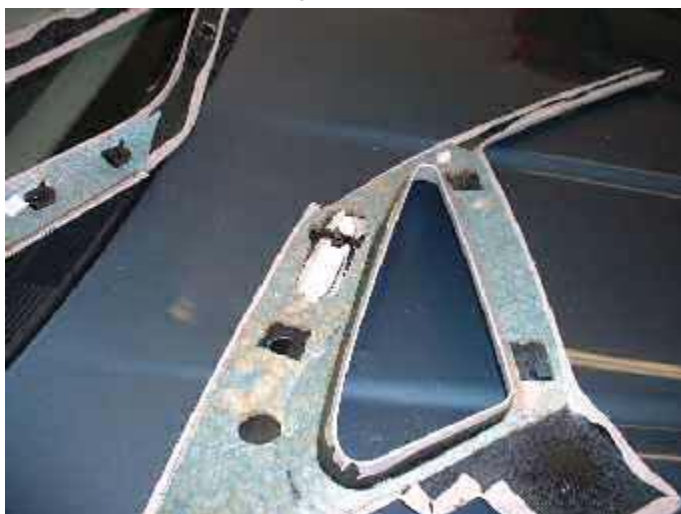
The side trim is attached with small plastic plugs. You can see the black plastic plugs in this picture. To remove them, give them a tug and they should come loose once you've removed the pull handles. It is only necessary to remove one of the rear panels, the other side of the headliner board can be slid from under the panel.

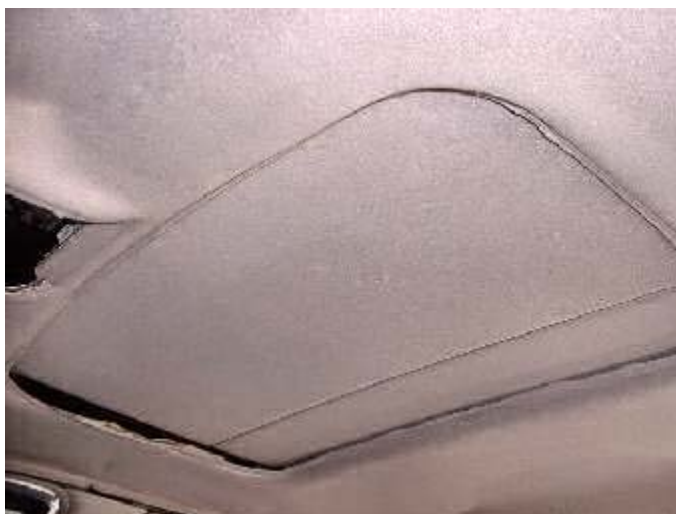
Remove the pinch welt from around the sunroof opening.

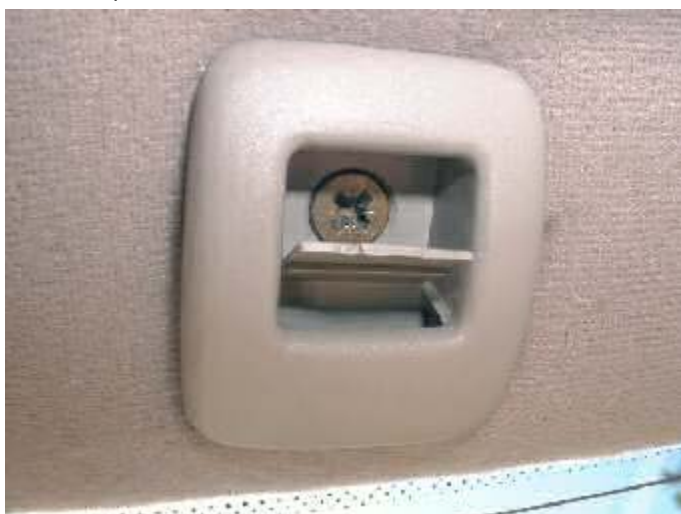
This is a shot of the plastic pieces at the rear of the headliner board, don't know exactly what they are for, but they must be removed. A phillips head screw can be seen once the small plastic cover is pulled up.

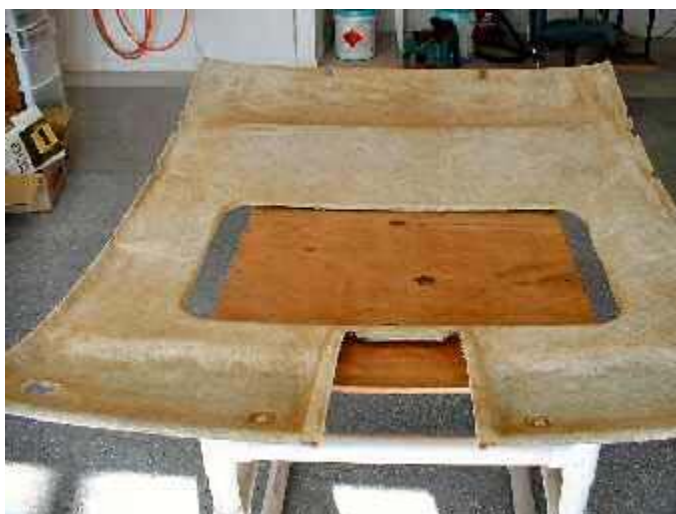
The headliner board of the 1998 Jaguar XJ8 after it has been cleaned. It's ready to be recovered.

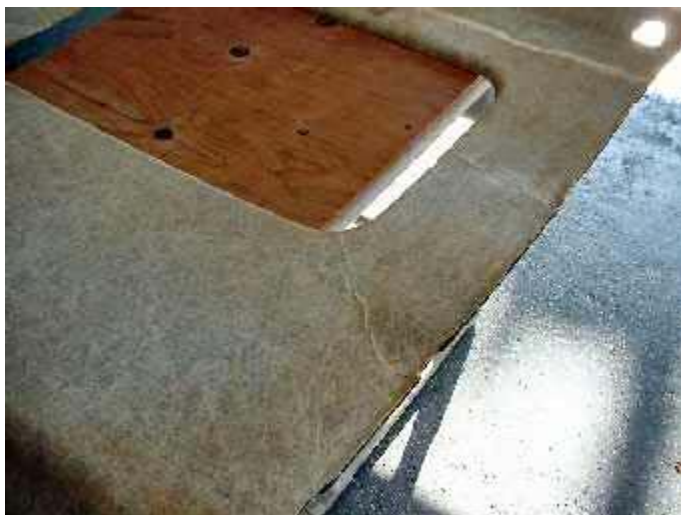
If you look closely, you can see the bend marks from the headliner board being removed. Again we say, it will look like it's going to break when removing it, but it is very resilient. [Read this for more on removing the board from the car](#)

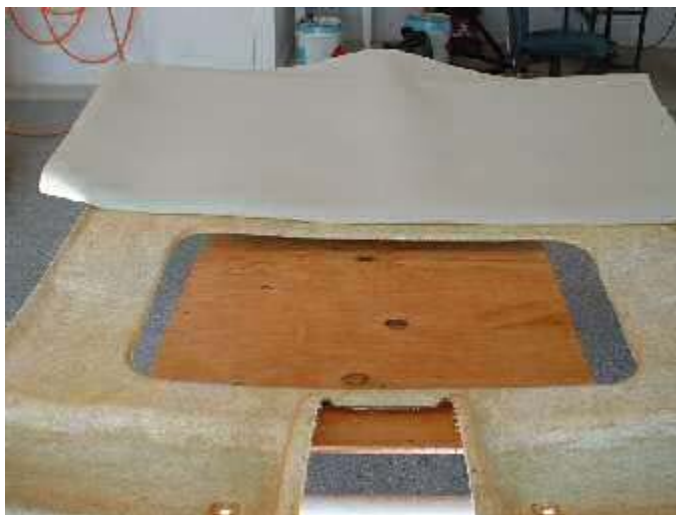
Recover the board about 1/3 at a time, this will give you time to work with the adhesive before it dries. When the board is fully recovered, cut the sunroof opening out leaving about 2 inches of overhang.

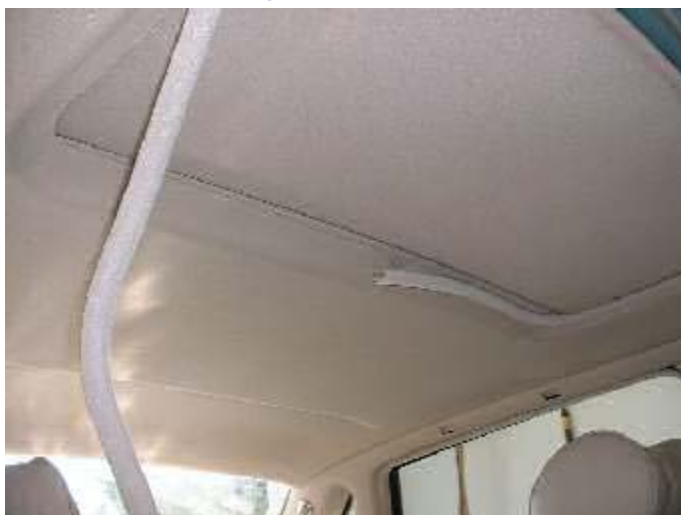
Put the headliner back into the car, and reattach everything just like it came out. Cut the excess off from around the sunroof opening and put the pinch welt back into place.
