Jaguar rear outer pivot arm greasing. Inboard brake style.

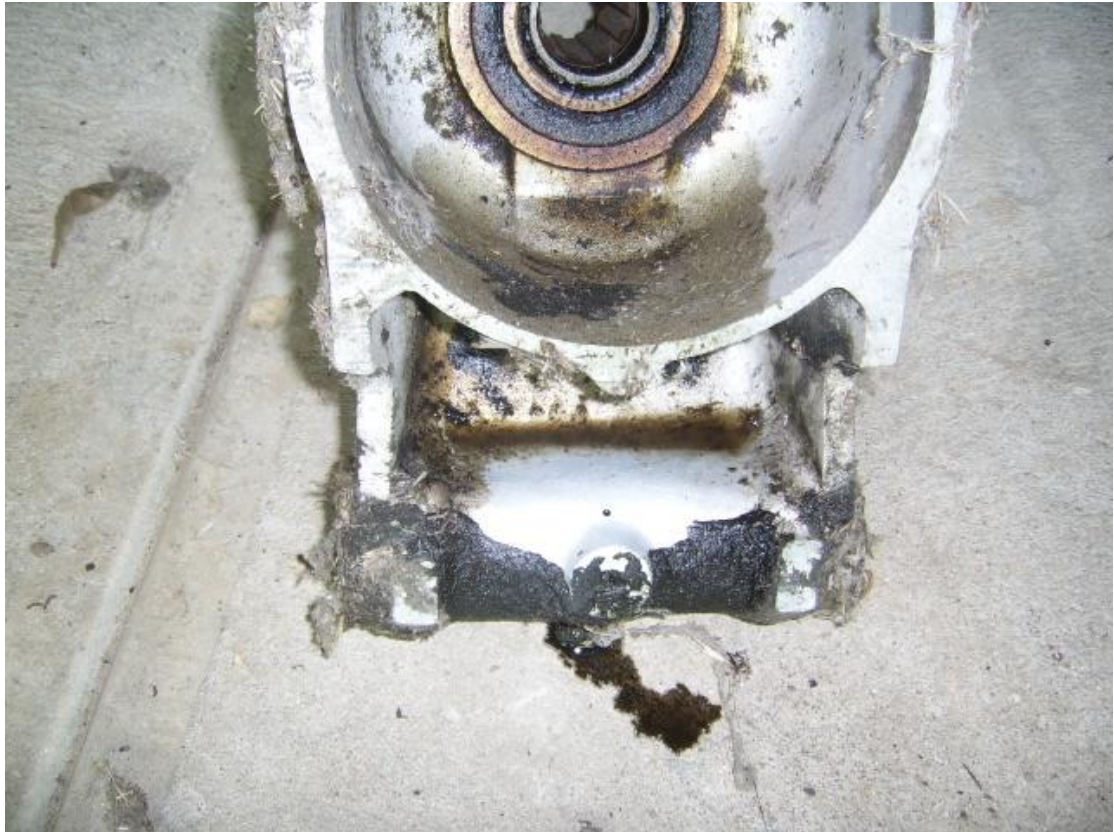
Figure 1General view of that SMALL hole

I simply drilled that bleed hole slightly larger, to suit whatever you choose to plug it, using wheel bearing grease on the drill bit, it is stickier than normal grease, and collects the drilling swarf perfectly. Then I inserted a suitable self tapping screw, VERY short in length, in that hole. You could go all fancy and tap a thread and put a suitable 4mm bolt in there, your car your choice, but it is NOT visible unless the rear hub is partly removed.

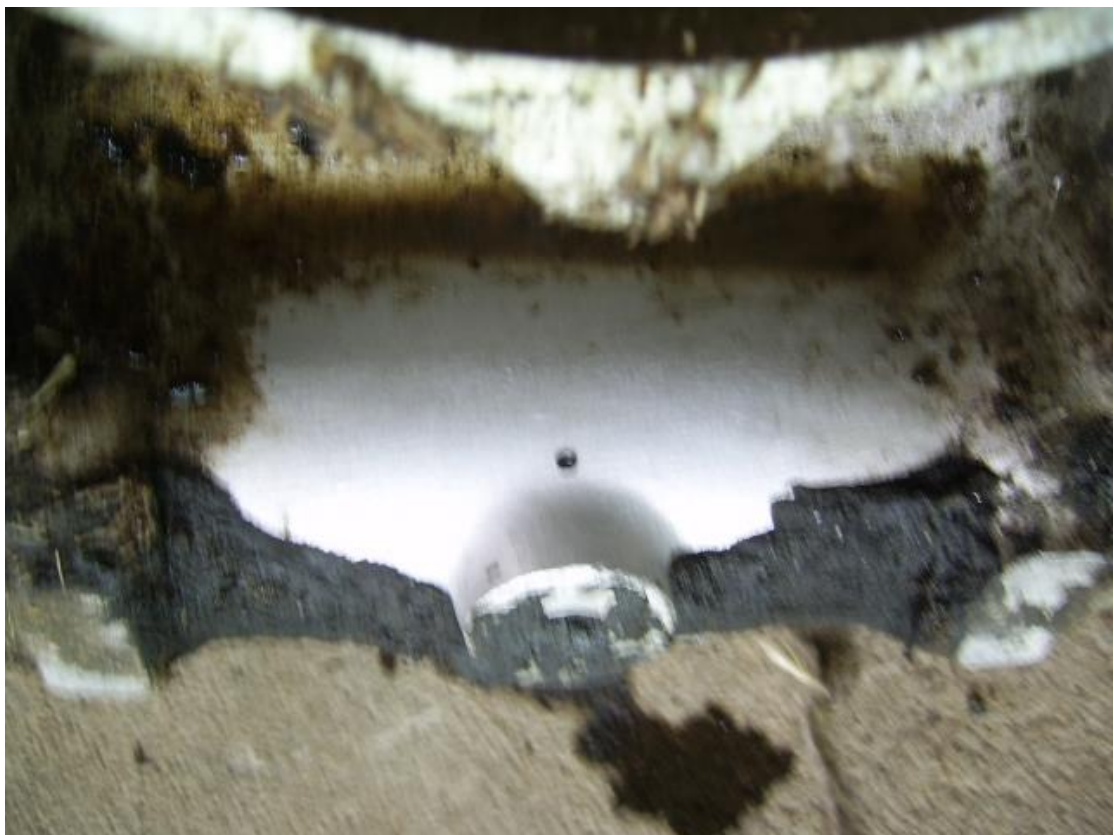
Figure 2Close up of said hole

This is an old hub under the bench, it clearly shows the hole I am discussing.

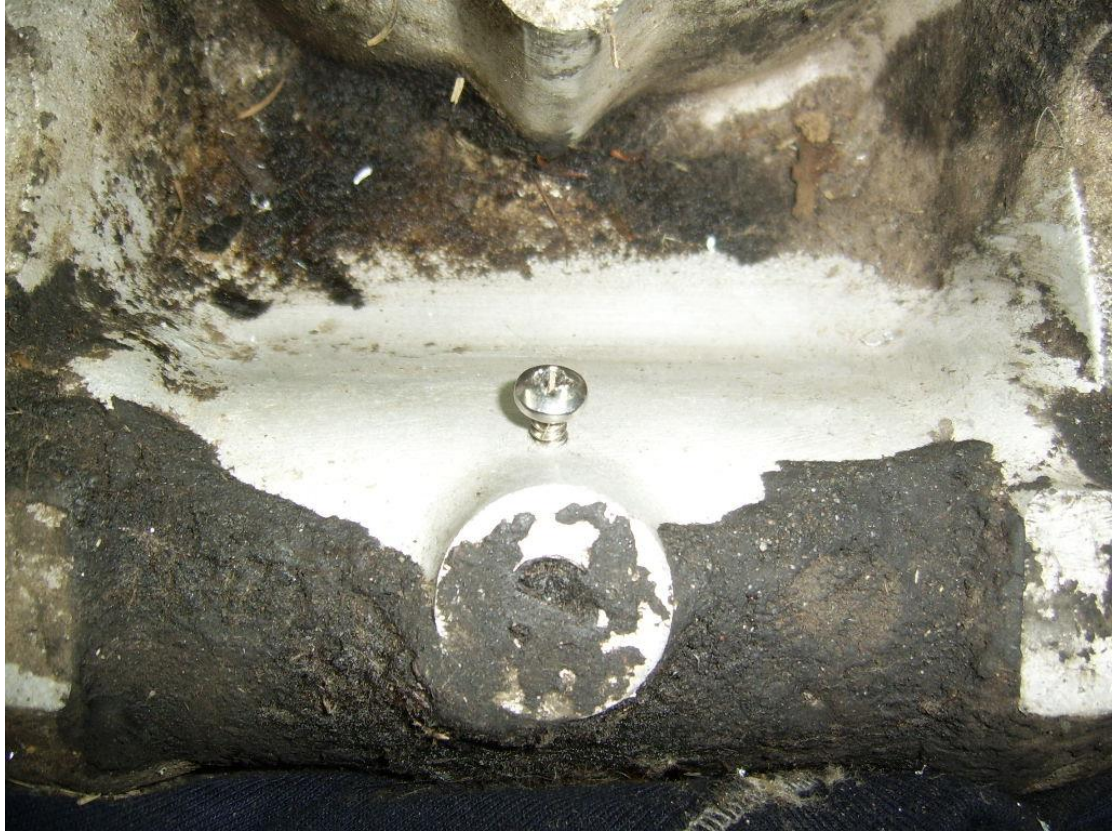
This the screw as a sample of what is needed. This is a tad too long, but for the sake of this article it serves the purpose.
