Replacing the Auxiliary Air Valve (AAV)

An electrically operated cold start device for the Jaguar V12

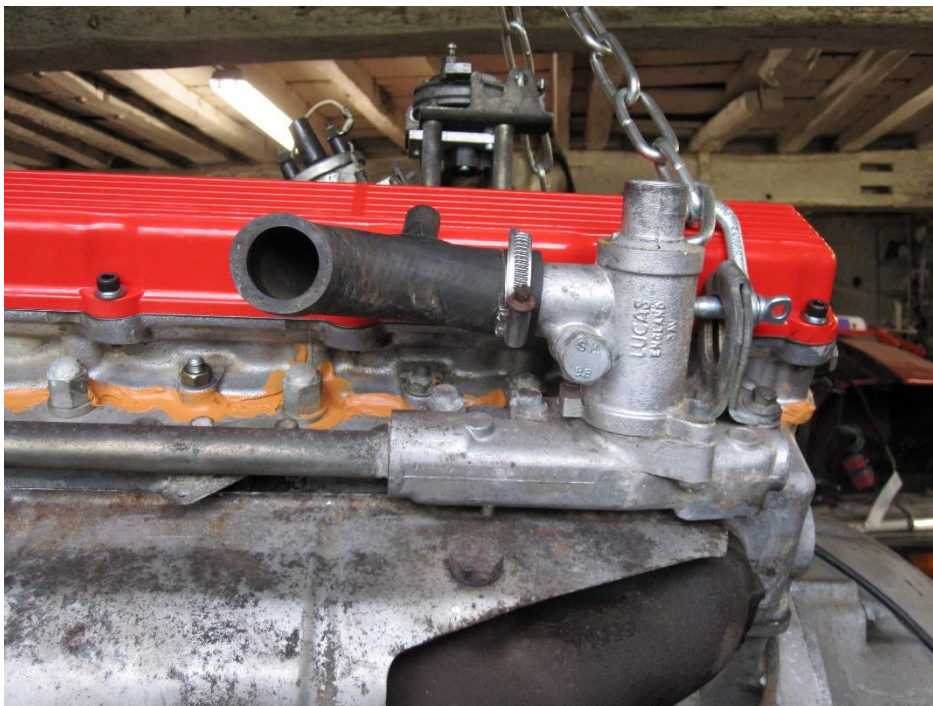
The AAV is a device to aid the cold start of the Jaguar V12 engine, and was fitted to all models of the V12 that were installed in the XJS throughout its 21 year production run. This type of device, originally a Bosch design, was fitted to many different cars made in Europe during the same production era. It works by having an extra airway into the inlet manifold that opens when the coolant is cold to increase engine RPM, which progressively closes as the engine warms up. The actuating device is a thermostatic bulb, quite similar to that used in a car radiator thermostat. This pushes a steel piston up into a cast aluminium cylinder, and the piston thus progressively closes off an air passage as it rises. Below is a photo of the AAV on the engine (induction manifolds removed in the photo).

A second important function of the AAV is to provide a slow-running (tickover) adjustment for the engine, and this is operated by a large bolt that screws in or out, and thus closes or opens an air bypass passage incorporated into the AAV casting. This adjusting bolt is obvious in the photo above.

The AAV works very reliably in my experience, **unless** the car is not used very frequently. When I used my car daily, it never gave any trouble, but now that I use the car only once or twice a week, and far less in winter, the AAV works far less reliably. The reason is that the cast aluminium cylinder corrodes if not used frequently. This causes the piston to jam, in turn this means the air passage remains open or partially so when the engine is warm, and this causes engine revolutions to exceed 1400 RPM on tickover. The engine's ECU thinks with revs over 1400 and a closed throttle, that the car is coasting on a trailing throttle and therefore stops the fuel injectors operating in order to save fuel. This, in turn, starts a "hunting" sequence whereby the engine races above 1400 rpm, the fuel gets cut so the revs drop, then the ECU starts the fuelling again and so on, giving a high rev/low rev/high rev/low rev cycling about once every 3 or 4 seconds. It is this disconcerting cycling that is the symptom of a failing AAV.

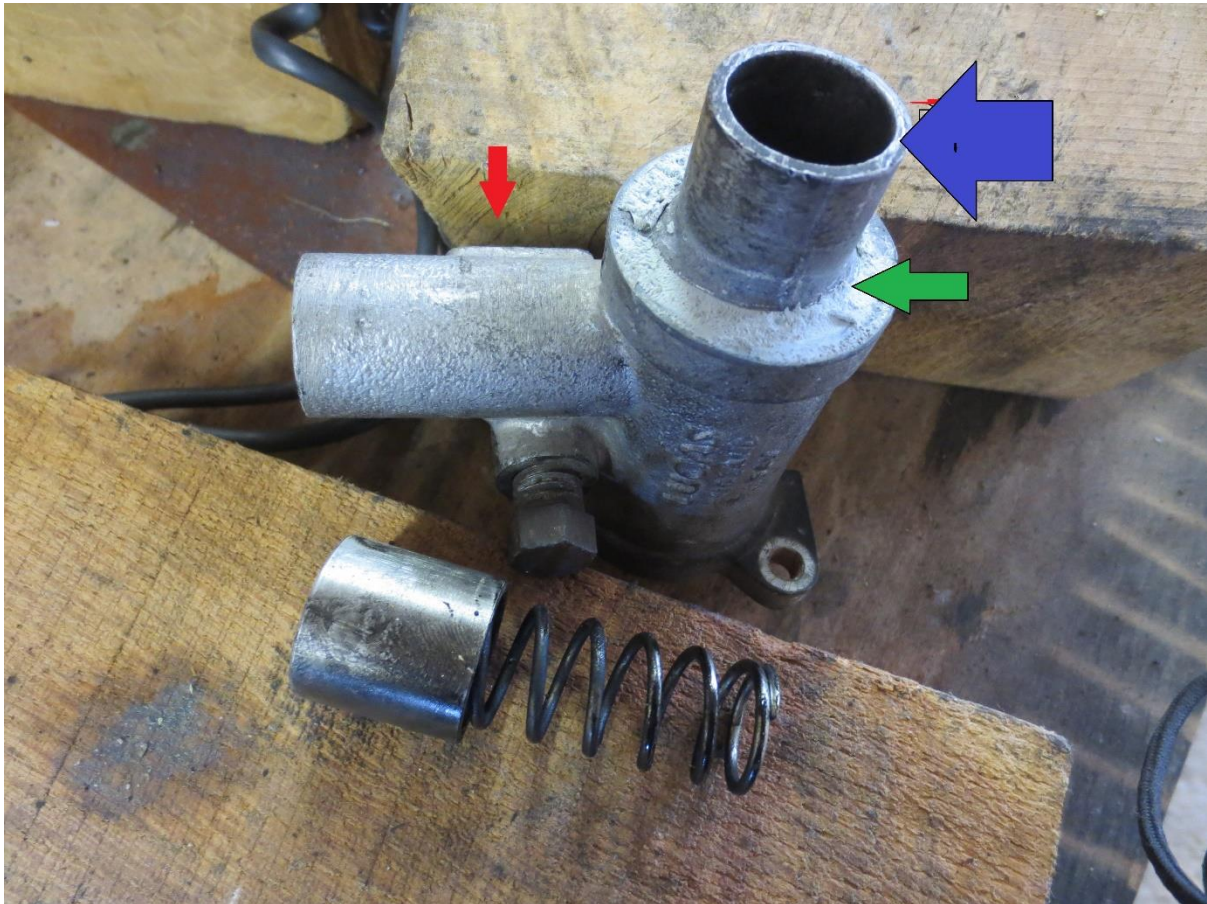
I wanted to have an electrically activated driver-controlled cold start device that could be switched on or off from the cabin, while retaining the slow running adjustment function of the AAV. As I had a non-functioning spare AAV, I followed Grant Francis' procedure (see link above) in order to dismantle it. Having taken it apart I removed the cylinder, piston and its return spring from the casting, then rotated the cylinder through 180 degrees to close off the airway, and used epoxy hard-setting putty to completely seal it. In the photo below, the large **blue arrow** indicates the

cylinder, the **green arrow** indicates where the cylinder has been released from the outer casing and turned 180 degrees to close the air passage and then resealed; the **red arrow** indicates the air entry tube from the air filter box. The original air passage opening is at the cylinder end of this air passage. The piston has been removed from the unit as is obvious. The following photo shows the air passage at the cylinder end completely sealed with epoxy putty.

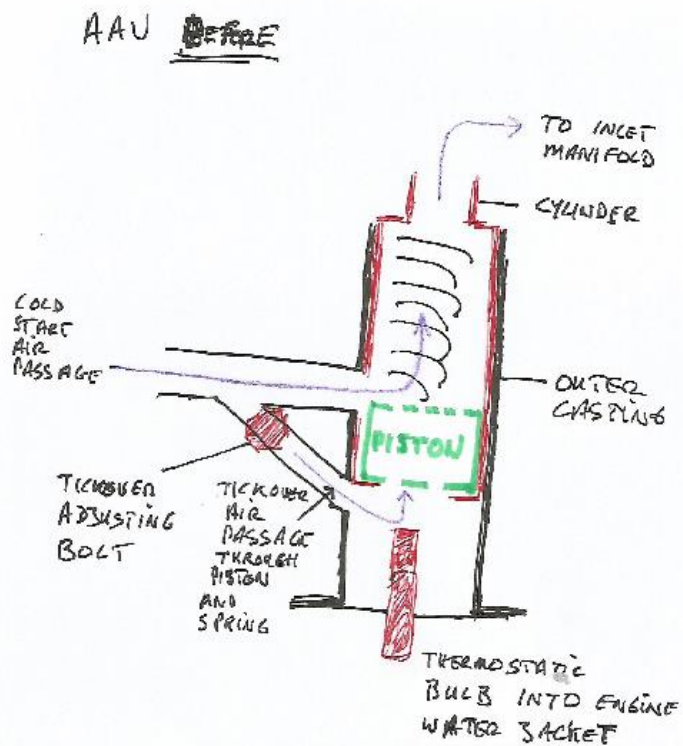
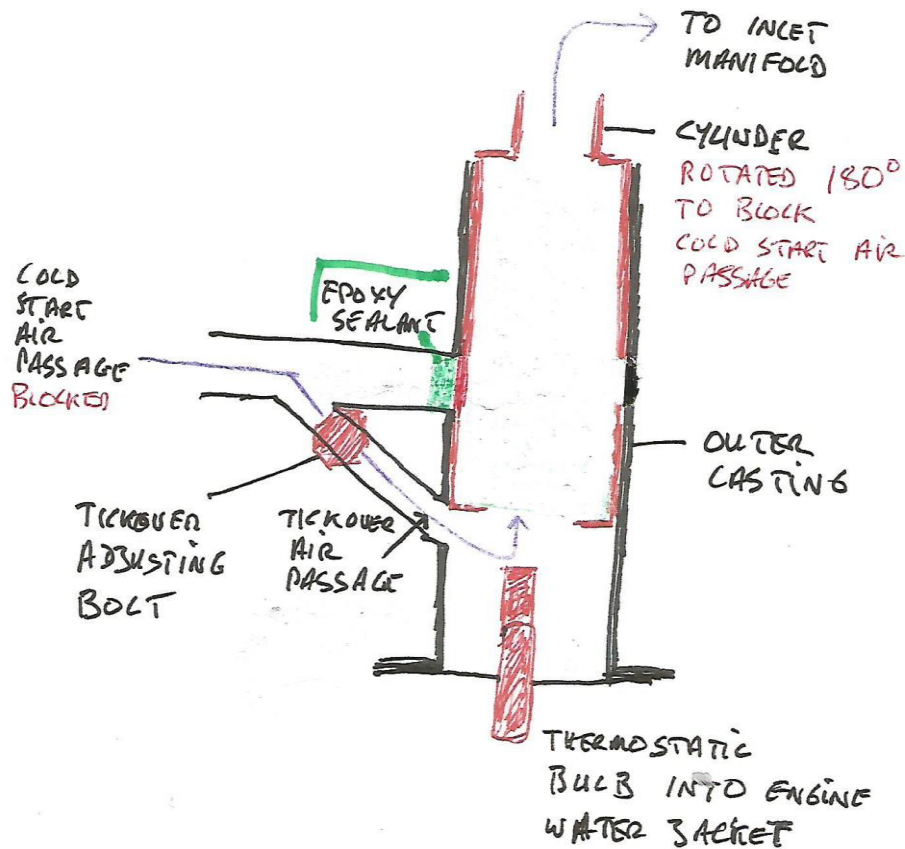
AAV AFTER

An important point to understand is that blocking this air passage does NOT block the function of the slow running adjustment screw. The air passage for the tickover adjustment has a separate route through the casting. In diagrammatic form, this is what has been done:

As the diagram shows, the AAV casing has been emptied of its moving parts except for the slow running (tickover) adjustment function. The AAV was then reinstalled on the engine just as before. There is no need to touch the thermostatic bulb.

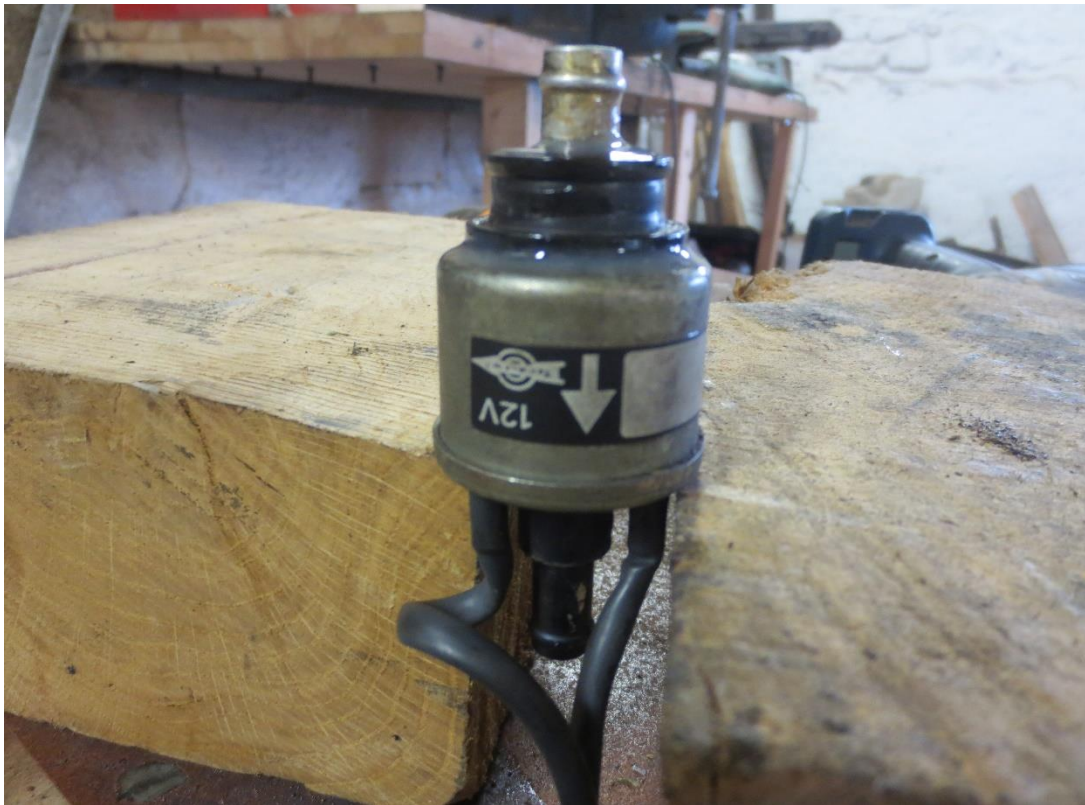
The ideal mechanism for this function is an electrically operated solenoid that can be switched on and off from the cabin. The problem was finding a suitable one that gave enough airflow. As standard, many V12 XJSs are fitted with a solenoid that is automatically activated when the air conditioning compressor runs. This is an extra air device to ensure that in traffic, or at a standstill for some other reason, the load produced by the compressor running does not stall the engine if it is ticking over. The OEM solenoid works well for this anti-stall function, but my experiments showed that it does not flow enough air to reliably run a stone cold engine from startup. The bore of the solenoid's air pipe is just too narrow. A photo of this item is shown below:

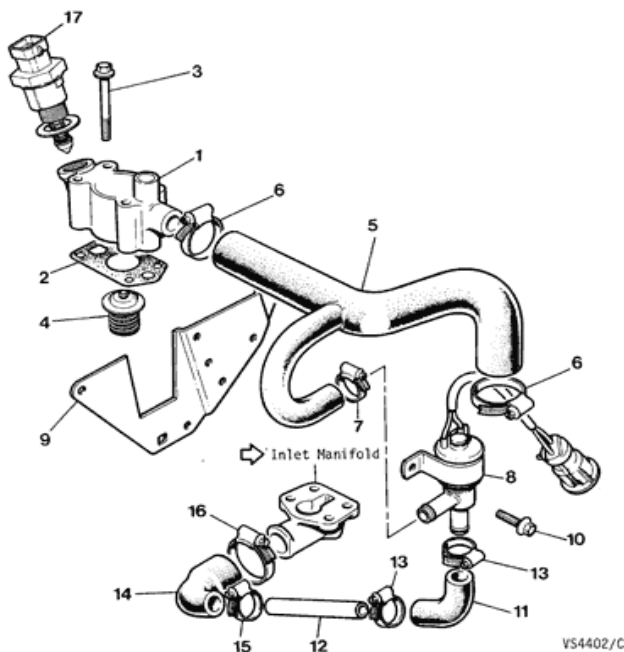
In the diagram below shows the part concerned is No. 8:

In the diagram, the air inlet is at the side of the solenoid and the outlet to the manifold is at the bottom of the unit. This solenoid flows enough air to enable the V12 to tickover at about 800 RPM when stone cold at an ambient temperature of 0 degrees C (32 F). The photo below shows the unit:

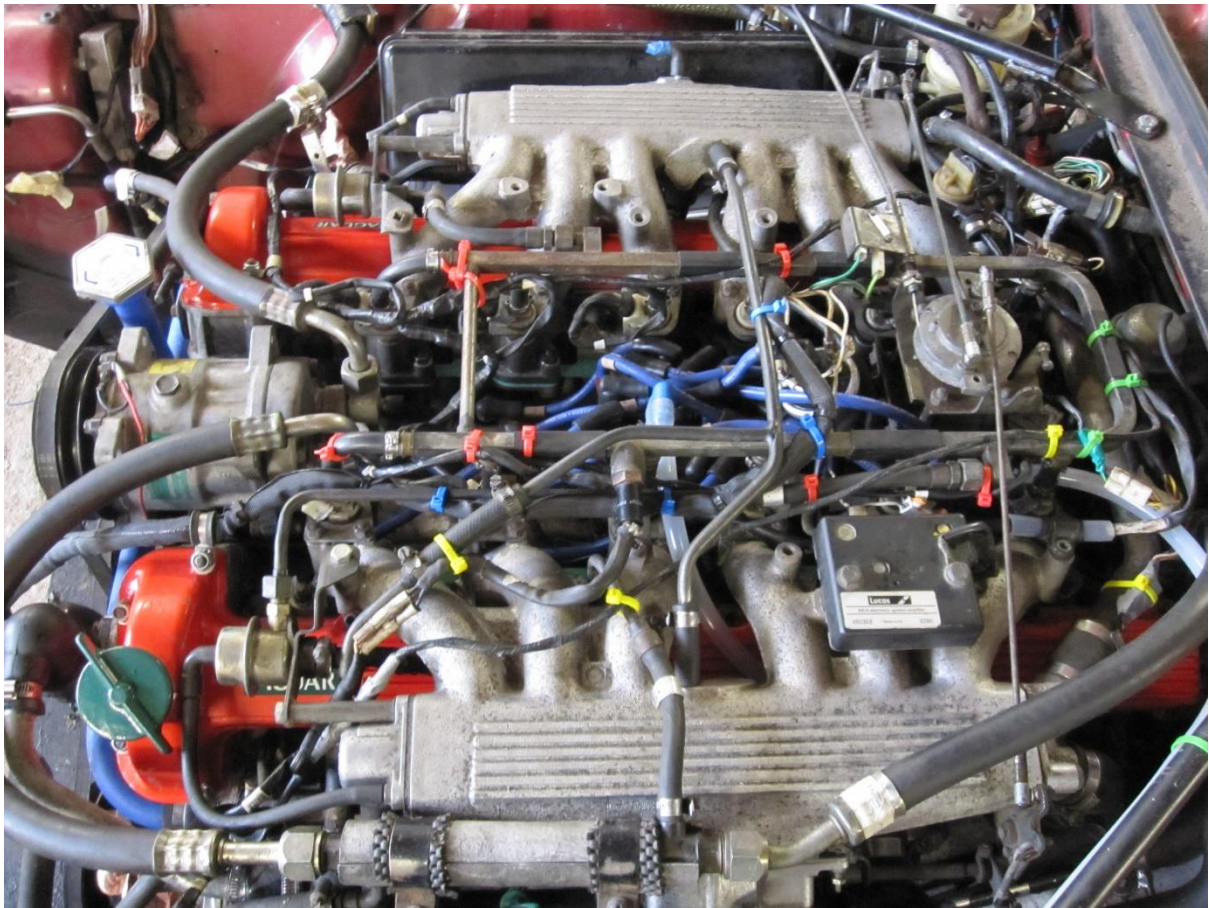
The photo below shows the PCV airbox to manifold pipe (basically a T shaped affair) before removal. In early experiments I used this pipe as the cold start air feed from the solenoid, while it worked, it was too small a bore to flow sufficient air immediately after a cold start on a really cold day, so the engine did not run evenly for the first minute or so. Using a 13mm ID pipe cured this problem.

The pipe concerned is the grey steel one that runs across the middle of the engine from the top centre of each manifold, and then the leg of the T shape runs forwards (leftwards in the photo) and downwards behind the manifold at the bottom of the photo. It has a yellow cable tie on it (the leftmost yellow tie in the photo) and a blue cable tie on it in its centre between the manifolds.

Although invisible in the photo, this pipe actually runs to the inside face of the B bank airbox. At the front end of the airbox there is an inlet from the crankcase breather. This breather inlet was blocked off as the crank breather on my car goes to a catch tank. The solenoid was installed on the rear of the B bank airbox, utilising the hole to which the removed manifold pipes and PCV sprung valve were connected before removal. The photo below shows the solenoid installation on the airbox:

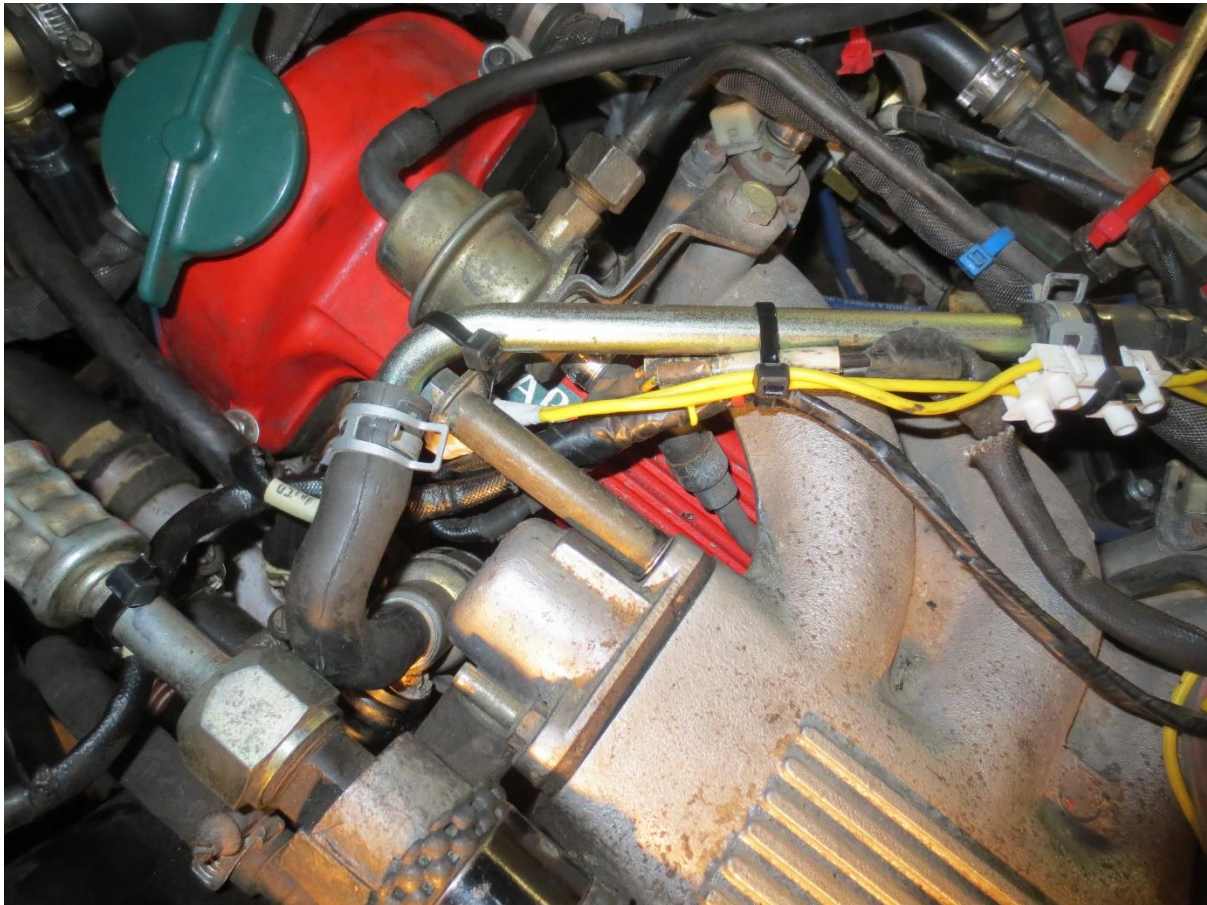
Various pieces of the manifold assembly had to be removed get access to fit the solenoid, but it is quite obvious what to do when you are looking at an actual engine. The following photo shows it all installed and the various bits that had to be removed for access purposes reattached to the B bank manifold. The flexible exit pipe from the solenoid can be seen clearly, linking to the gold steel pipe with a sprung clamp.

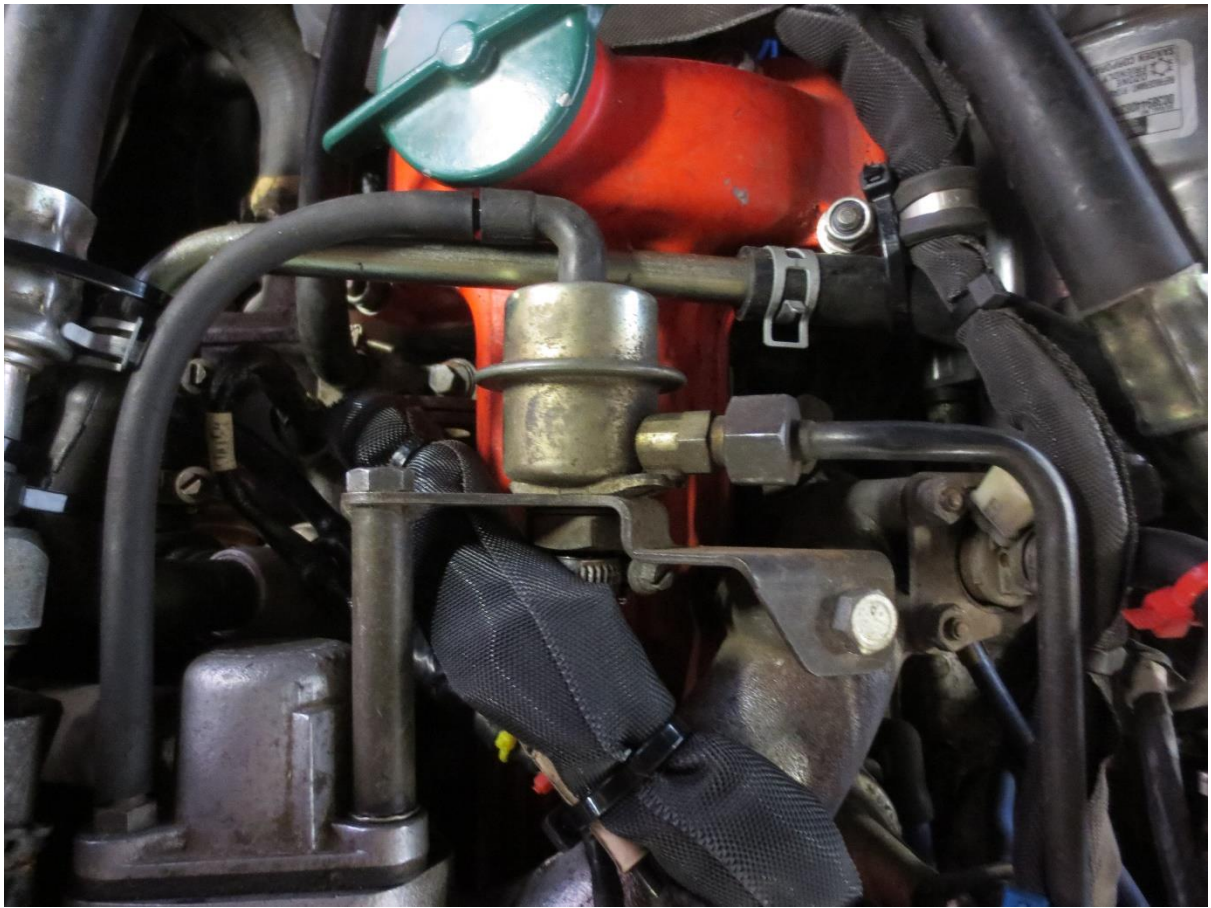
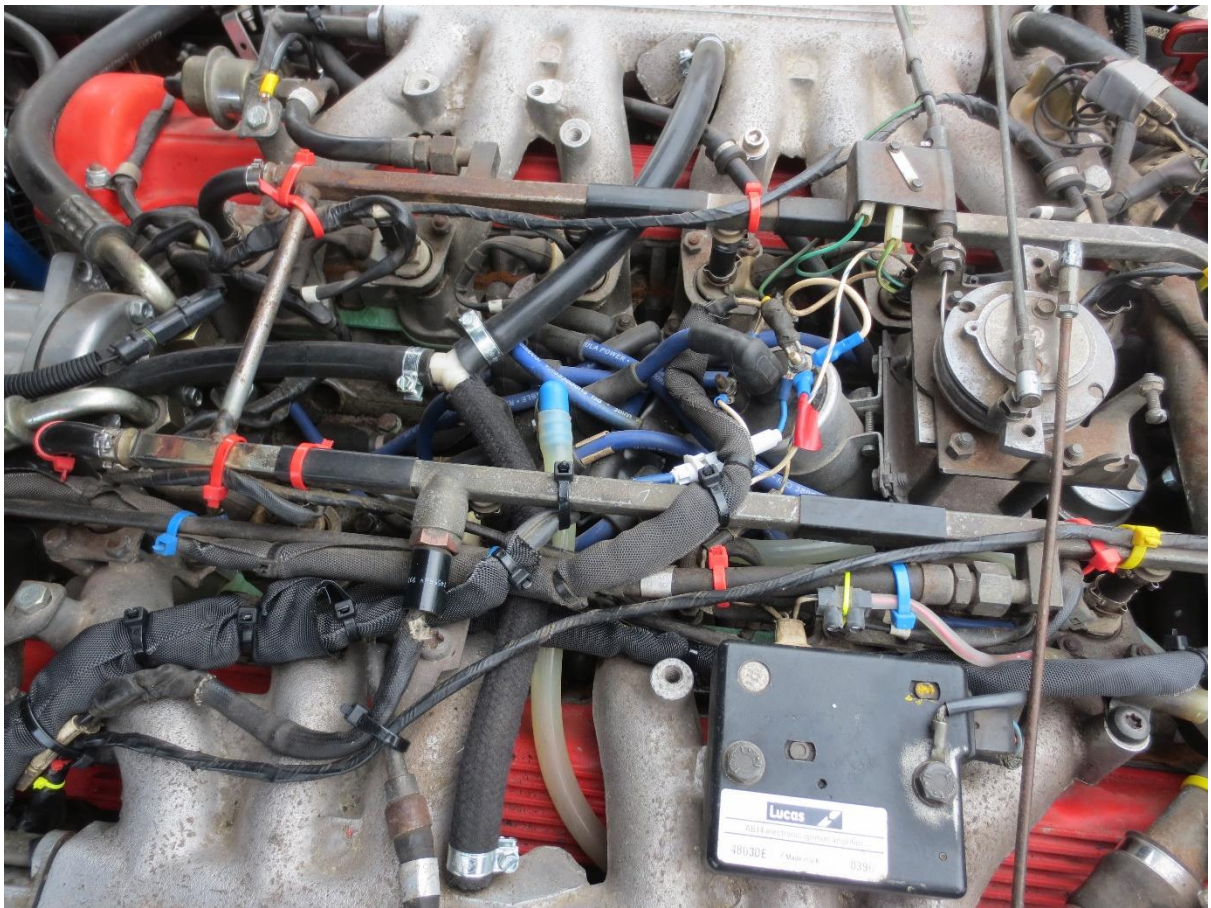
The following two photos show how the solenoid is connected to the inlet manifolds. In the first photo, the gold steel pipe with the spring clamps (shown in close-up above) is running under the fuel pressure regulator and is connecting to the main silicone tubing. This tubing is thick walled 13mm ID fibre-reinforced silicone tubing with a Y fitting to split the feed, as shown in the second photo below. Thick walled tubing is needed to prevent it collapsing under manifold vacuum when the system is switched off. In the second photo the silicone tubing, Y connector and tubing to the manifold throttle body inlet spigots is clearly visible; as is the wrapped loom to the system and the fused feed from the coil.

4. A new solenoid can still be purchased, but it is expensive; however second hand ones are easily available in the UK and quite cheap.
5. The feed pipes from the solenoid to the manifolds need to have an ID of 13mm minimum to provide enough flow and connect to the solenoid easily. I have used thick walled silicone tubing with reinforcing fibres that will easily withstand the engine bay heat and not collapse under manifold vacuum when the cold start system is switched off.

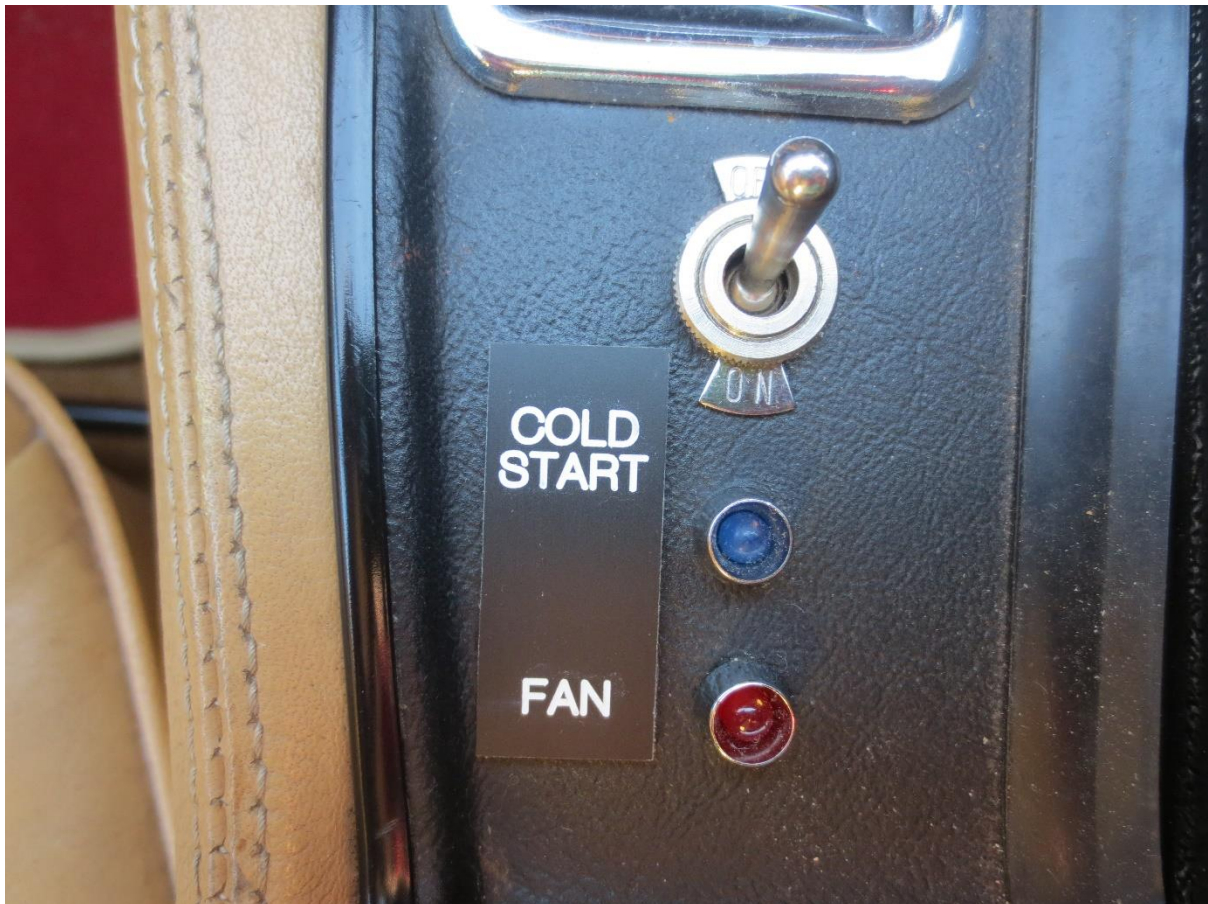
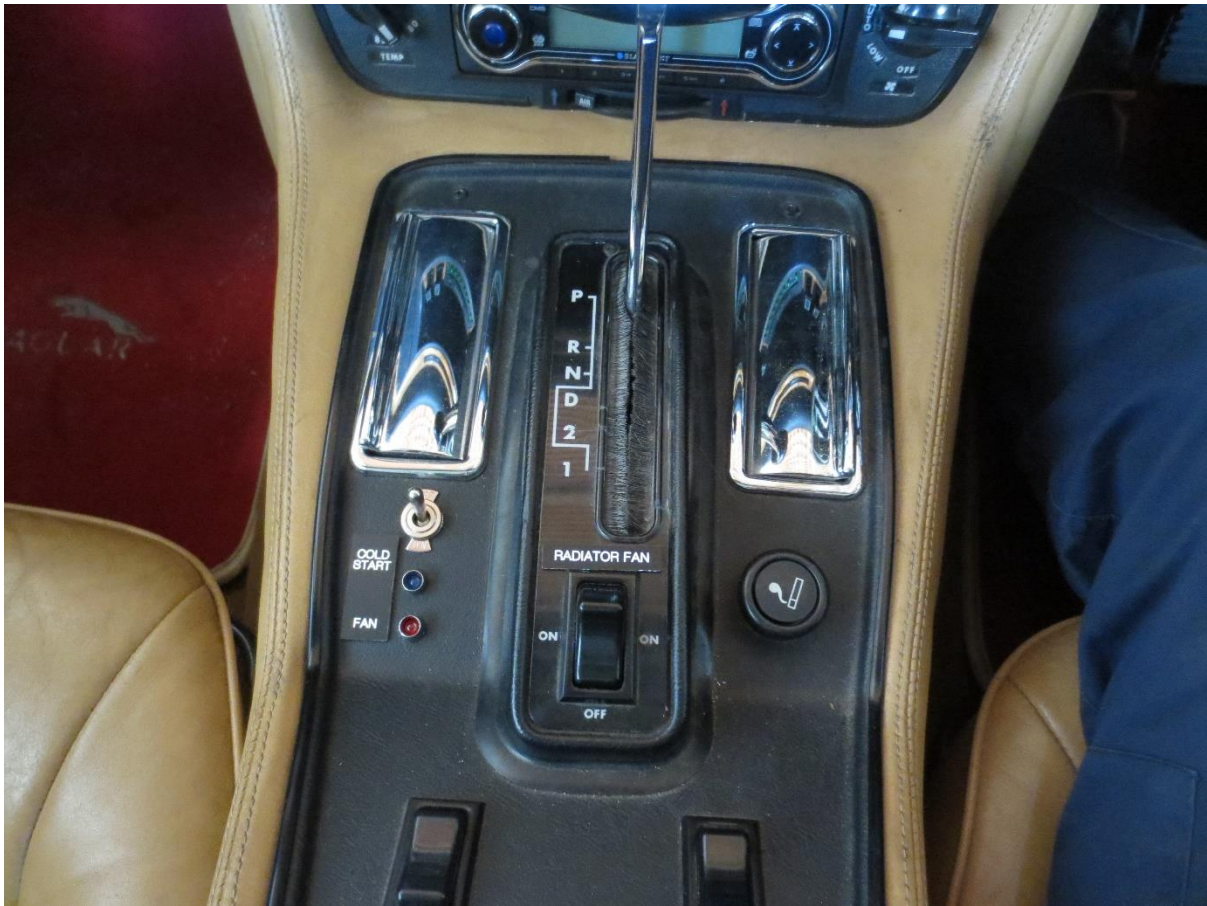
The solenoid is powered by a feed taken from the coil positive terminal, it draws less than an amp and that only when activated, so should not overload the circuit. It has a dedicated inline fuse between the coil terminal and the solenoid. The switching is done to earth from a wire that runs into the cabin through the same routing that the heater unit vacuum tube takes. The cabin switch is installed in the console top just behind the ashtray, together with a dedicated warning light, as shown in the following two photos.

Note that on my car, as the cruise control is removed and I have an electric main fan installed, the cruise control master switch has been repurposed as a switch for the main radiator fan in the event of the thermostatically operated system failing. My car has a "fan running" warning light installed in addition to the cold start warning light and switch.
