XJS inboard-braked handbrake improvement

This paper explains in detail what the problems are with the mechanical handbrake mechanism as fitted to inboard-braked Jaguar double rear wishbone axles; it also explains how one enthusiastic owner has attempted to improve its performance and reliability.

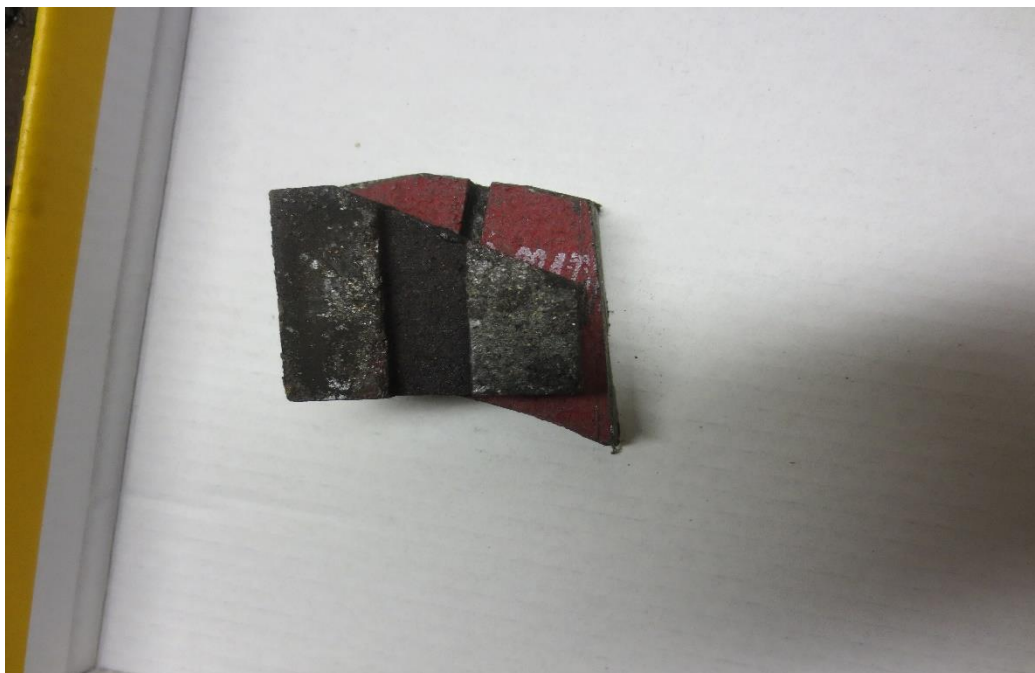
1. Enlarging the pad area: The photograph below shows the difference between the standard pad and the author’s modified pad.

It is estimated that this gives around 30% more pad area. There is scope for a substantially greater increase in pad area, as the unswept part of the disc in this photograph shows:

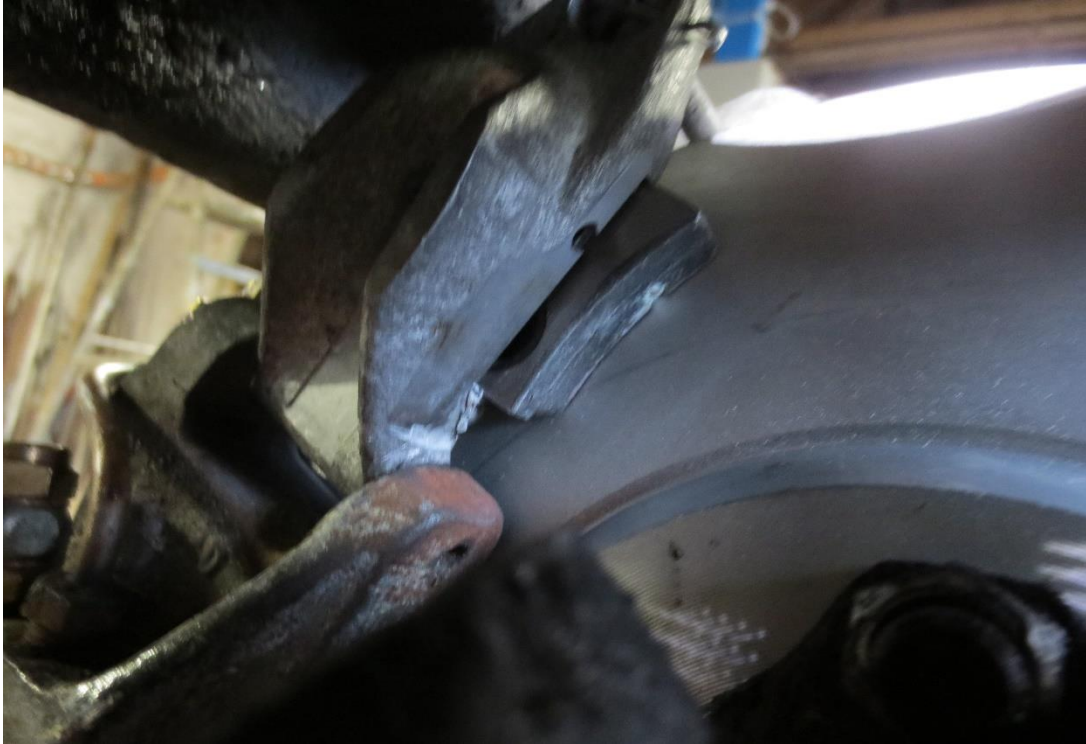
The problem with using this unswept area would be that more than half of the pad would not be directly supported by the calliper, but be “hanging” out of the bottom of it. Whether this would be a problem in practice, as the pad and its backing is bolted to the calliper, is not known. However caution was exercised and a much larger pad was not used in this first stage of modifications. It would be possible to weld an extension onto the calliper arm if testing proves extra pad area is necessary.

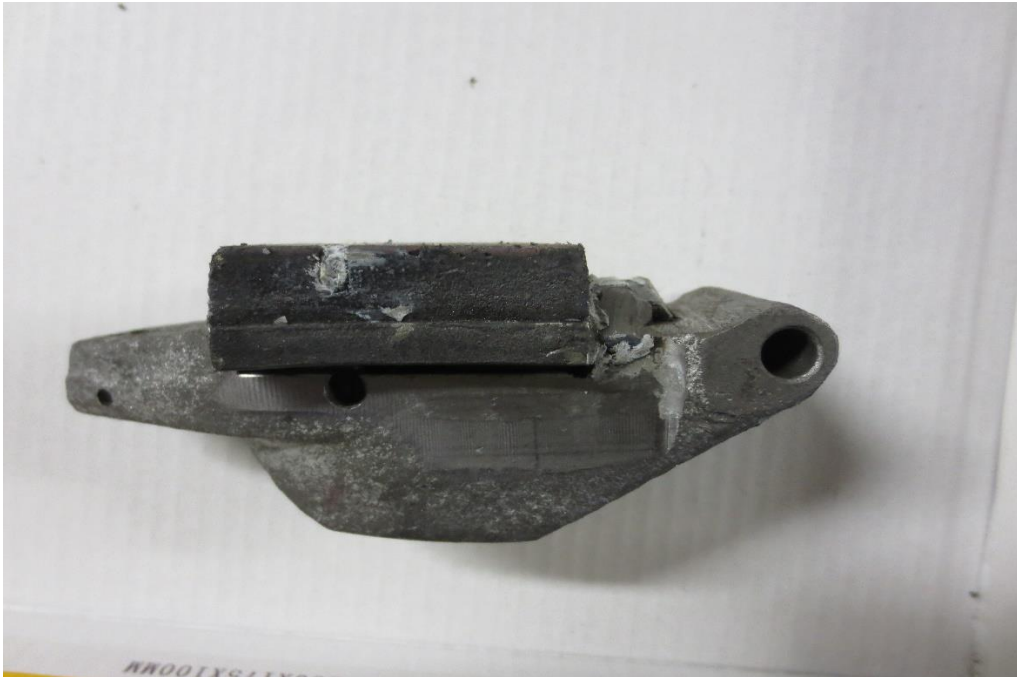
The new type of pad fitted to the modified calliper arm, with the pad material butting up to the newly welded shoulder, is shown here:

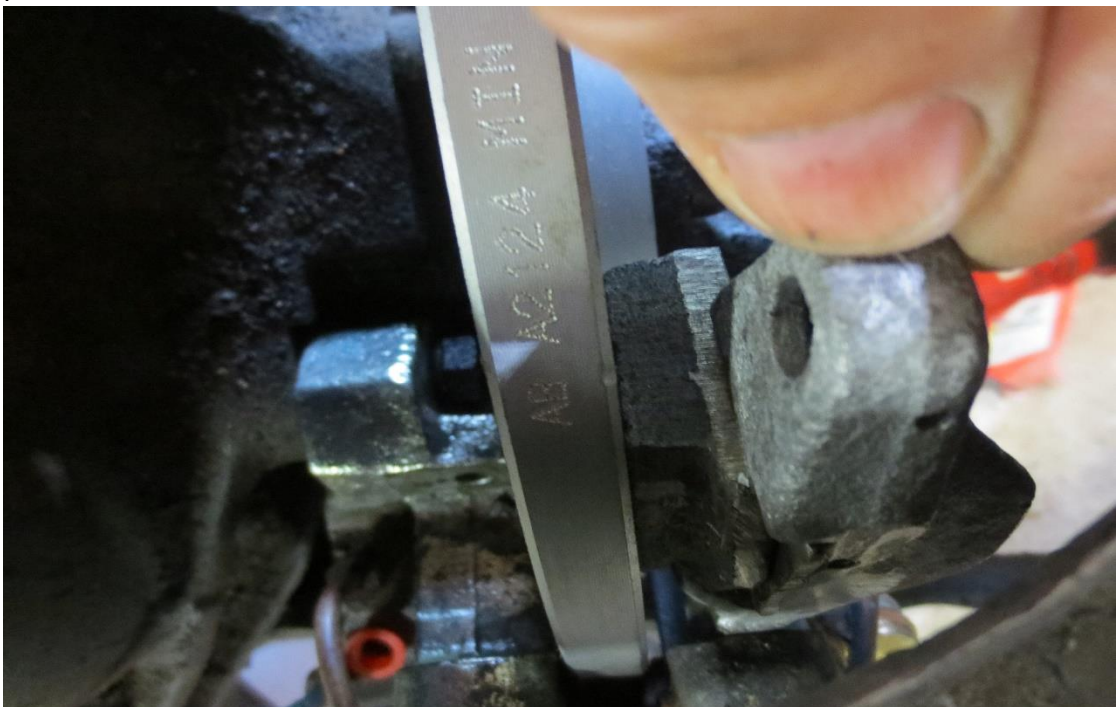
4. Removing as much lost motion from the system as possible and aligning the pad with the disc precisely: The mechanism does not push the pad evenly and squarely against the disc, but in a swinging motion pivoting at one end of the calliper and moving inwards towards the disc at the other. Therefore it is essential to trial fit the calliper arm, with the pad attached, against the disc to ensure a close and parallel pad to disc fit.

and parallel to it. If not, when the handbrake is applied not all the pad area will act on the disc, and consequently brake effectiveness will be reduced and the pad-to-backing plate join will be stressed. The photograph above shows the author trial fitting a calliper arm which is swinging on its pivot; the pad has been shimmed between the backing plate and the calliper arm and is sitting evenly against the disc and close to it. The photograph below shows some of the shims used:

The aim of the trial fit is to then adjust the pad position by using shims (or by sanding down the pad if it is too thick) so that the pad is, at rest, about 5 thou from the disc

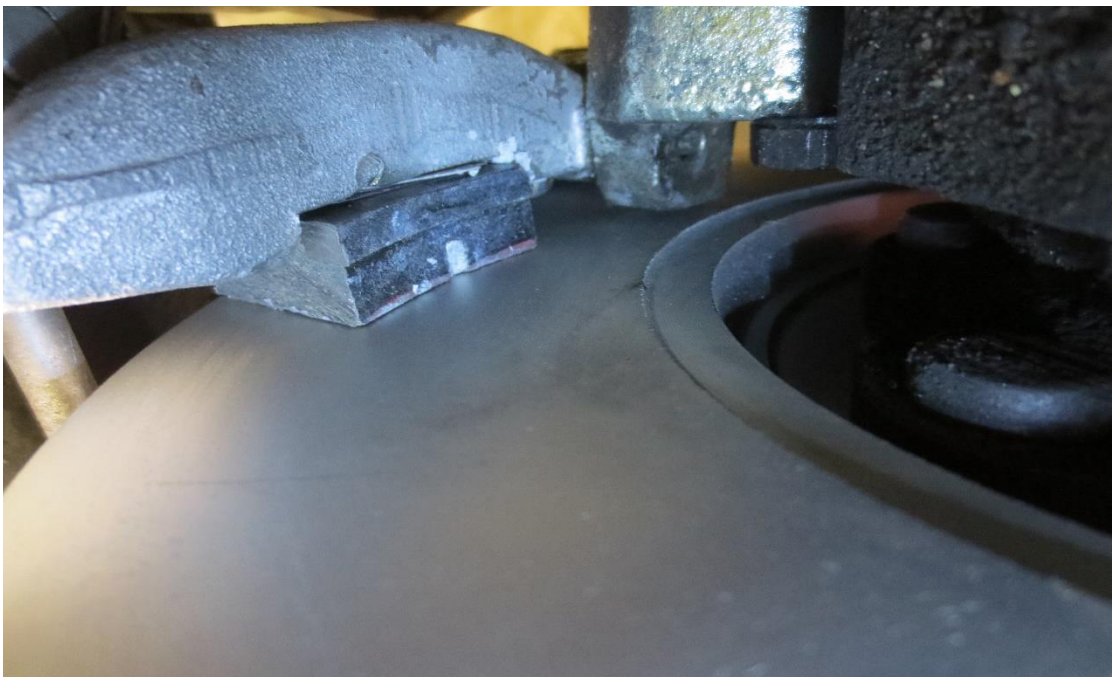
In the photograph below of the finished job, a shim used can just be seen between the calliper arm and the pad:

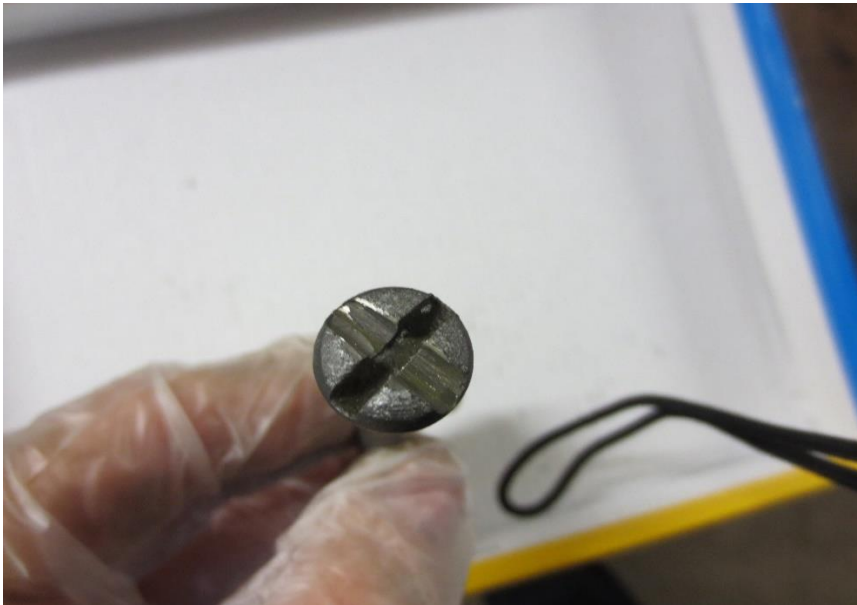
Finally, the automatic adjustment system that compensates for pad wear has a threaded screw that sets the pad position initially. It is then locked into position by means of a split pin that anchors a slot in the screw head to the calliper arm.

Therefore the screw, which has a coarse thread, has to be adjusted a minimum of half a turn at a time, which is too coarse an adjustment in the author's view, who was aiming for a 5 thou gap at rest between the pad and the disc. The photograph above shows a second slot that was cut in this screw head to allow quarter turn adjustments.

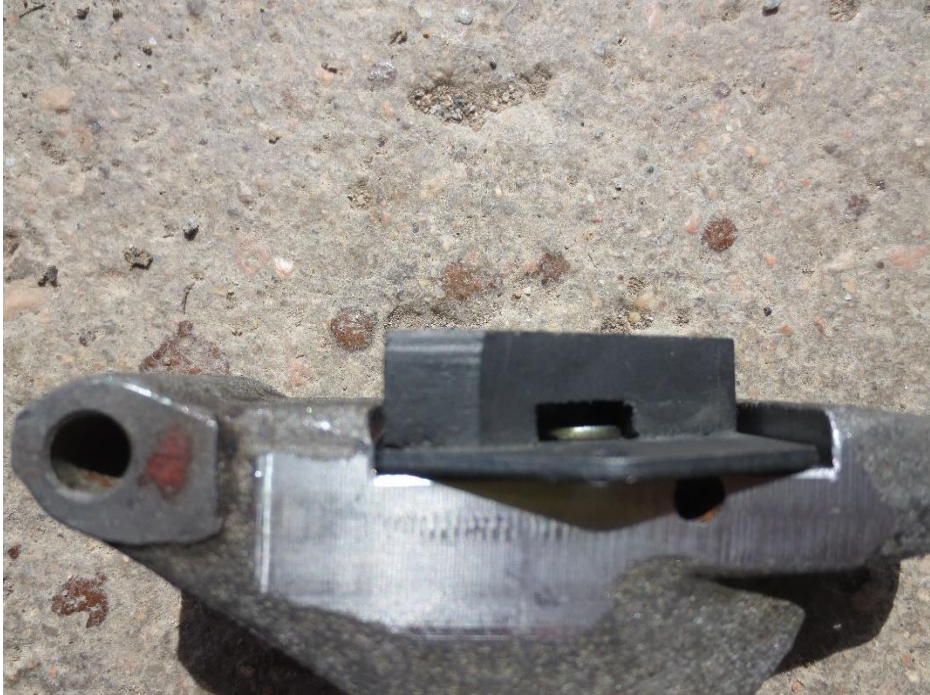
5. Robustly attaching the pads to the calliper arms: The type of pads being used are cut-down footbrake pads, EBC reference number DP 680, which are 15mm thick in total. The original pads are 13.5mm thick in total of which the backing plate is 2mm. On the original pads, a T headed bolt slips into an indentation in the pad material and a nut is threaded onto the bolt where it protrudes through the back of the arm, as shown in the photograph below

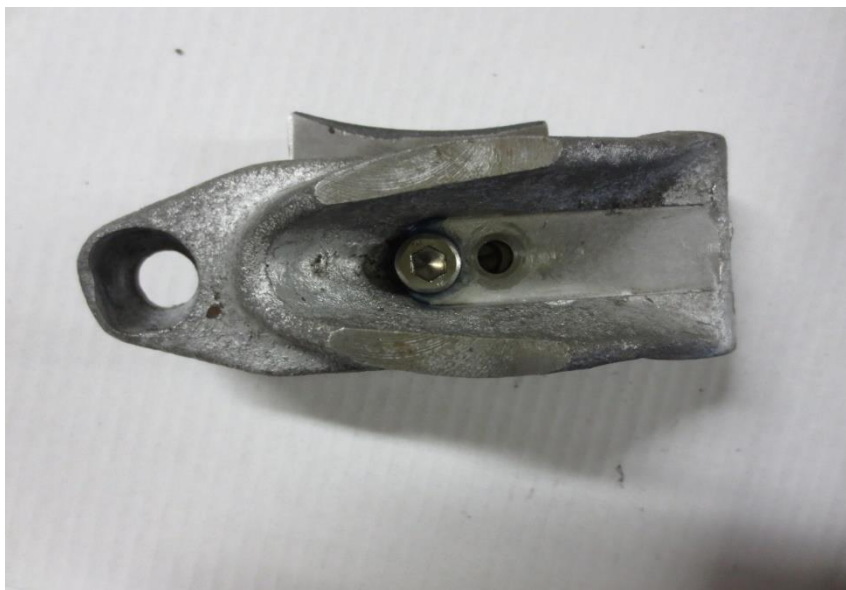
On the replacement pads the backing plate is 6 mm thick, and so quite thick enough to be tapped in order to bolt the pad to the calliper arm. The author replicated the essentials of the original attachment system on the replacement pads, by drilling and tapping the 6mm backing plate of the new pads and bolting them up to the arm with a ¼ inch UNC stainless Allen headed bolt as shown here:
